Asbestos Report

YARRIAMBIACK SHIRE COUNCIL

PROPERTY ADDRESS:
LB27 ELDERLY CITIZEN CLUBROOMS (OLD
BANK)
59 BROOK STREET
WOOMELANG VIC 3485

INSPECTION DATE: 11 FEBRUARY 2021
REFERENCE NUMBER: 62150

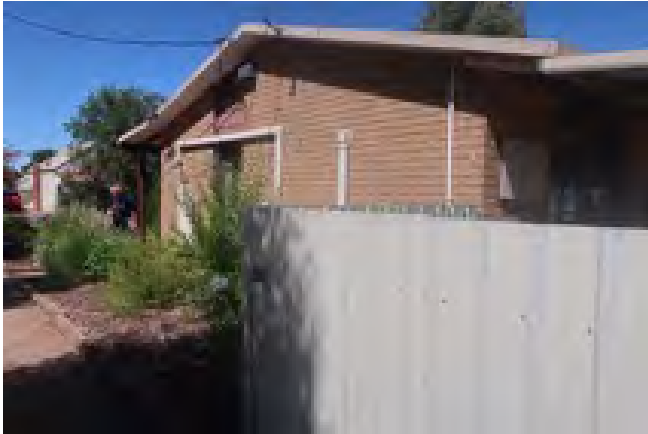
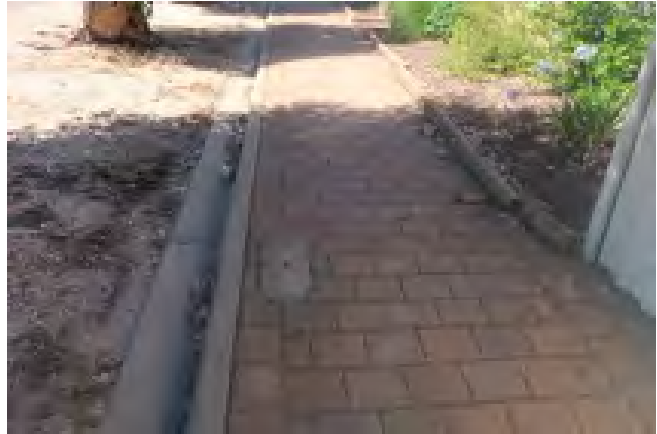
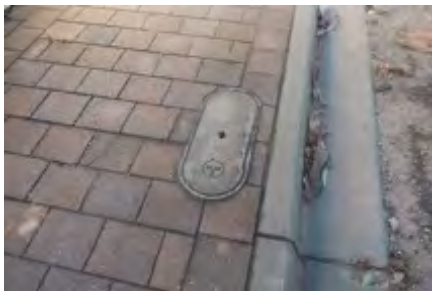
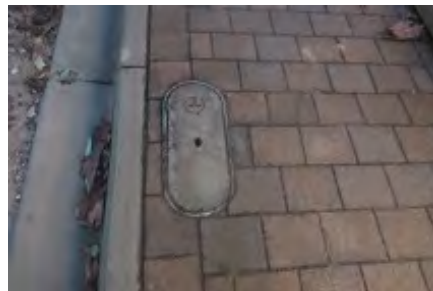
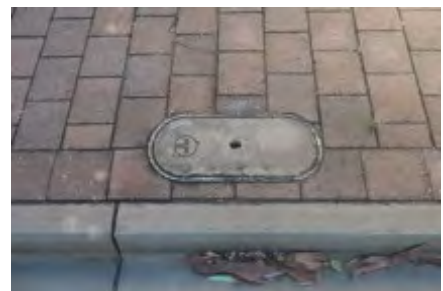
Area 3

LB27 Elderly Citizen Clubrooms (Old Bank): right side of building. The Service pit (Fibrous Cement Product) has Asbestos Containing Material (ACM) present.

RISK ASSESSMENT					
Type of Asbestos or Hazardous Material	Chrysotile	Condition	AVERAGE	Likelihood of Damage	M (Medium) - likely
	Sample taken 62150-003	Activity	Moderate		
		Sealed	No	Friability	Bonded (non-friable)
		Labelled	No	Exposure Risk	Medium - Moderate risk
		Quantity

RISK CONTROL					
Priority	HIGH	Label Required	Yes	Re- Audit Date	11 Feb 2022
Action	Remedial repairs required - seal raw material / edges				
Recommendation	Raw material sheeting - The area requires immediate remedial repairs. It is recommended the asbestos material be sealed with an approved membrane.				
Legislative Requirements Victorian Regulation 2007	Damaged ACM visible in area. Requires IMMEDIATE ATTENTION. WARNING labels should be affixed. Avoid mechanical damage and abrasion. Remove if refurbishment, structural alteration or demolition is to be carried out in this area. Re-inspect every 12 months or earlier if disturbed or removed in accordance with the Victorian OH&S Regulation 2017. All remedial/removal repairs require a Clearance Inspection & Certificate to be recorded by an approved and competent assessor.

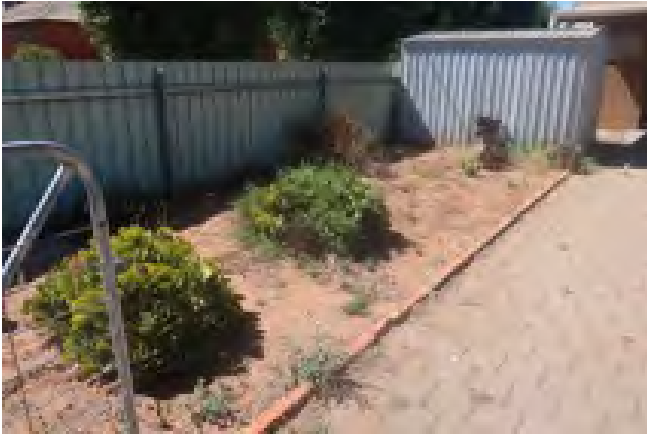
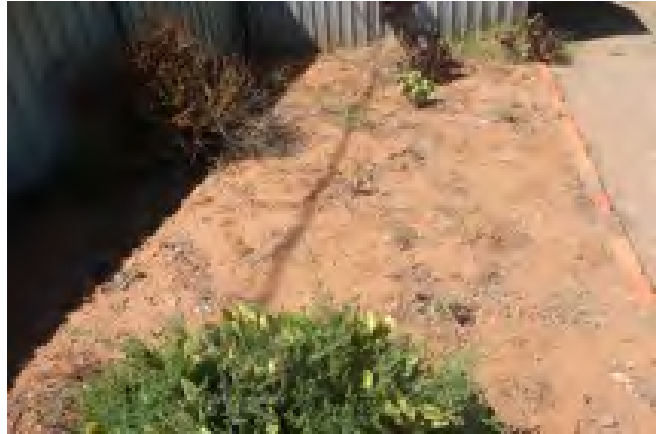
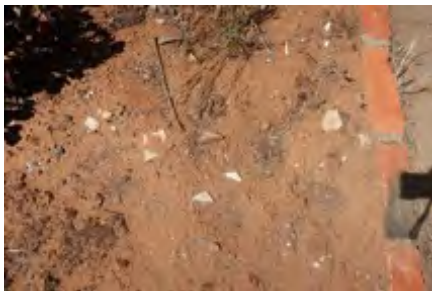
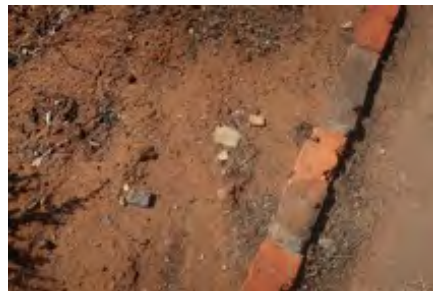
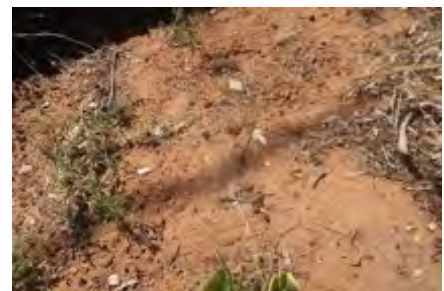
LB27 Elderly Citizen Clubrooms (Old Bank): rear of building. The Debris - Broken (Debris) has Asbestos Containing Material (ACM) present.

RISK ASSESSMENT					
Type of Asbestos or Hazardous Material	No sample taken - Visual ID	Condition	POOR	Likelihood of Damage	H (High) - almost certain
		Activity	Moderate		
		Sealed	No	Friability	Exposed Fibres
		Labelled	Y	Exposure Risk	High - Short term exposure risk
		Quantity

RISK CONTROL					
Priority	IMMEDIATE	Label Required	Yes	Re- Audit Date	11 Feb 2022
Action	Restrict access and target for imminent removal				
Recommendation	Debris on Surface - The Debris requires immediate cleanup and disposal with specialised equipment and with licensed removalist to safely remove the asbestos debris.				
Legislative Requirements Victorian Regulation 2007	ACM debris visible. Recommend cleanup by licensed Asbestos Removalist. Warning labels should be affixed. Avoid mechanical damage and abrasion. Remove if refurbishment, structural alteration or demolition is to be carried out in this area. Re-inspect every 12 months or earlier if disturbed or removed in accordance with the Victorian OH&S Regulation 2017. All remedial/removal repairs require a Clearance Inspection & Certificate to be recorded by an approved and competent assessor.

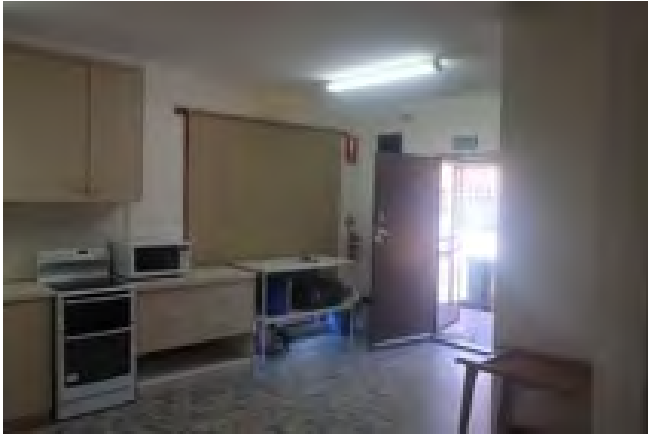
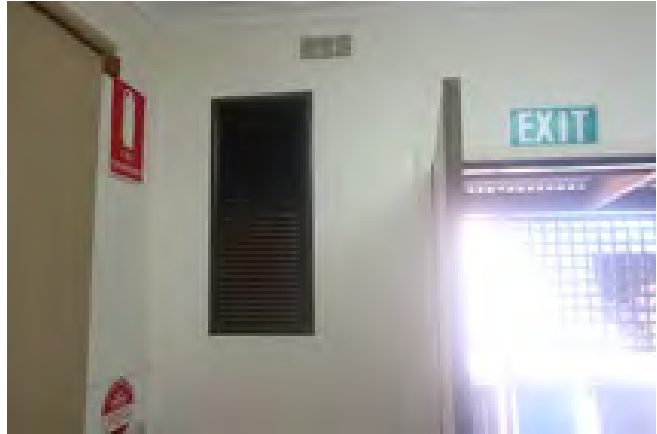
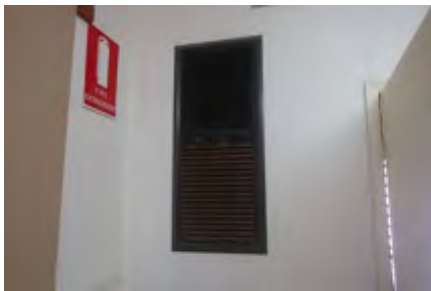
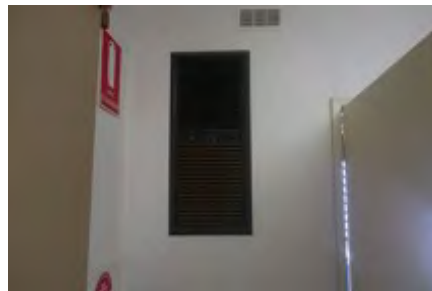
LB27 Elderly Citizen Clubrooms (Old Bank): Kitchen 2. The Heater banks (Fire Retardant & Backing board) has Asbestos Containing Material (ACM) present.

RISK ASSESSMENT					
Type of Asbestos or Hazardous Material	No sample taken - Visual ID	Condition	GOOD	Likelihood of Damage	L (Low) – possible
		Activity	Moderate		
		Sealed	Yes	Friability	Bonded (non-friable)
		Labelled	Y	Exposure Risk	Low - Negligible or low risk
		Quantity

RISK CONTROL					
Priority	MEDIUM	Label Required	Yes	Re- Audit Date	11 Feb 2022
Action	No remedial action required, unless disturbed				
Recommendation	Maintain paint or sealant to ACM surfaces. Particular attention should be given to side edges, ensure paint/sealant covers ALL exposed ACM surfaces.				
Legislative Requirements Victorian Regulation 2007	Warning labels should be affixed. Avoid mechanical damage and abrasion. Remove if refurbishment, structural alteration or demolition is to be carried out in this area. Re-inspect every 12 months or earlier if disturbed or removed in accordance with the Victorian OH&S Regulation 2017. All remedial/removal repairs require a Clearance Inspection & Certificate to be recorded by an approved and competent assessor.

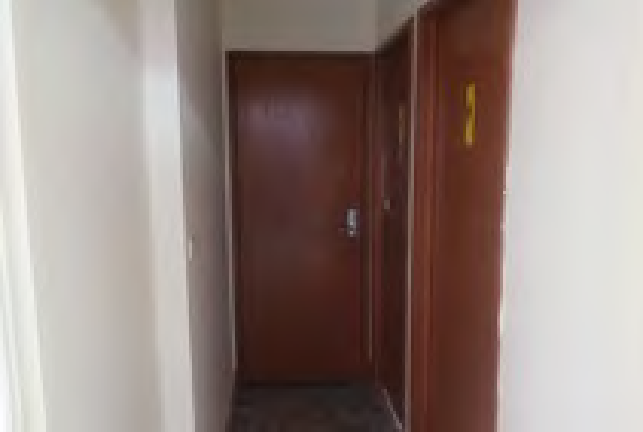
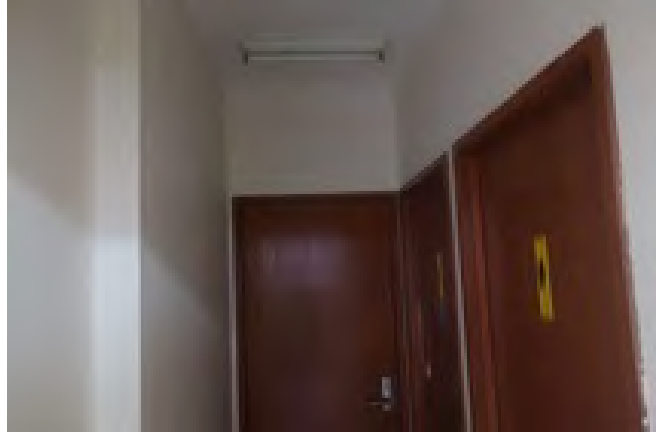
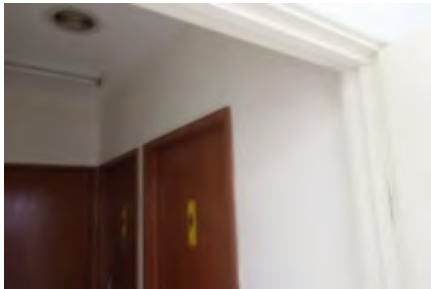
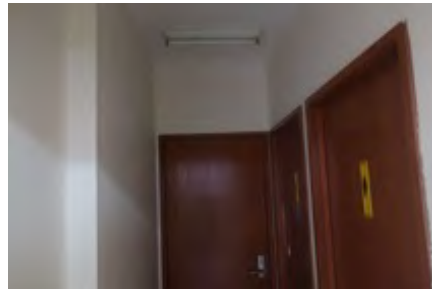
Area 4**LB27 Elderly Citizen Clubrooms (Old Bank): Bathroom walkway 3. The Walls (F C Sheeting) has Asbestos Containing Material (ACM) present.****RISK ASSESSMENT**

Type of Asbestos or Hazardous Material	No sample taken - Visual ID	Condition	GOOD	Likelihood of Damage	L (Low) – possible
		Activity	Moderate		
		Sealed	Yes	Friability	Bonded (non-friable)
		Labelled	Y	Exposure Risk	Low - Negligible or low risk
		Quantity

Priority	MEDIUM	Label Required	Yes	Re- Audit Date	11 Feb 2022
Action	No remedial action required, unless disturbed				
Recommendation	Maintain paint or sealant to ACM surfaces. Particular attention should be given to side edges, ensure paint/sealant covers ALL exposed ACM surfaces.				
Legislative Requirements Victorian Regulation 2007	Warning labels should be affixed. Avoid mechanical damage and abrasion. Remove if refurbishment, structural alteration or demolition is to be carried out in this area. Re-inspect every 12 months or earlier if disturbed or removed in accordance with the Victorian OH&S Regulation 2017. All remedial/removal repairs require a Clearance Inspection & Certificate to be recorded by an approved and competent assessor.

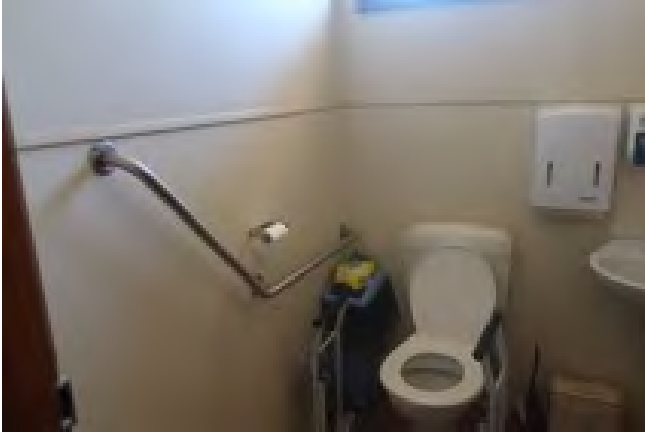
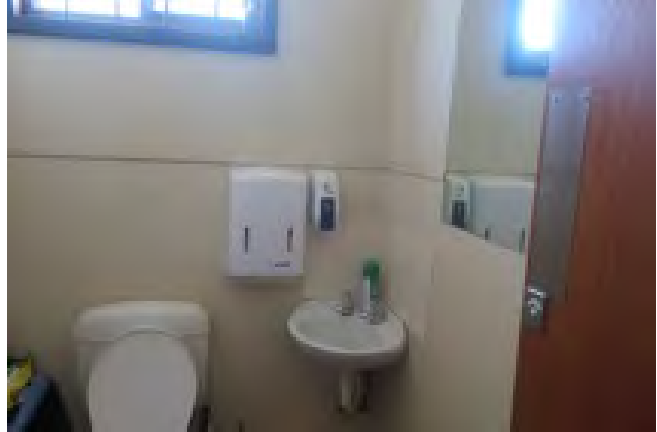
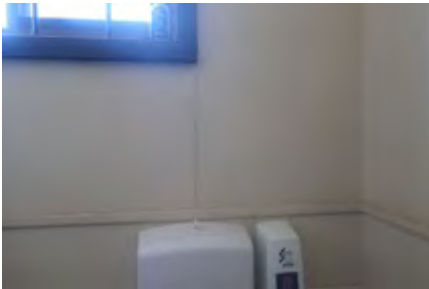
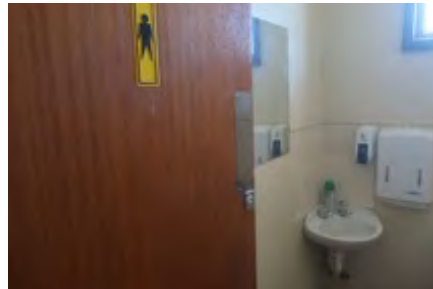
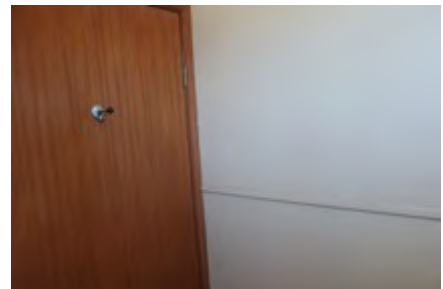
Area 6**LB27 Elderly Citizen Clubrooms (Old Bank): Male bathroom 3.1. The Walls (F C Sheeting) has Asbestos Containing Material (ACM) present.****RISK ASSESSMENT**

Type of Asbestos or Hazardous Material	No sample taken - Visual ID	Condition	GOOD	Likelihood of Damage	L (Low) – possible
		Activity	Moderate		
		Sealed	Yes	Friability	Bonded (non-friable)
		Labelled	Y	Exposure Risk	Low - Negligible or low risk
		Quantity

Priority	MEDIUM	Label Required	Yes	Re- Audit Date	11 Feb 2022
Action	No remedial action required, unless disturbed				
Recommendation	Maintain paint or sealant to ACM surfaces. Particular attention should be given to side edges, ensure paint/sealant covers ALL exposed ACM surfaces.				
Legislative Requirements Victorian Regulation 2007	Warning labels should be affixed. Avoid mechanical damage and abrasion. Remove if refurbishment, structural alteration or demolition is to be carried out in this area. Re-inspect every 12 months or earlier if disturbed or removed in accordance with the Victorian OH&S Regulation 2017. All remedial/removal repairs require a Clearance Inspection & Certificate to be recorded by an approved and competent assessor.
