**Global
Asbestos
Audits**

Asbestos Report

PROPERTY ADDRESS:
LB65 TIP WOOMELANG
121 CHURCH STREET
WOOMELANG VIC 3485

INSPECTION DATE: 11 FEBRUARY 2021
REFERENCE NUMBER: 62151

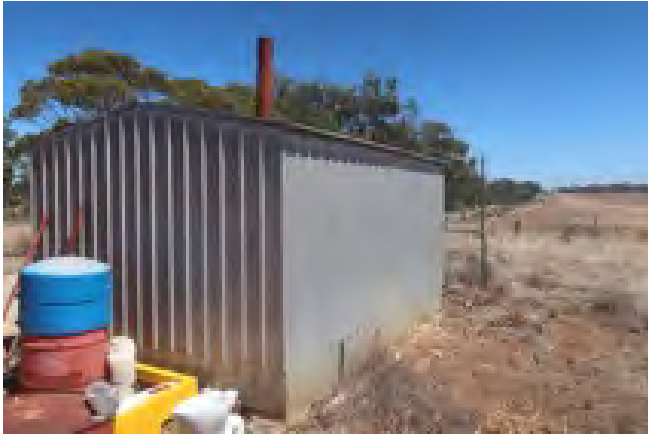
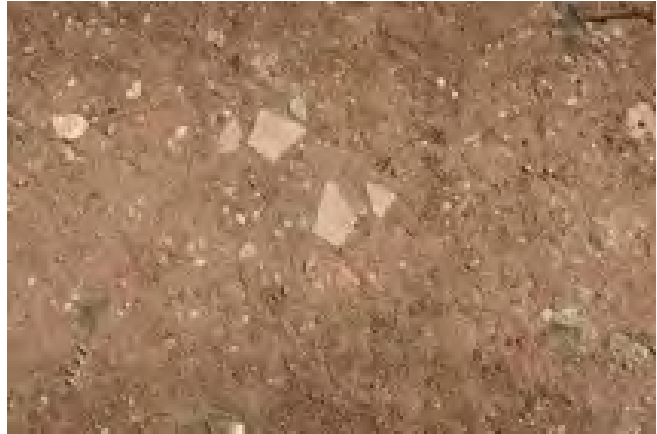
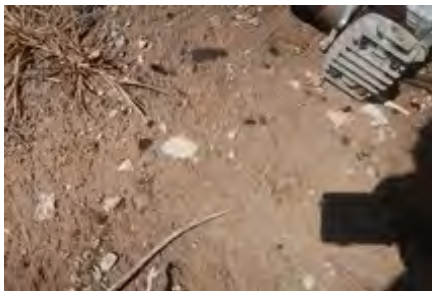
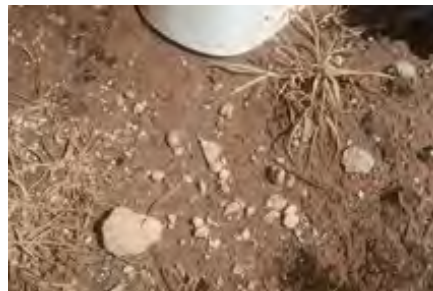
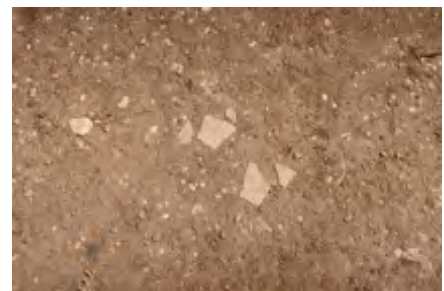
Area 2

Shed LB65 Tip: right & rear of building. The Debris - Broken (Debris) has Asbestos Containing Material (ACM) present.

RISK ASSESSMENT					
Type of Asbestos or Hazardous Material	No sample taken - Visual ID	Condition	POOR	Likelihood of Damage	H (High) - almost certain
		Activity	Moderate		
		Sealed	No	Friability	Exposed Fibres
		Labelled	No	Exposure Risk	High - Short term exposure risk
		Quantity

RISK CONTROL					
Priority	IMMEDIATE	Label Required	Yes	Re- Audit Date	11 Feb 2022
Action	Restrict access and target for imminent removal				
Recommendation	<p>Preliminary soil testing should be done to establish level of contamination & potential exposure. Debris on Surface - The Debris requires immediate cleanup and disposal with specialised equipment and with licensed removalist to safely remove the asbestos debris.</p> <p>In the meantime a wetting down program should be implemented and include minimal disturbance.</p>				
Legislative Requirements Victorian Regulation 2007	<p>URGENT - ACM visible in area. The ACM appears to be of a friable nature. The services of an "A" class Asbestos removal consultant are urgently required. Immediately cease any access to the area and affix warning signs to all entry points. Avoid physical and mechanical damage. Avoid mechanical damage and abrasion. Re-inspect every 12 months or earlier if disturbed or removed in accordance with the Victorian OH&S Regulation 2017.</p> <p>All remedial/removal repairs require a Clearance Inspection & Certificate to be recorded by an approved and competent assessor.</p>

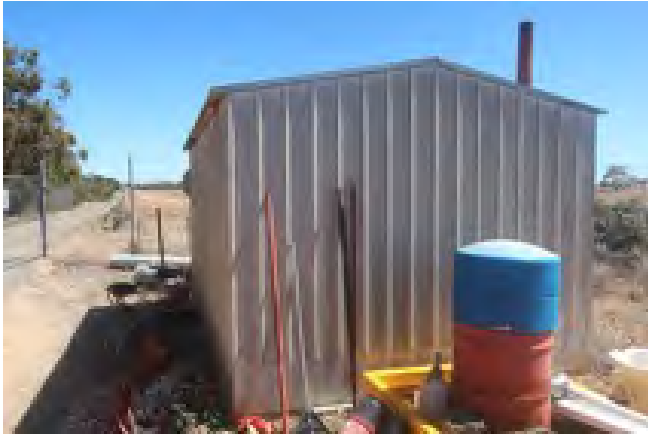
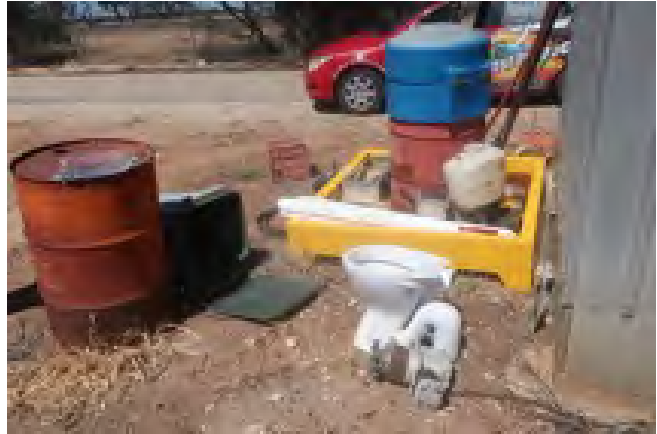
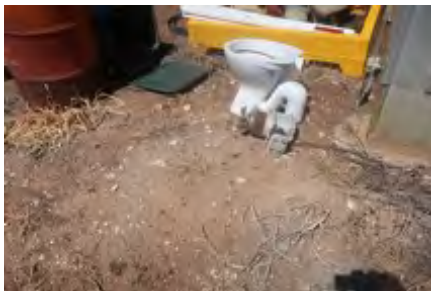
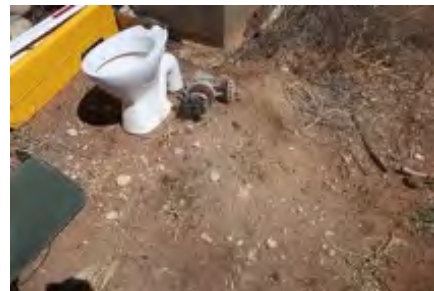
Shed LB65 Tip: right side of building. The Debris - Broken (Debris - contamination (Asbestos Fines)) has Asbestos Containing Material (ACM) present.

RISK ASSESSMENT					
Type of Asbestos or Hazardous Material	No sample taken - Visual ID	Condition	POOR	Likelihood of Damage	H (High) - almost certain
		Activity	Moderate		
		Sealed	No	Friability	Friable
		Labelled	No	Exposure Risk	High - Short term exposure risk
		Quantity

Priority	IMMEDIATE	Label Required	Yes	Re- Audit Date	11 Feb 2022
Action	Restrict access and target for imminent removal				
Recommendation	<p>Preliminary soil testing should be done to establish level of contamination & potential exposure. Debris on Surface - The Debris requires immediate cleanup and disposal with specialised equipment and with licensed removalist to safely remove the asbestos debris.</p> <p>In the meantime a wetting down program should be implemented and include minimal disturbance.</p>				
Legislative Requirements Victorian Regulation 2007	<p>URGENT - ACM visible in area. The ACM appears to be of a friable nature. The services of an "A" class Asbestos removal consultant are urgently required. Immediately cease any access to the area and affix warning signs to all entry points. Avoid physical and mechanical damage. Avoid mechanical damage and abrasion. Re-inspect every 12 months or earlier if disturbed or removed in accordance with the Victorian OH&S Regulation 2017.</p> <p>All remedial/removal repairs require a Clearance Inspection & Certificate to be recorded by an approved and competent assessor.</p>

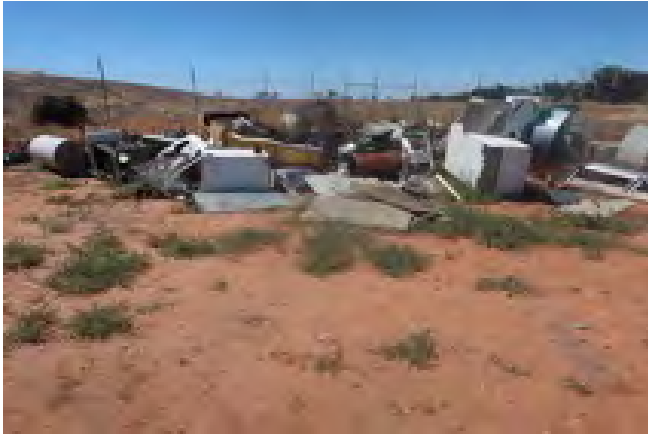
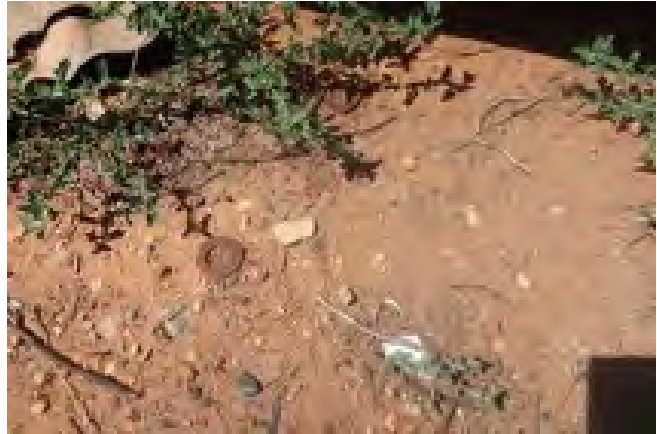
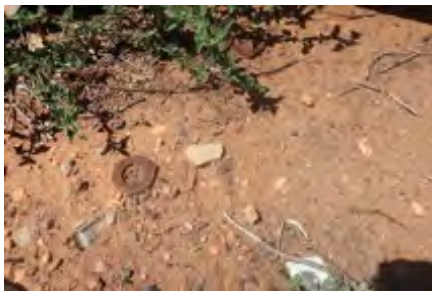
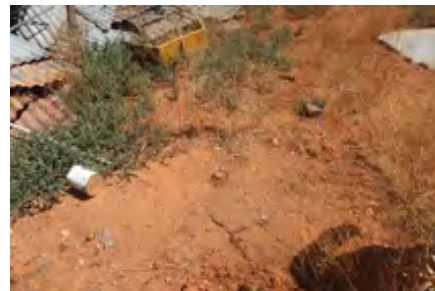
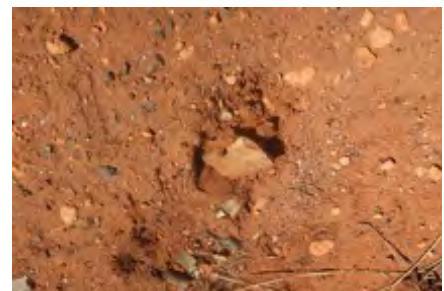
Area 1

Grounds: Tip. The Debris - Broken (Debris) has Asbestos Containing Material (ACM) present.

RISK ASSESSMENT					
Type of Asbestos or Hazardous Material	No sample taken - Visual ID	Condition	POOR	Likelihood of Damage	H (High) - almost certain
		Activity	Moderate		
		Sealed	No	Friability	Friable
		Labelled	No	Exposure Risk	High - Short term exposure risk
		Quantity

RISK CONTROL					
Priority	IMMEDIATE	Label Required	Yes	Re- Audit Date	11 Feb 2022
Action	Restrict access and target for imminent removal				
Recommendation	<p>Preliminary soil testing should be done to establish level of contamination & potential exposure. Debris on Surface - The Debris requires immediate cleanup and disposal with specialised equipment and with licensed removalist to safely remove the asbestos debris.</p> <p>In the meantime a wetting down program should be implemented and include minimal disturbance.</p>				
Legislative Requirements Victorian Regulation 2007	<p>URGENT - ACM visible in area. The ACM appears to be of a friable nature. The services of an "A" class Asbestos removal consultant are urgently required. Immediately cease any access to the area and affix warning signs to all entry points. Avoid physical and mechanical damage. Avoid mechanical damage and abrasion. Re-inspect every 12 months or earlier if disturbed or removed in accordance with the Victorian OH&S Regulation 2017.</p> <p>All remedial/removal repairs require a Clearance Inspection & Certificate to be recorded by an approved and competent assessor.</p>
