Asbestos Report

YARRIAMBIACK SHIRE COUNCIL

PROPERTY ADDRESS:
LB100 WOOMELANG UNITS
24 GLOUCESTER AVENUE
WOOMELANG VIC 3485

INSPECTION DATE: 11 FEBRUARY 2021
REFERENCE NUMBER: 62153

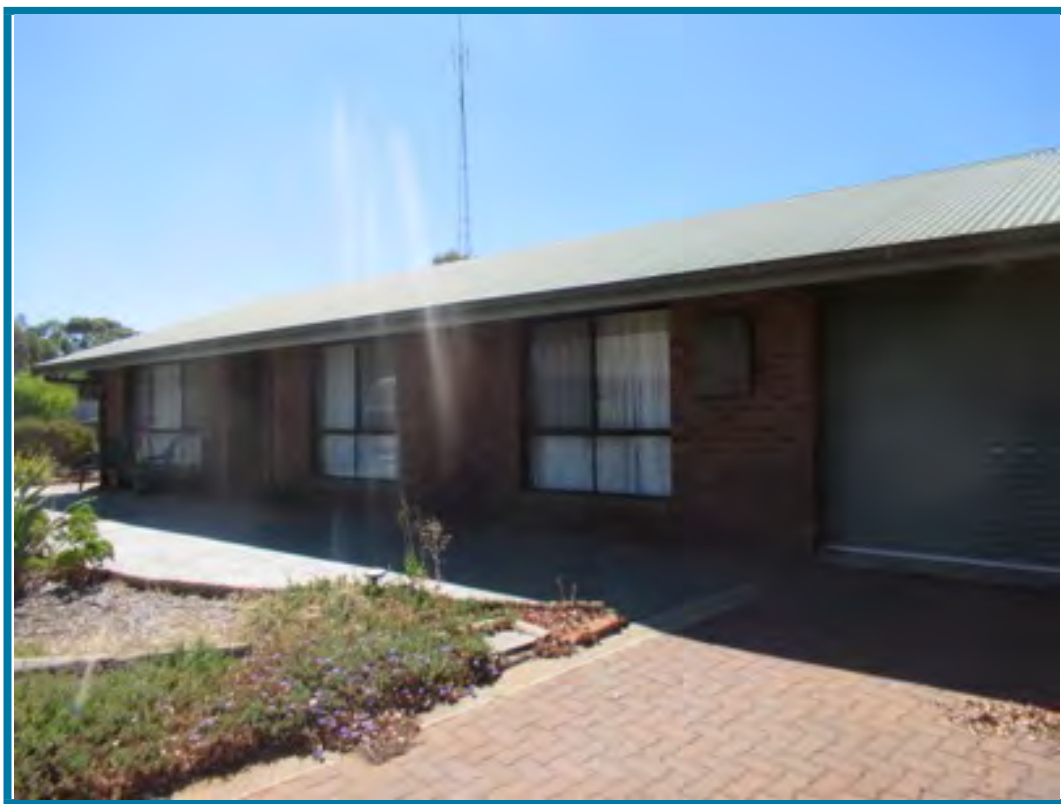
Location	Area	Component Materials	ACM Identified	Type Asbestos Assessment	Condition Priority	Signage Required
Unit 1 - entire perimeter of building.	Soffit	F C Sheeting	No	No Asbestos Detected		
						Same as Sample - 62153-001

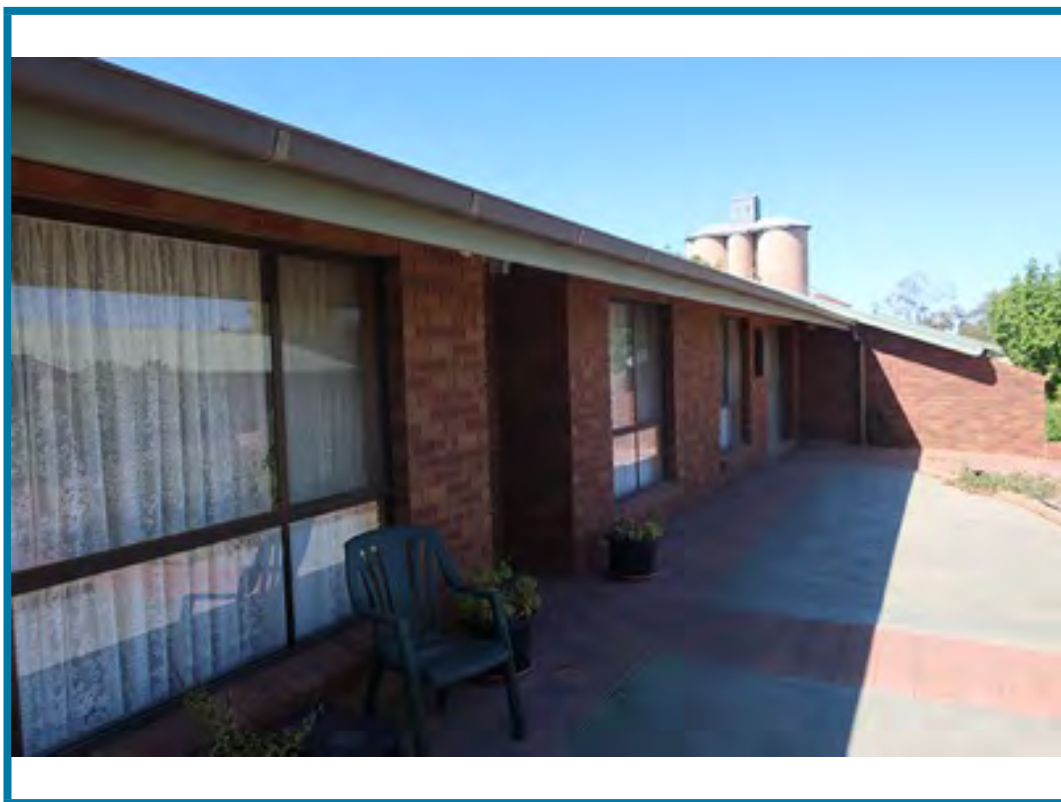
Location	Area	Component Materials	ACM Identified	Type Asbestos Assessment	Condition Priority	Signage Required
Unit 2 - entire perimeter of building.	Soffit	F C Sheeting	No	No Asbestos Detected		
						Same as Sample - 62153-001

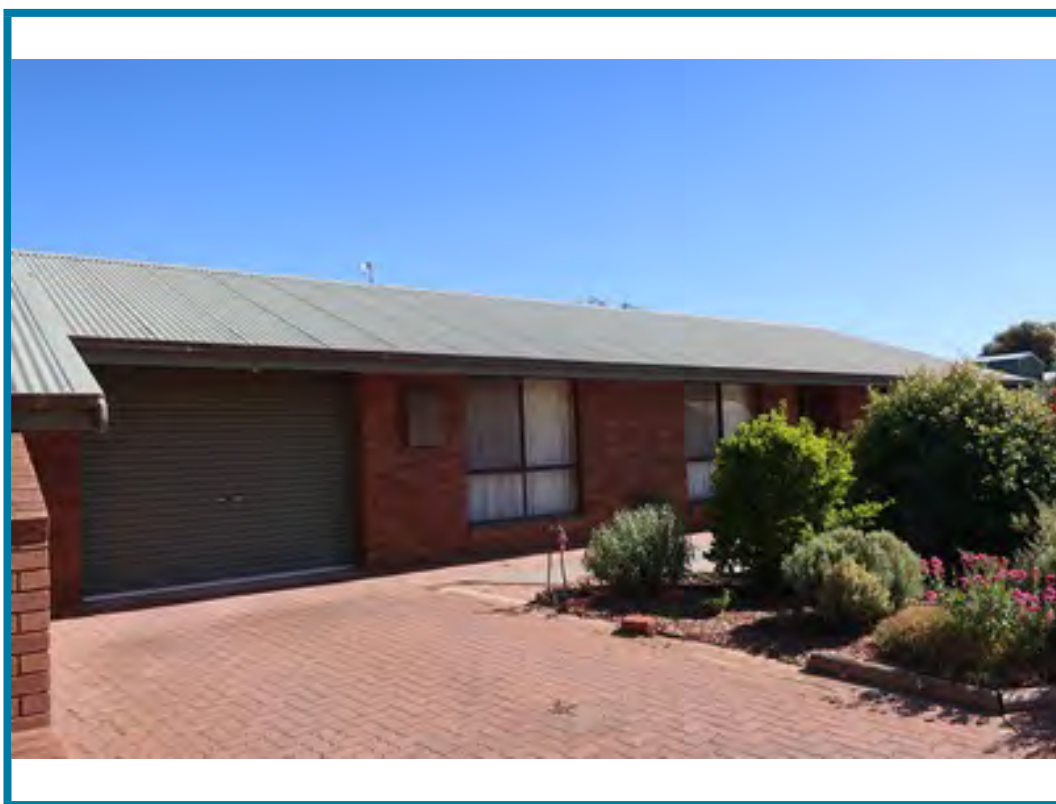
Location	Area	Component Materials	ACM Identified	Type Asbestos Assessment	Condition Priority	Signage Required
Unit 3 - entire perimeter of building.	Soffit	F C Sheeting	No	No Asbestos Detected		
						Sample taken 62153-001

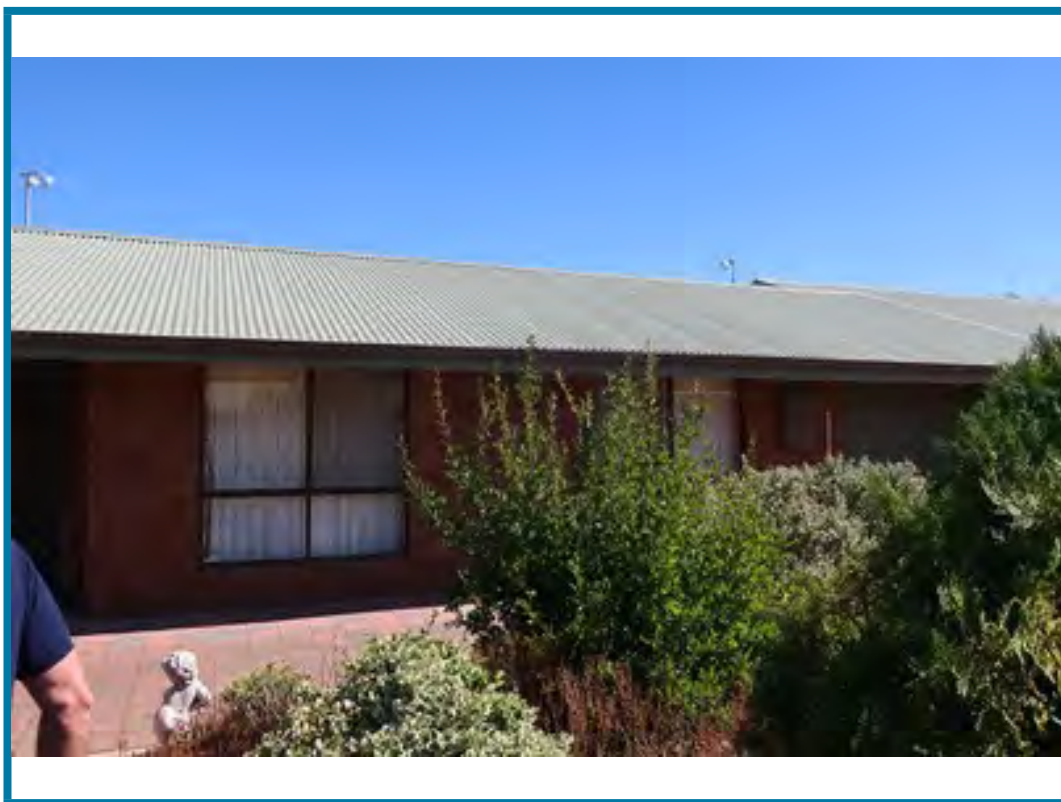
Location	Area	Component Materials	ACM Identified	Type Asbestos Assessment	Condition Priority	Signage Required
Unit 4 - entire perimeter of building.	Soffit	F C Sheeting	No	No Asbestos Detected		
						Same as Sample - 62153-001

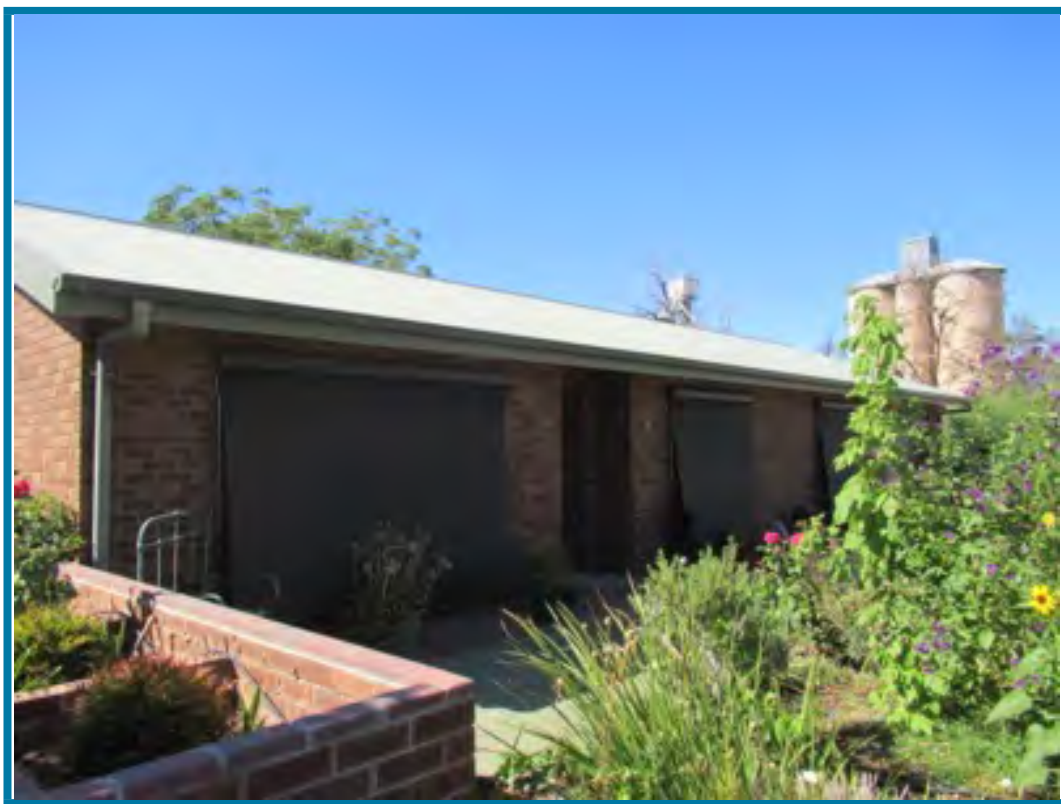
Location	Area	Component Materials	ACM Identified	Type Asbestos Assessment	Condition Priority	Signage Required
Unit 5 - entire perimeter of building.	Soffit	F C Sheeting	No	No Asbestos Detected		
						Same as Sample - 62153-001
