Asbestos Report

YARRIAMBIACK SHIRE COUNCIL

PROPERTY ADDRESS:
LR30 TIP
599 RAINBOW YAAPEET ROAD
YAAPEET VIC 3424

INSPECTION DATE: 11 FEBRUARY 2021
REFERENCE NUMBER: 62154

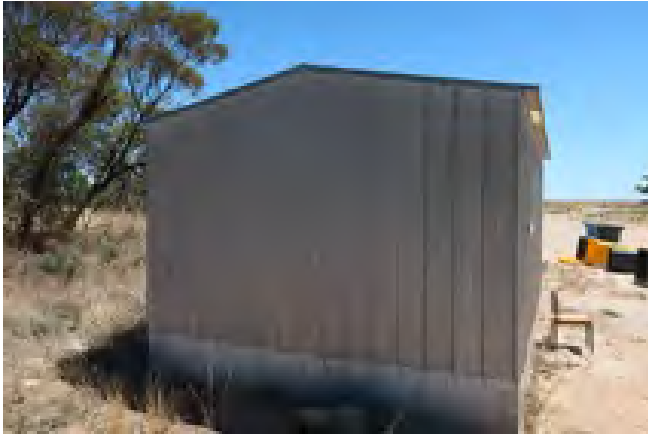
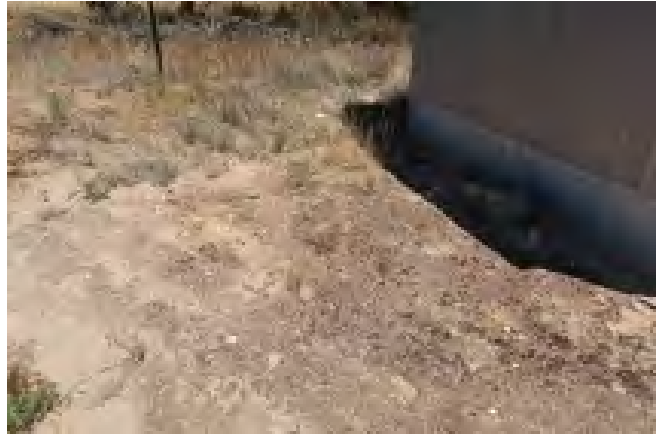
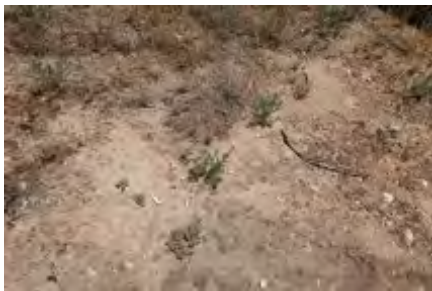
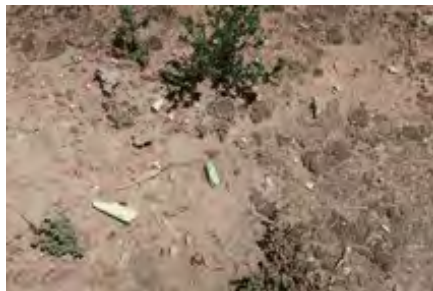
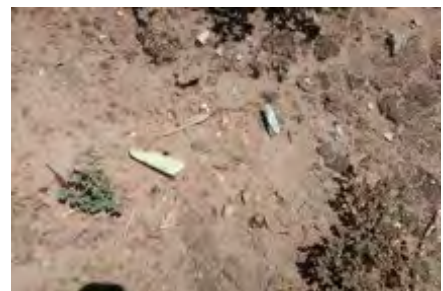
Area 5

Shed LR30 Tip: left side of building. The Debris - Broken (Debris) has Asbestos Containing Material (ACM) present.

RISK ASSESSMENT					
Type of Asbestos or Hazardous Material	No sample taken - Visual ID	Condition	POOR	Likelihood of Damage	H (High) - almost certain
		Activity	Moderate		
		Sealed	No	Friability	Exposed Fibres
		Labelled	No	Exposure Risk	High - Short term exposure risk
		Quantity

RISK CONTROL					
Priority	IMMEDIATE	Label Required	Yes	Re- Audit Date	11 Feb 2022
Action	Restrict access and target for imminent removal				
Recommendation	<p>Preliminary soil testing should be done to establish level of contamination & potential exposure. Debris on Surface - The Debris requires immediate cleanup and disposal with specialised equipment and with licensed removalist to safely remove the asbestos debris.</p> <p>In the meantime a wetting down program should be implemented and include minimal disturbance.</p>				
Legislative Requirements Victorian Regulation 2007	<p>ACM debris visible. Recommend cleanup by licensed Asbestos Removalist. Warning labels should be affixed. Avoid mechanical damage and abrasion. Remove if refurbishment, structural alteration or demolition is to be carried out in this area. Re-inspect every 12 months or earlier if disturbed or removed in accordance with the Victorian OH&S Regulation 2017.</p> <p>All remedial/removal repairs require a Clearance Inspection & Certificate to be recorded by an approved and competent assessor.</p>

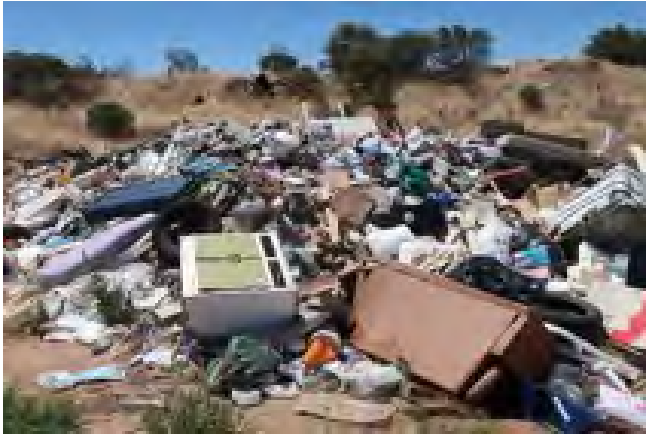
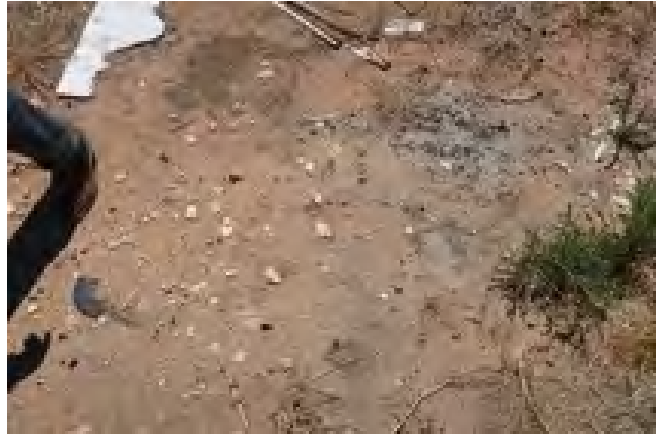
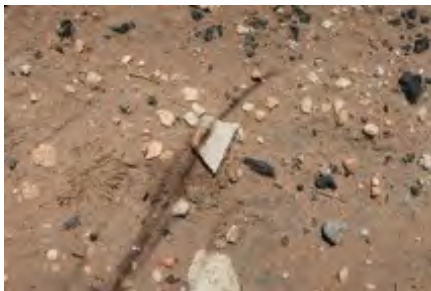
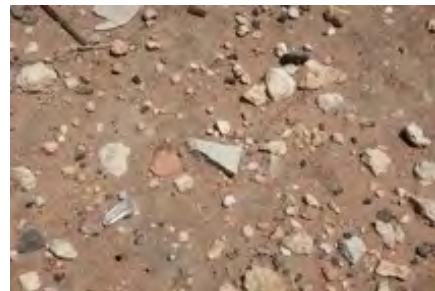
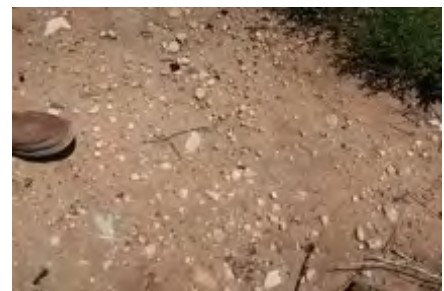
Area 4

Grounds: Tip. The Debris - Broken (Debris) has Asbestos Containing Material (ACM) present.

RISK ASSESSMENT					
Type of Asbestos or Hazardous Material	Chrysotile Amosite Same as Sample - 62154 -001	Condition	POOR	Likelihood of Damage	H (High) - almost certain
		Activity	Moderate		
		Sealed	No	Friability	Exposed Fibres
		Labelled	No	Exposure Risk	High - Short term exposure risk
		Quantity

RISK CONTROL					
Priority	IMMEDIATE	Label Required	Yes	Re- Audit Date	11 Feb 2022
Action	Restrict access and target for imminent removal				
Recommendation	<p>Preliminary soil testing should be done to establish level of contamination & potential exposure. Debris on Surface - The Debris requires immediate cleanup and disposal with specialised equipment and with licensed removalist to safely remove the asbestos debris.</p> <p>In the meantime a wetting down program should be implemented and include minimal disturbance.</p>				
Legislative Requirements Victorian Regulation 2007	<p>ACM debris visible. Recommend cleanup by licensed Asbestos Removalist. Warning labels should be affixed. Avoid mechanical damage and abrasion. Remove if refurbishment, structural alteration or demolition is to be carried out in this area. Re-inspect every 12 months or earlier if disturbed or removed in accordance with the Victorian OH&S Regulation 2017.</p> <p>All remedial/removal repairs require a Clearance Inspection & Certificate to be recorded by an approved and competent assessor.</p>

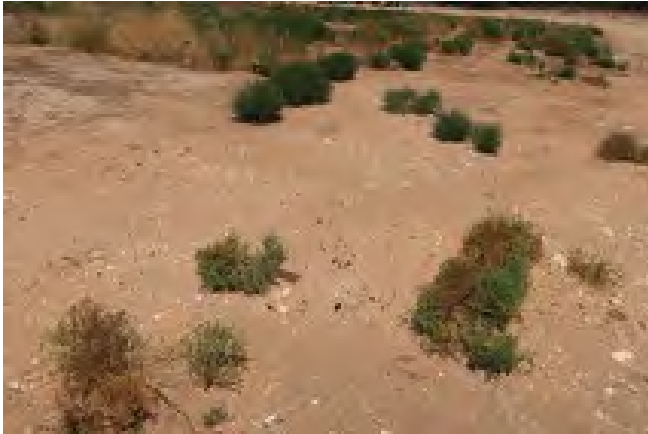
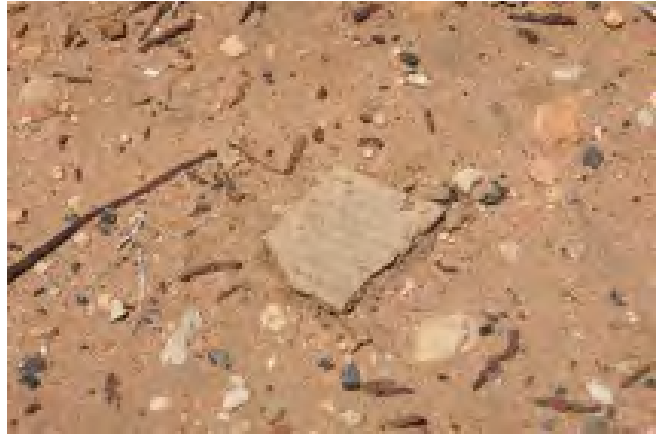
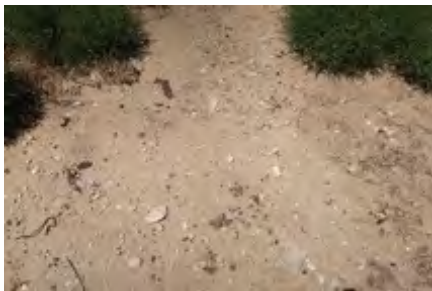
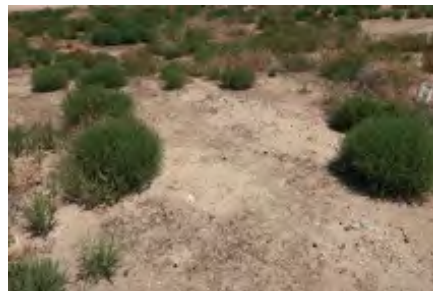
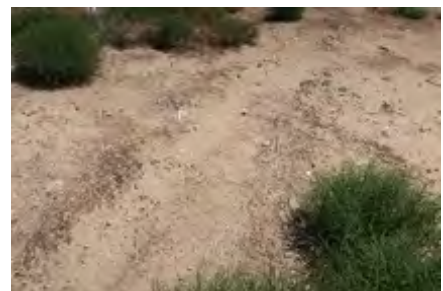
Grounds: The Debris - Broken (Debris) has Asbestos Containing Material (ACM) present.

RISK ASSESSMENT					
Type of Asbestos or Hazardous Material	Chrysotile Amosite Same as Sample - 62154-001	Condition	POOR	Likelihood of Damage	H (High) - almost certain
		Activity	Moderate		
		Sealed	No	Friability	Exposed Fibres
		Labelled	No	Exposure Risk	High - Short term exposure risk
		Quantity

RISK CONTROL					
Priority	IMMEDIATE	Label Required	Yes	Re- Audit Date	11 Feb 2022
Action	Restrict access and target for imminent removal				
Recommendation	<p>Preliminary soil testing should be done to establish level of contamination & potential exposure. Debris on Surface - The Debris requires immediate cleanup and disposal with specialised equipment and with licensed removalist to safely remove the asbestos debris.</p> <p>In the meantime a wetting down program should be implemented and include minimal disturbance.</p>				
Legislative Requirements Victorian Regulation 2007	<p>ACM debris visible. Recommend cleanup by licensed Asbestos Removalist. Warning labels should be affixed. Avoid mechanical damage and abrasion. Remove if refurbishment, structural alteration or demolition is to be carried out in this area. Re-inspect every 12 months or earlier if disturbed or removed in accordance with the Victorian OH&S Regulation 2017. All remedial/removal repairs require a Clearance Inspection & Certificate to be recorded by an approved and competent assessor.</p>

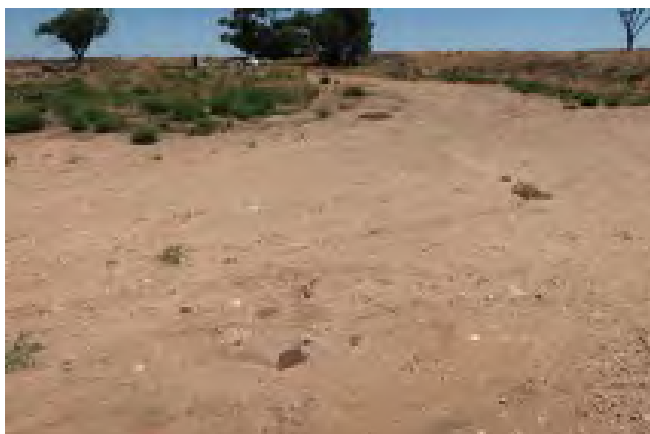
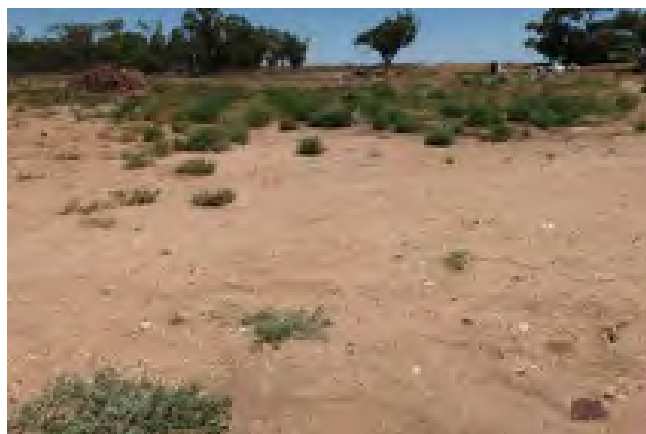
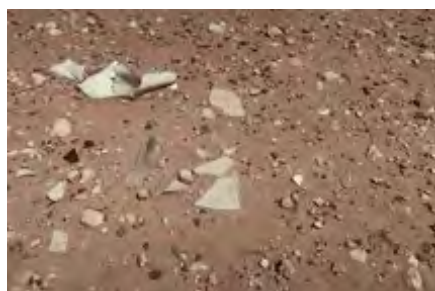
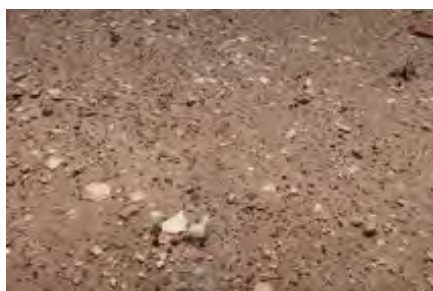
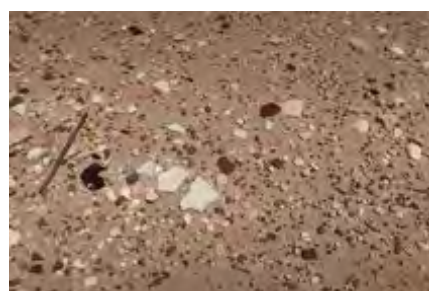
Grounds: The Debris - Broken (Debris) has Asbestos Containing Material (ACM) present.

RISK ASSESSMENT					
Type of Asbestos or Hazardous Material	Chrysotile	Condition	POOR	Likelihood of Damage	H (High) - almost certain
	Amosite	Activity	Moderate		
	Same as Sample - 62154 -001	Sealed	No	Friability	Exposed Fibres
		Labelled	No	Exposure Risk	High - Short term exposure risk
		Quantity

RISK CONTROL					
Priority	IMMEDIATE	Label Required	Yes	Re- Audit Date	11 Feb 2022
Action	Restrict access and target for imminent removal				
Recommendation	<p>Preliminary soil testing should be done to establish level of contamination & potential exposure. Debris on Surface - The Debris requires immediate cleanup and disposal with specialised equipment and with licensed removalist to safely remove the asbestos debris.</p> <p>In the meantime a wetting down program should be implemented and include minimal disturbance.</p>				
Legislative Requirements Victorian Regulation 2007	<p>ACM debris visible. Recommend cleanup by licensed Asbestos Removalist. Warning labels should be affixed. Avoid mechanical damage and abrasion. Remove if refurbishment, structural alteration or demolition is to be carried out in this area. Re-inspect every 12 months or earlier if disturbed or removed in accordance with the Victorian OH&S Regulation 2017. All remedial/removal repairs require a Clearance Inspection & Certificate to be recorded by an approved and competent assessor.</p>

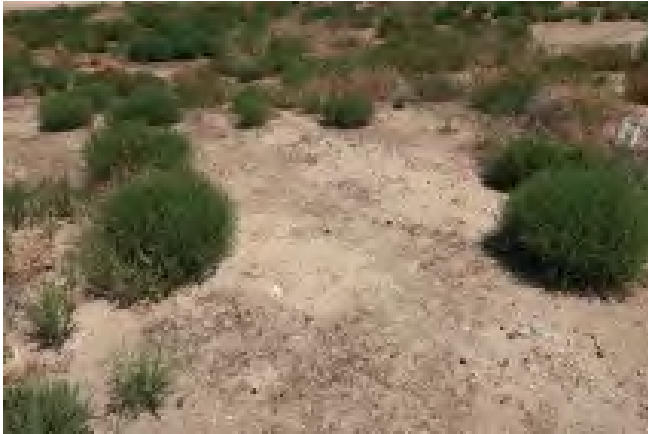
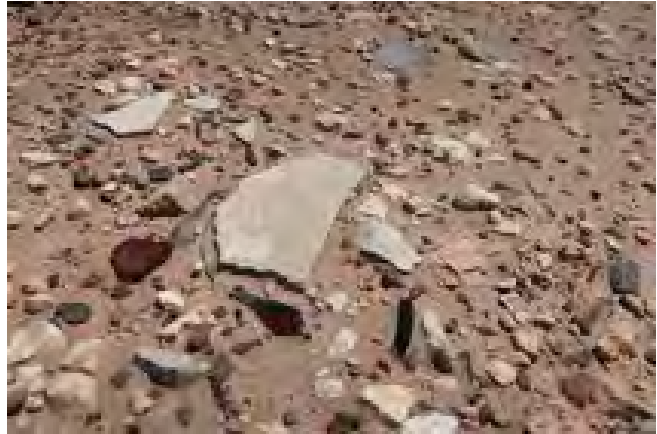
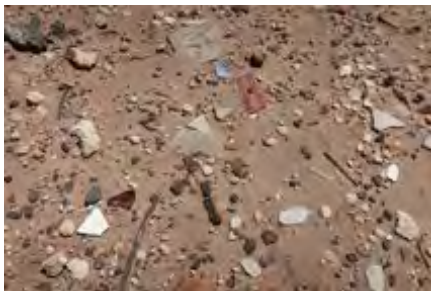
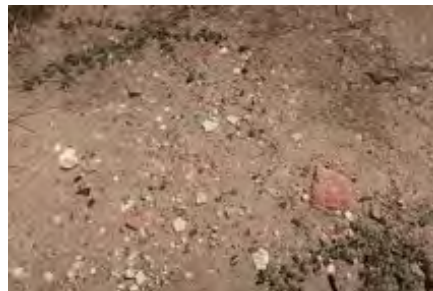
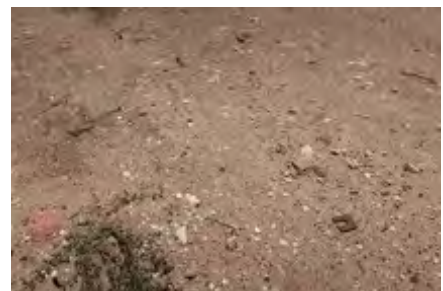
Grounds: The Debris - Broken (Debris) has Asbestos Containing Material (ACM) present.

RISK ASSESSMENT					
Type of Asbestos or Hazardous Material	Chrysotile Amosite Sample taken 62154-001	Condition	POOR	Likelihood of Damage	H (High) - almost certain
		Activity	Moderate		
		Sealed	No	Friability	Exposed Fibres
		Labelled	No	Exposure Risk	High - Short term exposure risk
		Quantity

RISK CONTROL					
Priority	IMMEDIATE	Label Required	Yes	Re- Audit Date	11 Feb 2022
Action	Restrict access and target for imminent removal				
Recommendation	<p>Preliminary soil testing should be done to establish level of contamination & potential exposure. Debris on Surface - The Debris requires immediate cleanup and disposal with specialised equipment and with licensed removalist to safely remove the asbestos debris.</p> <p>In the meantime a wetting down program should be implemented and include minimal disturbance.</p>				
Legislative Requirements Victorian Regulation 2007	<p>ACM debris visible. Recommend cleanup by licensed Asbestos Removalist. Warning labels should be affixed. Avoid mechanical damage and abrasion. Remove if refurbishment, structural alteration or demolition is to be carried out in this area. Re-inspect every 12 months or earlier if disturbed or removed in accordance with the Victorian OH&S Regulation 2017. All remedial/removal repairs require a Clearance Inspection & Certificate to be recorded by an approved and competent assessor.</p>

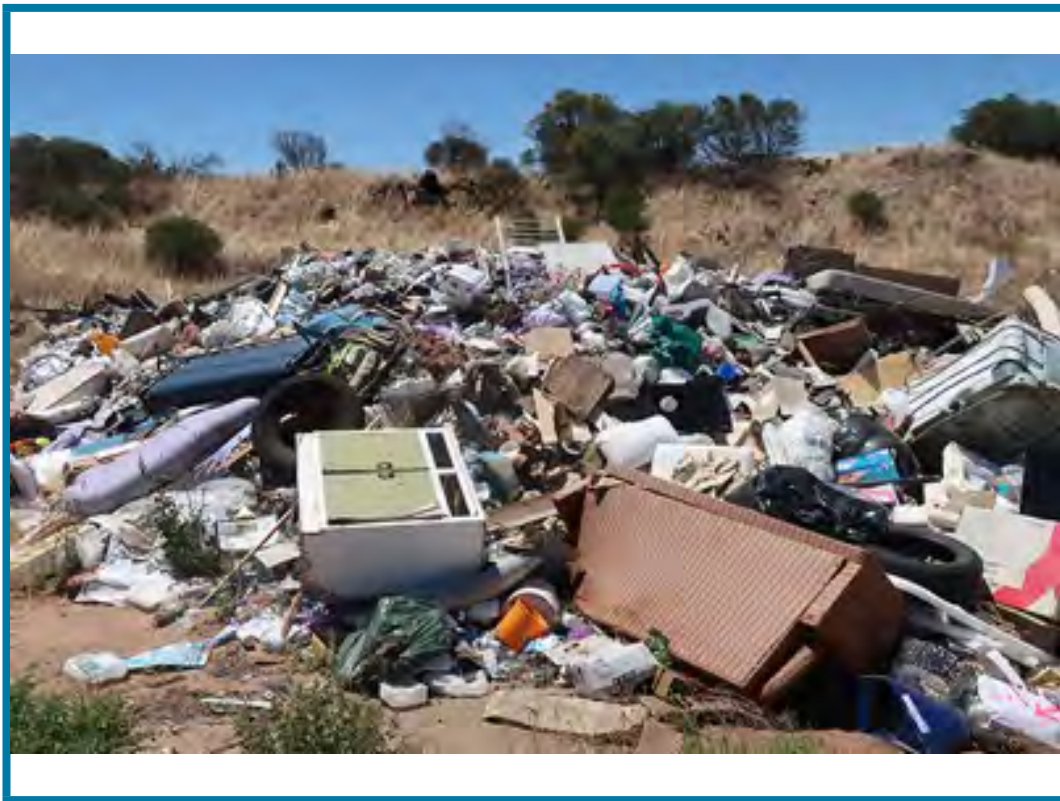
Location	Area	Component Materials	ACM Identified	Type Asbestos Assessment	Condition	Priority	Signage Required
Grounds - Tip.	Debris - Broken	Debris	Yes	Chrysotile Amosite			
						POOR IMMEDIATE	Yes
				Refer to the Abestos Register for more information.			
Grounds - Grounds.	Debris - Broken	Debris	Yes	Chrysotile Amosite			
						POOR IMMEDIATE	Yes
				Refer to the Abestos Register for more information.			
Grounds - Grounds.	Debris - Broken	Debris	Yes	Chrysotile Amosite			
						POOR IMMEDIATE	Yes
				Refer to the Abestos Register for more information.			
Grounds - Grounds.	Debris - Broken	Debris	Yes	Chrysotile Amosite			
						POOR IMMEDIATE	Yes
				Refer to the Abestos Register for more information.

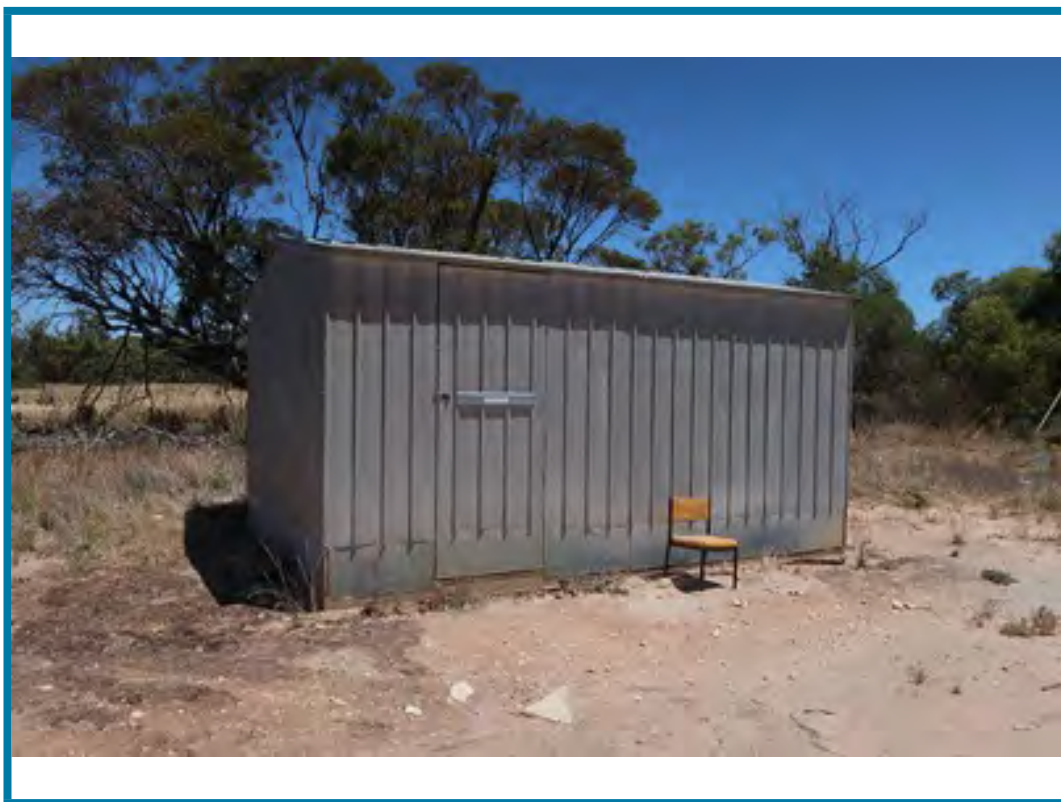
Location	Area	Component Materials	ACM Identified	Type Asbestos Assessment	Condition	Priority	Signage Required
Shed - entire perimeter of building.		No Asbestos Materials	No	No sample taken - Visual ID

Shed - left side of building.	Debris - Broken	Debris	Yes	No sample taken - Visual ID
