# Asbestos Report

YARRIAMBIACK SHIRE COUNCIL

PROPERTY ADDRESS:  
OLD POWERHOUSE (DEPOT)  
51 Lascelles Street  
HOPETOUN VIC 3396

Inspection Date: 22 January 2021  
Reference Number: 62061

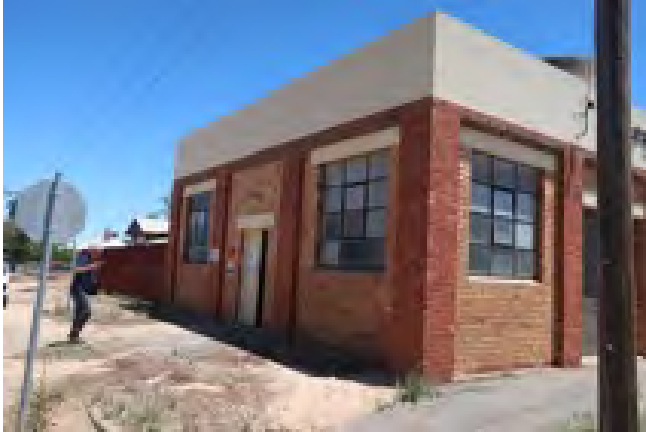
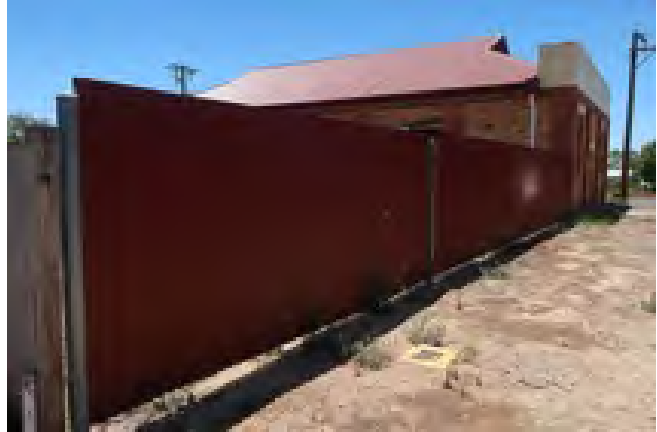
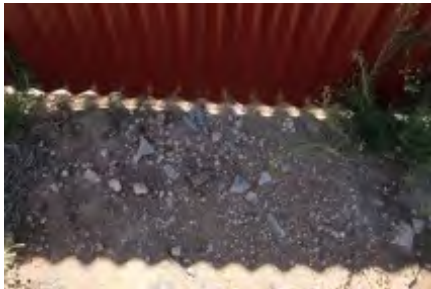
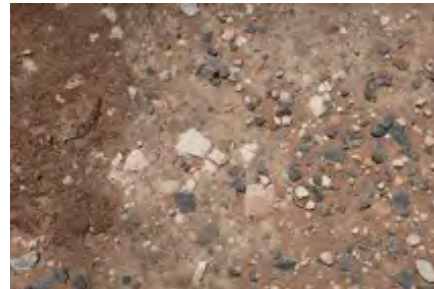
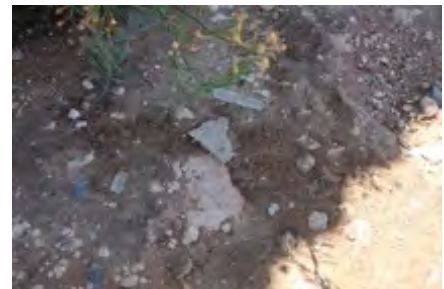
**Area 3**

**Old Powerhouse (Depot): left side of building left side of building - Footpath. The Debris - Broken (Debri) has Asbestos Containing Material (ACM) present.**

RISK ASSESSMENT									
Type of Asbestos or Hazardous Material	Chrysotile	Condition	POOR	Likelihood of Damage	H (High) - almost certain				
	Same as Sample - 62061-002	Activity	Moderate			Friability	Exposed Fibres		
		Sealed	No	Exposure Risk	High - Short term exposure risk				
		Labelled	No					Quantity	
		Quantity

Debri on Ground

Priority	IMMEDIATE	Label Required	Yes	Re- Audit Date	22 Jan 2022
Action	Restrict access and target for imminent removal				
Recommendation	Debri on Ground - The Debris requires immediate cleanup and disposal with specialized equipment and with licenced removalist to safely remove the asbestos debri. Detailed Site Investigation (DSI) required to delineate the contamination and for the preparation of a Technical Removal Specification and scope of works for the licenced removalist.				
Legislative Requirements Victorian Regulation 2007	ACM debri visible. Site delineation and soil testing required including a Div. 6 audit. Clearance Certificate required for removal works. Recommend cleanup by licenced Asbestos Removalist. Warning labels should be affixed. Avoid mechanical damage and abrasion. Remove if refurbishment, structural alteration or demolition is to be carried out in this area. Re-inspect every 12 months or earlier if disturbed or removed in accordance with the Victorian Regulation 2007. <b>All remedial/removal repairs require a Clearance Inspection &amp; Certificate to be recorded by an approved and competent assessor.</b>

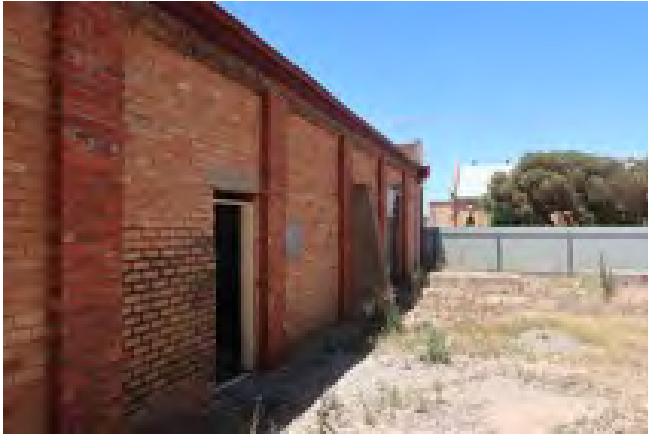
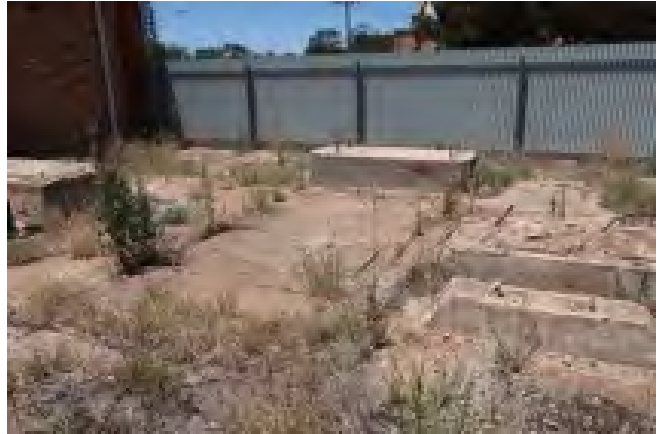
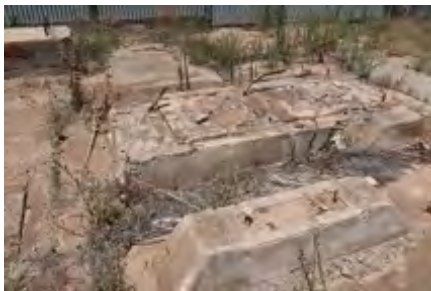
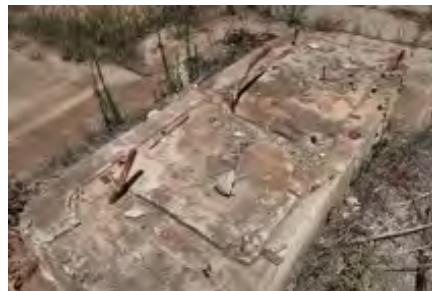
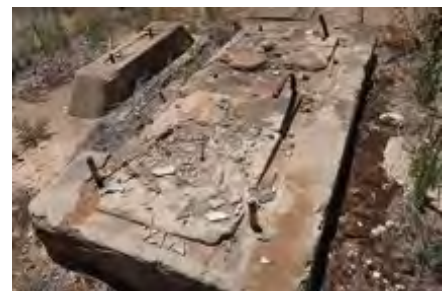
**Old Powerhouse (Depot): left side of building left side of building - Yard. The Debris - Broken (Debris/Contamination) has Asbestos Containing Material (ACM) present.**

RISK ASSESSMENT					
Type of Asbestos or Hazardous Material	Chrysotile	Condition	POOR	Likelihood of Damage	H (High) - almost certain
	Sample taken 62061-002	Activity	Moderate		
		Sealed	No	Friability	Exposed Fibres
		Labelled	No	Exposure Risk	High - Short term exposure risk
		Quantity

Debris on Ground

Priority	IMMEDIATE	Label Required	Yes	Re- Audit Date	22 Jan 2022
Action	Restrict access and target for imminent removal				
Recommendation	Debris on Ground - The Debris requires immediate cleanup and disposal with specialized equipment and with licenced removalist to safely remove the asbestos debris. Detailed Site Investigation (DSI) required to delineate the contamination and for the preparation of a Technical Removal Specification and scope of works for the licenced removalist.				
Legislative Requirements Victorian Regulation 2007	ACM debris visible. Site delineation and soil testing required including a Div. 6 audit. Clearance Certificate required for removal works. Recommend cleanup by licenced Asbestos Removalist. Warning labels should be affixed. Avoid mechanical damage and abrasion. Remove if refurbishment, structural alteration or demolition is to be carried out in this area. Re-inspect every 12 months or earlier if disturbed or removed in accordance with the Victorian Regulation 2007. <b>All remedial/removal repairs require a Clearance Inspection &amp; Certificate to be recorded by an approved and competent assessor.</b>

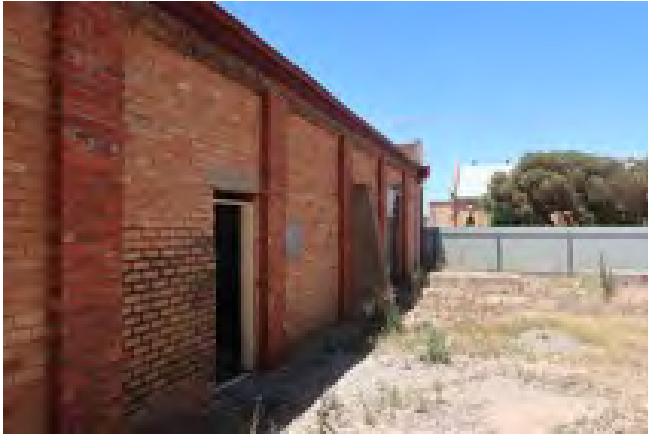
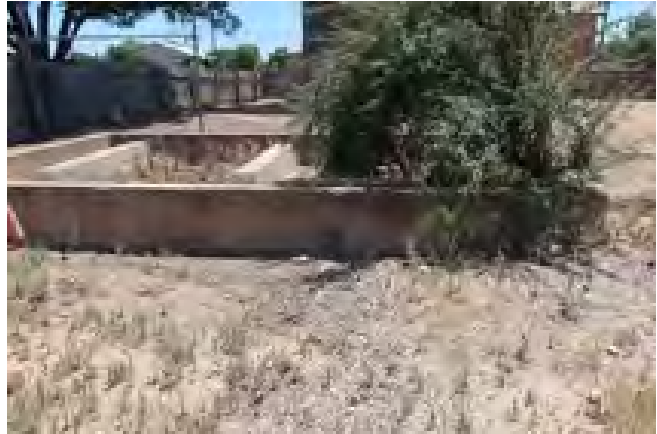
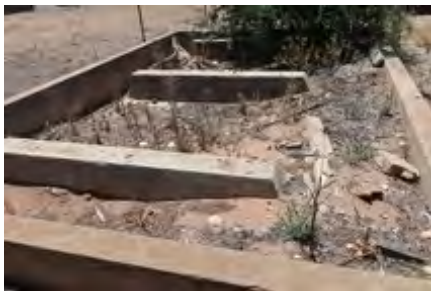
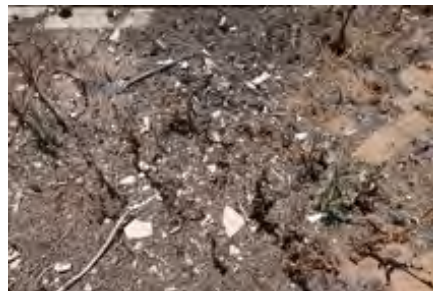
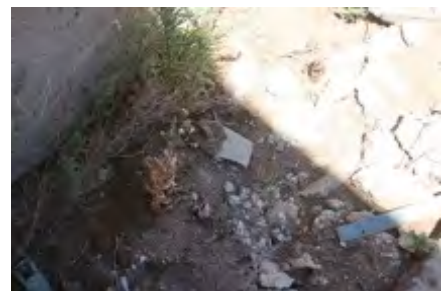
**Old Powerhouse (Depot): left side of building - Yard. The Debris - Broken (Debri) has Asbestos Containing Material (ACM) present.**

RISK ASSESSMENT					
Type of Asbestos or Hazardous Material	Chrysotile	Condition	POOR	Likelihood of Damage	H (High) - almost certain
	Same as Sample - 62061-002	Activity	Moderate		
		Sealed	No	Friability	Exposed Fibres
		Labelled	No	Exposure Risk	High - Short term exposure risk
		Quantity

Debri on Ground

Priority	IMMEDIATE	Label Required	Yes	Re- Audit Date	22 Jan 2022
Action	Restrict access and target for imminent removal				
Recommendation	Debri on Ground - The Debris requires immediate cleanup and disposal with specialized equipment and with licenced removalist to safely remove the asbestos debri. Detailed Site Investigation (DSI) required to delineate the contamination and for the preparation of a Technical Removal Specification and scope of works for the licenced removalist.				
Legislative Requirements Victorian Regulation 2007	ACM debri visible. Site delineation and soil testing required including a Div. 6 audit. Clearance Certificate required for removal works. Recommend cleanup by licenced Asbestos Removalist. Warning labels should be affixed. Avoid mechanical damage and abrasion. Re-inspect every 12 months or earlier if disturbed or removed in accordance with the Victorian Regulation 2007. <b>All remedial/removal repairs require a Clearance Inspection &amp; Certificate to be recorded by an approved and competent assessor.</b>

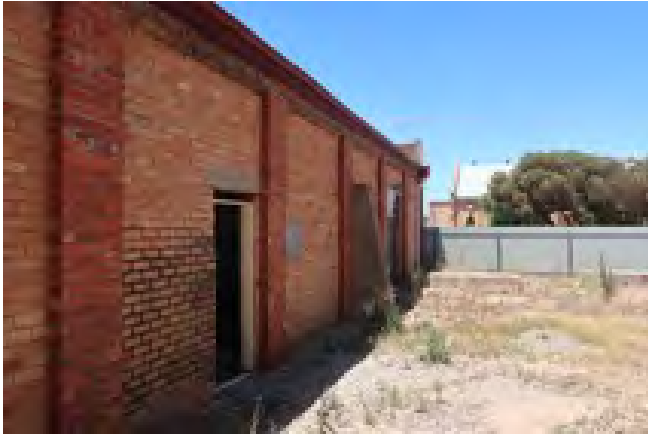
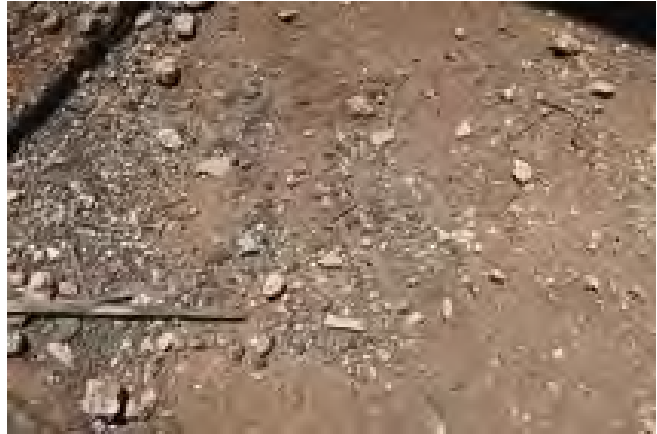
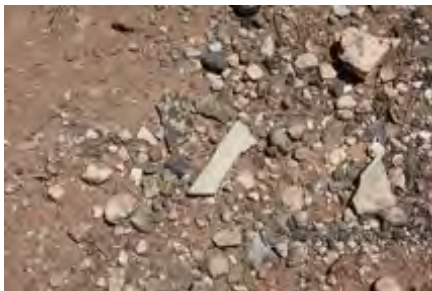
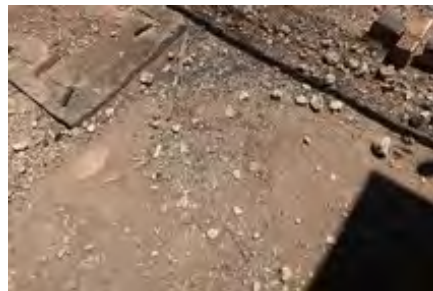
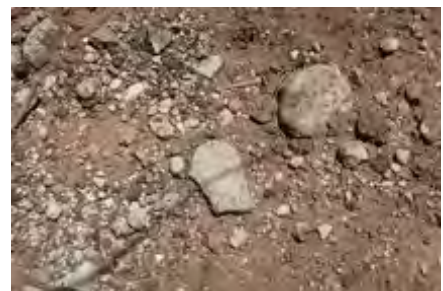
**Old Powerhouse (Depot): left side of building - Yard. The Debris - Broken (Debris/contamination) has Asbestos Containing Material (ACM) present.**

RISK ASSESSMENT					
Type of Asbestos or Hazardous Material	Chrysotile	Condition	POOR	Likelihood of Damage	H (High) - almost certain
	Same as Sample - 62061-002	Activity	Moderate		
		Sealed	No	Friability	Exposed Fibres
		Labelled	No	Exposure Risk	High - Short term exposure risk
		Quantity

Debris on Ground

Priority	IMMEDIATE	Label Required	Yes	Re- Audit Date	22 Jan 2022
Action	Restrict access and target for imminent removal				
Recommendation	Debris on Ground - The Debris requires immediate cleanup and disposal with specialized equipment and with licenced removalist to safely remove the asbestos debris. Detailed Site Investigation (DSI) required to delineate the contamination and for the preparation of a Technical Removal Specification and scope of works for the licenced removalist.				
Legislative Requirements Victorian Regulation 2007	ACM debris visible. Site delineation and soil testing required including a Div. 6 audit. Clearance Certificate required for removal works. Recommend cleanup by licensed Asbestos Removalist. Warning labels should be affixed. Avoid mechanical damage and abrasion. Re-inspect every 12 months or earlier if disturbed or removed in accordance with the Victorian Regulation 2007. <b>All remedial/removal repairs require a Clearance Inspection &amp; Certificate to be recorded by an approved and competent assessor.</b>

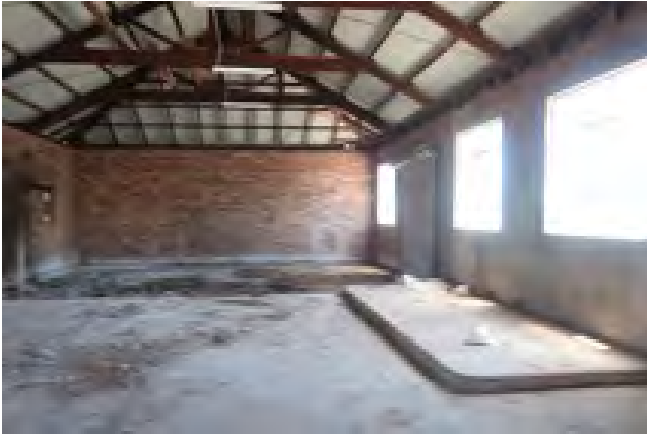
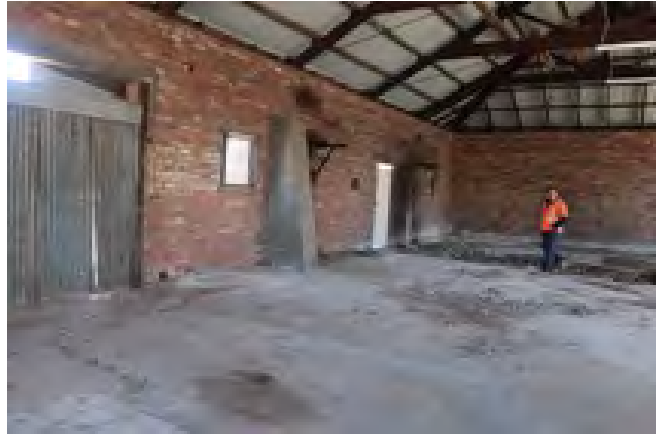
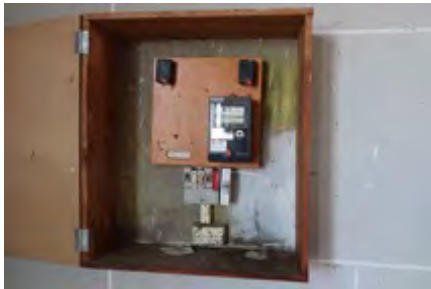
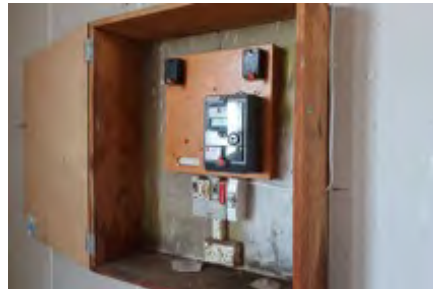
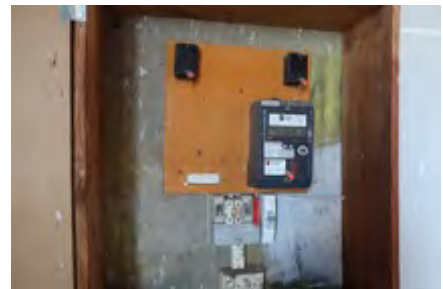
**Old Powerhouse (Depot): Open room. The Electrical board (F C Sheet at rear) has Asbestos Containing Material (ACM) present.**

RISK ASSESSMENT					
Type of Asbestos or Hazardous Material	No sample taken - Visual ID	Condition	AVERAGE	Likelihood of Damage	L (Low) – possible
		Activity	Moderate		
		Sealed	No	Friability	Bonded (non-friable)
		Labelled	Y	Exposure Risk	Medium - Moderate risk
		Quantity

Raw Material

RISK CONTROL					
Priority	HIGH	Label Required	Yes	Re- Audit Date	22 Jan 2022
Action	Remedial repairs required - seal raw material / edges				
Recommendation	Raw material sheeting - The area requires remedial repairs. It is recommended the asbestos material be sealed with an approved membrane.				
Legislative Requirements Victorian Regulation 2007	Damaged ACM visible in area. Requires IMMEDIATE ATTENTION. WARNING labels should be affixed. Avoid mechanical damage and abrasion. Remove if refurbishment, structural alteration or demolition is to be carried out in this area. Re-inspect every 12 months or earlier if disturbed or removed in accordance with the Victorian Regulation 2007. <b>All remedial/removal repairs require a Clearance Inspection &amp; Certificate to be recorded by an approved and competent assessor.</b>

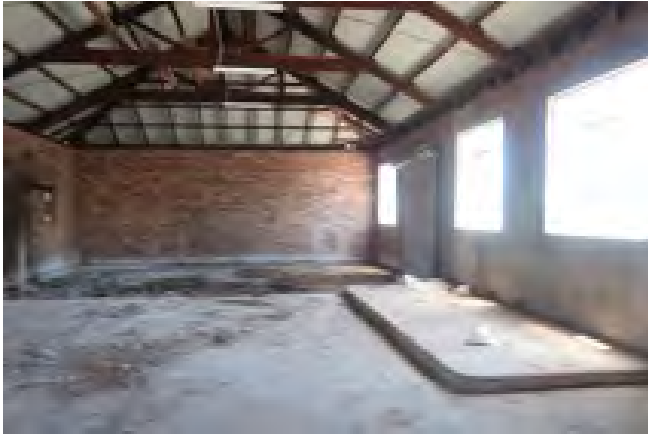
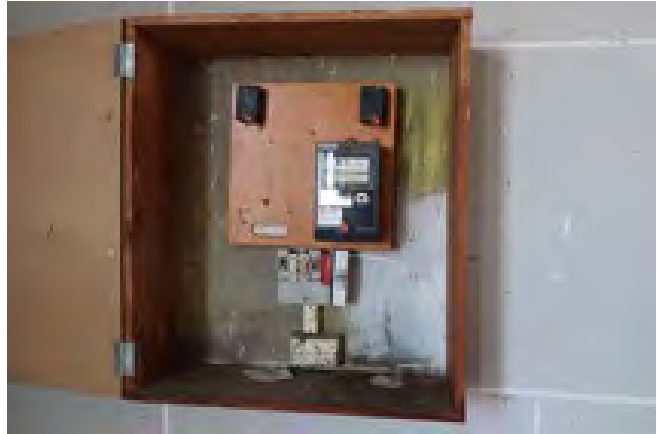
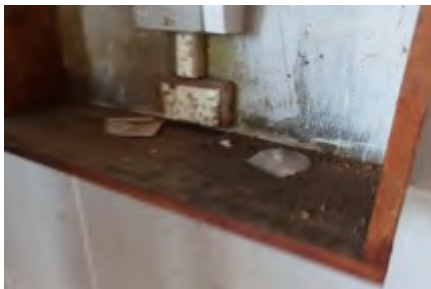
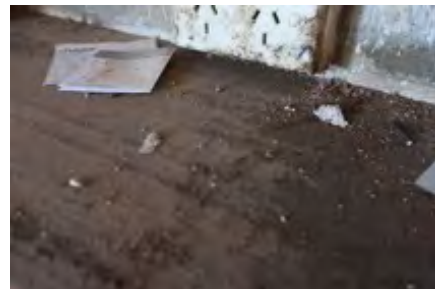
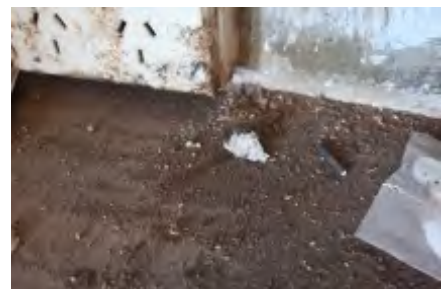
**Old Powerhouse (Depot): Open room. The Electrical cabinet (Debris/contamination) has Asbestos Containing Material (ACM) present.**

RISK ASSESSMENT					
Type of Asbestos or Hazardous Material	No sample taken - Visual ID	Condition	POOR	Likelihood of Damage	L (Low) – possible
		Activity	Moderate		
		Sealed	No	Friability	Exposed Fibres
		Labelled	Y	Exposure Risk	High - Short term exposure risk
		Quantity

Debris in cabinet

Priority	IMMEDIATE	Label Required	Yes	Re- Audit Date	22 Jan 2022
Action	Restrict access and target for imminent removal				
Recommendation	Debris in the cabinet- The Debris requires immediate cleanup and disposal with specialized equipment and with licenced removalist to safely remove the asbestos debris.				
Legislative Requirements Victorian Regulation 2007	ACM debris visible. Clearance Certificate required for removal works. Recommend cleanup by licensed Asbestos Removalist. Warning labels should be affixed. Avoid mechanical damage and abrasion. Re-inspect every 12 months or earlier if disturbed or removed in accordance with the Victorian Regulation 2007. <b>All remedial/removal repairs require a Clearance Inspection &amp; Certificate to be recorded by an approved and competent assessor.</b>

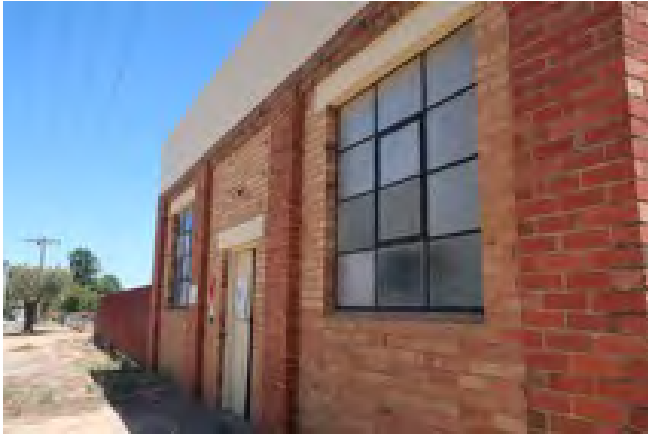
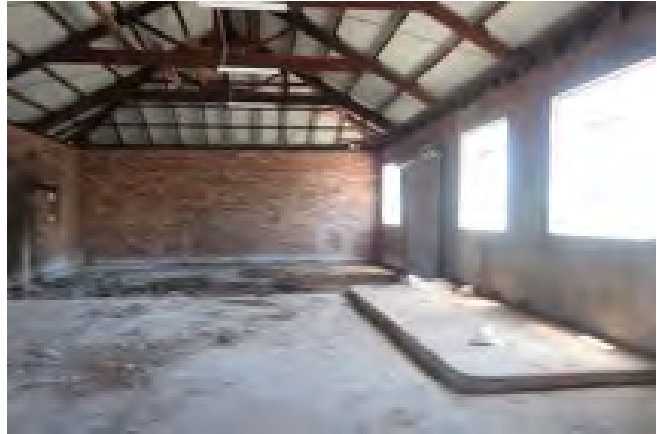
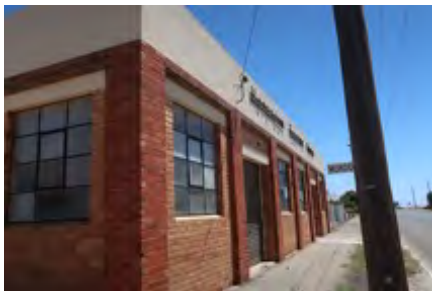
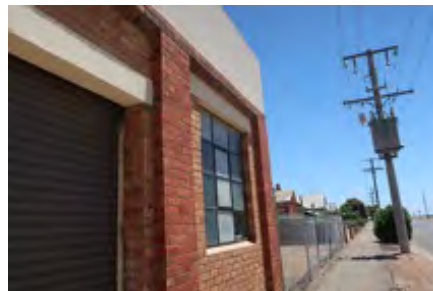
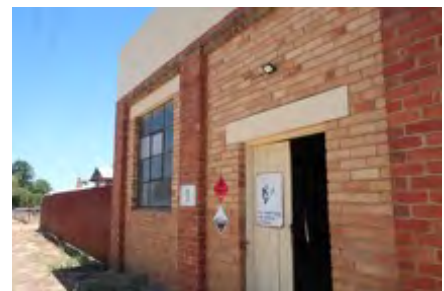
**Old Powerhouse (Depot): External & Internal. The Windows (Steel framed) (Putty) has Asbestos Containing Material (ACM) present.**

RISK ASSESSMENT					
Type of Asbestos or Hazardous Material	No sample taken - Visual ID	Condition	GOOD	Likelihood of Damage	L (Low) – possible
		Activity	Moderate		
		Sealed	Yes	Friability	Bonded (non-friable)
		Labelled	Y	Exposure Risk	Low - Negligible or low risk
		Quantity

Maintain paint or sealant

Priority	MEDIUM	Label Required	Yes	Re- Audit Date	22 Jan 2022
Action	No remedial action required, unless disturbed				
Recommendation	Maintain paint or sealant to ACM surfaces. Particular attention should be given to side edges, ensure paint/sealant covers ALL exposed ACM surfaces.				
Legislative Requirements Victorian Regulation 2007	Warning labels should be affixed. Avoid mechanical damage and abrasion. Remove if refurbishment, structural alteration or demolition is to be carried out in this area. Re-inspect every 12 months or earlier if disturbed or removed in accordance with the Victorian Regulation 2007. <b>All remedial/removal repairs require a Clearance Inspection &amp; Certificate to be recorded by an approved and competent assessor.</b>
