**Global
Asbestos
Audits**

Asbestos Report

YARRIAMBIACK SHIRE COUNCIL

PROPERTY ADDRESS:
LB77 MEMORIAL HALL
13 AUSTIN STREET
HOPETOUN VIC 3396

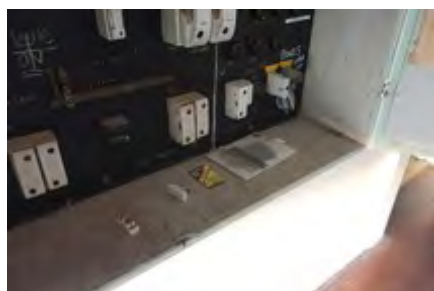
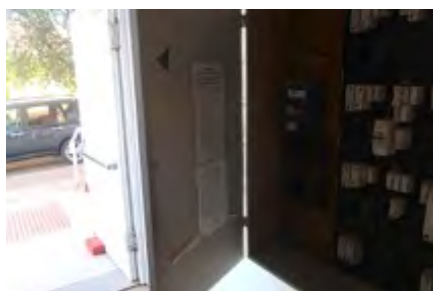
Area 4**LB77 Memorial Hall: Ground Floor Entrance 1. The Electrical cabinet - lining (F C Sheeting) has Asbestos Containing Material (ACM) present.****RISK ASSESSMENT**

Type of Asbestos or Hazardous Material	No sample taken - Visual ID	Condition	AVERAGE	Likelihood of Damage	L (Low) – possible
		Activity	Moderate		
		Sealed	Yes	Friability	Exposed Fibres
		Labelled	Y	Exposure Risk	High - Short term exposure risk
		Quantity

Holes (impact)

Priority	HIGH	Label Required	Yes	Re- Audit Date	27 Jan 2022
Action	Remedial repairs required - seal exposed edges or replace or laminate over damaged material				
Recommendation	Holes (impact) - The damaged area requires immediate remedial repairs. It is recommended the asbestos sheeting be replaced (preferred) or edges sealed with approved sealant and then the area be concealed by laminating (sheeting).				
Legislative Requirements Victorian Regulation 2007	Damaged ACM visible in area. Requires IMMEDIATE ATTENTION. WARNING labels should be affixed. Avoid mechanical damage and abrasion. Remove if refurbishment, structural alteration or demolition is to be carried out in this area. Re-inspect every 12 months or earlier if disturbed or removed in accordance with the Victorian OH&S Regulation 2017. All remedial/removal repairs require a Clearance Inspection & Certificate to be recorded by an approved and competent assessor.

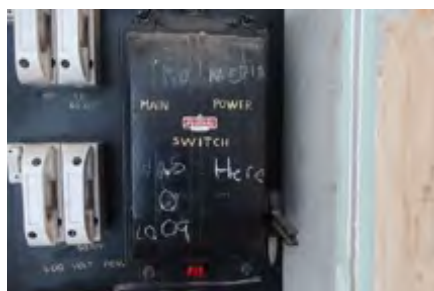
Area 11**LB77 Memorial Hall: Ground Floor Entrance 1. The Electrical Switch - Arc shields (F C Sheet) has Asbestos Containing Material (ACM) present.****RISK ASSESSMENT**

Type of Asbestos or Hazardous Material	No sample taken - Visual ID	Condition	GOOD	Likelihood of Damage	L (Low) – possible
		Activity	Moderate		
		Sealed	Yes	Friability	Bonded (non-friable)
		Labelled	Y	Exposure Risk	Low - Negligible or low risk
		Quantity

Maintain paint or sealant

Priority	MEDIUM	Label Required	Yes	Re- Audit Date	27 Jan 2022
Action	No remedial action required, unless disturbed				
Recommendation	Maintain paint or sealant to ACM surfaces. Particular attention should be given to side edges, ensure paint/sealant covers ALL exposed ACM surfaces.				
Legislative Requirements Victorian Regulation 2007	Warning labels should be affixed. Avoid mechanical damage and abrasion. Remove if refurbishment, structural alteration or demolition is to be carried out in this area. Re-inspect every 12 months or earlier if disturbed or removed in accordance with the Victorian OH&S Regulation 2017. All remedial/removal repairs require a Clearance Inspection & Certificate to be recorded by an approved and competent assessor.

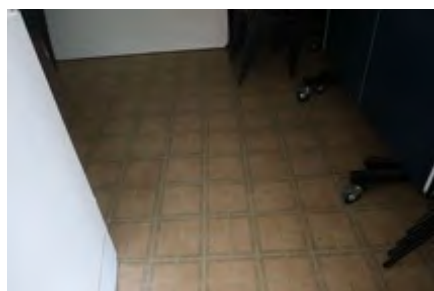
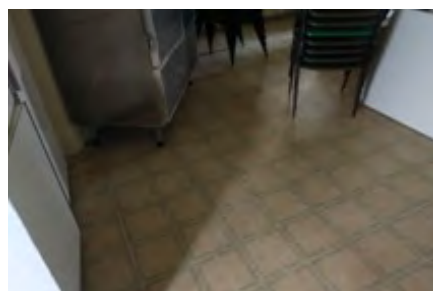
Area 17**LB77 Memorial Hall: Ground Floor Storage 2. The Floor (Linoleum) has Asbestos Containing Material (ACM) present.****RISK ASSESSMENT**

Type of Asbestos or Hazardous Material	No sample taken - Visual ID	Condition	GOOD	Likelihood of Damage	L (Low) – possible
		Activity	Moderate		
		Sealed	Yes	Friability	Bonded (non-friable)
		Labelled	Y	Exposure Risk	Low - Negligible or low risk
		Quantity

Maintain paint or sealant

Priority	MEDIUM	Label Required	Yes	Re- Audit Date	27 Jan 2022
Action	No remedial action required, unless disturbed				
Recommendation	Maintain paint or sealant to ACM surfaces. Particular attention should be given to side edges, ensure paint/sealant covers ALL exposed ACM surfaces.				
Legislative Requirements Victorian Regulation 2007	Warning labels should be affixed. Avoid mechanical damage and abrasion. Remove if refurbishment, structural alteration or demolition is to be carried out in this area. Re-inspect every 12 months or earlier if disturbed or removed in accordance with the Victorian OH&S Regulation 2017. All remedial/removal repairs require a Clearance Inspection & Certificate to be recorded by an approved and competent assessor.

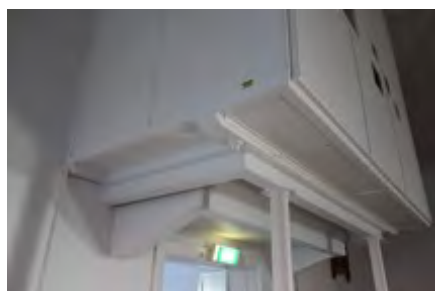
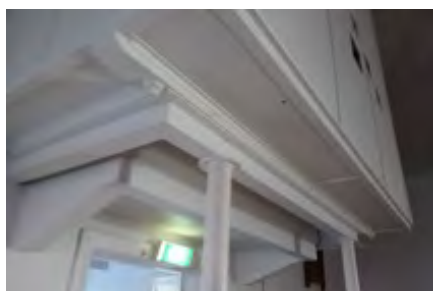
Area 13**LB77 Memorial Hall: Ground Floor Hall 5. The Projector box - ceiling (F C Sheeting) has Asbestos Containing Material (ACM) present.****RISK ASSESSMENT**

Type of Asbestos or Hazardous Material	No sample taken - Visual ID	Condition	GOOD	Likelihood of Damage	L (Low) – possible
		Activity	Moderate		
		Sealed	Yes	Friability	Bonded (non-friable)
		Labelled	Y	Exposure Risk	Low - Negligible or low risk
		Quantity

Maintain paint or sealant

Priority	MEDIUM	Label Required	Yes	Re- Audit Date	27 Jan 2022
Action	No remedial action required, unless disturbed				
Recommendation	Maintain paint or sealant to ACM surfaces. Particular attention should be given to side edges, ensure paint/sealant covers ALL exposed ACM surfaces.				
Legislative Requirements Victorian Regulation 2007	Warning labels should be affixed. Avoid mechanical damage and abrasion. Remove if refurbishment, structural alteration or demolition is to be carried out in this area. Re-inspect every 12 months or earlier if disturbed or removed in accordance with the Victorian OH&S Regulation 2017. All remedial/removal repairs require a Clearance Inspection & Certificate to be recorded by an approved and competent assessor.

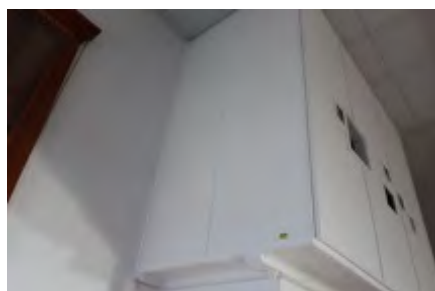
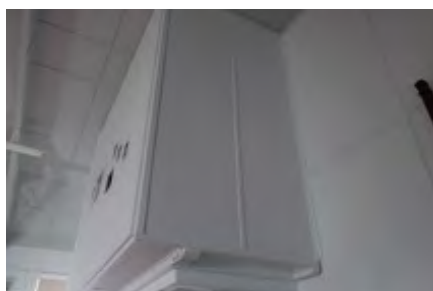
Area 14**LB77 Memorial Hall: Ground Floor Hall 5. The Projector box - side walls (F C Sheet) has Asbestos Containing Material (ACM) present.****RISK ASSESSMENT**

Type of Asbestos or Hazardous Material	Chrysotile	Condition	GOOD	Likelihood of Damage	L (Low) – possible
	Sample taken 62071-006	Activity	Moderate		
		Sealed	Yes	Friability	Bonded (non-friable)
		Labelled	Y	Exposure Risk	Low - Negligible or low risk
		Quantity

Maintain paint or sealant

Priority	MEDIUM	Label Required	Yes	Re- Audit Date	27 Jan 2022
Action	No remedial action required, unless disturbed				
Recommendation	Maintain paint or sealant to ACM surfaces. Particular attention should be given to side edges, ensure paint/sealant covers ALL exposed ACM surfaces.				
Legislative Requirements Victorian Regulation 2007	Warning labels should be affixed. Avoid mechanical damage and abrasion. Remove if refurbishment, structural alteration or demolition is to be carried out in this area. Re-inspect every 12 months or earlier if disturbed or removed in accordance with the Victorian OH&S Regulation 2017. All remedial/removal repairs require a Clearance Inspection & Certificate to be recorded by an approved and competent assessor.

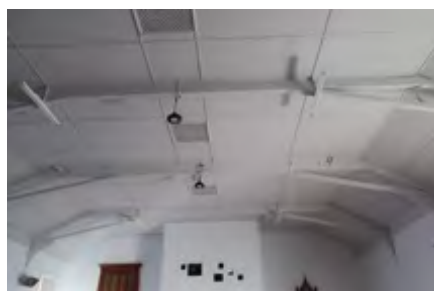
Area 12**LB77 Memorial Hall: Ground Floor Hall 5. The Ceiling (F C Sheeting) has Asbestos Containing Material (ACM) present.****RISK ASSESSMENT**

Type of Asbestos or Hazardous Material	No sample taken - Visual ID	Condition	GOOD	Likelihood of Damage	L (Low) – possible
		Activity	Moderate		
		Sealed	Yes	Friability	Bonded (non-friable)
		Labelled	Y	Exposure Risk	Low - Negligible or low risk
		Quantity

Maintain paint or sealant

Priority	MEDIUM	Label Required	Yes	Re- Audit Date	27 Jan 2022
Action	No remedial action required, unless disturbed				
Recommendation	Maintain paint or sealant to ACM surfaces. Particular attention should be given to side edges, ensure paint/sealant covers ALL exposed ACM surfaces.				
Legislative Requirements Victorian Regulation 2007	Warning labels should be affixed. Avoid mechanical damage and abrasion. Remove if refurbishment, structural alteration or demolition is to be carried out in this area. Re-inspect every 12 months or earlier if disturbed or removed in accordance with the Victorian OH&S Regulation 2017. All remedial/removal repairs require a Clearance Inspection & Certificate to be recorded by an approved and competent assessor.

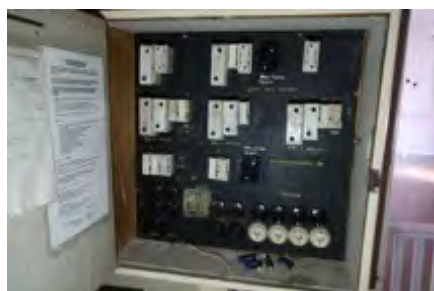
Area 5**LB77 Memorial Hall: Ground Floor Stage 6. The Electrical Cabinet - lining (F C Sheeting) has Asbestos Containing Material (ACM) present.****RISK ASSESSMENT**

Type of Asbestos or Hazardous Material	No sample taken - Visual ID	Condition	AVERAGE	Likelihood of Damage	L (Low) – possible
		Activity	Moderate		
		Sealed	No	Friability	Bonded (non-friable)
		Labelled	Y	Exposure Risk	Medium - Moderate risk
		Quantity

Raw Material

Priority	HIGH	Label Required	Yes	Re- Audit Date	27 Jan 2022
Action	Remedial repairs required - seal raw material / edges				
Recommendation	Raw material sheeting - The area requires immediate remedial repairs. It is recommended the asbestos material be sealed with an approved membrane.				
Legislative Requirements Victorian Regulation 2007	<p>Damaged ACM visible in area. Requires IMMEDIATE ATTENTION. WARNING labels should be affixed. Avoid mechanical damage and abrasion. Remove if refurbishment, structural alteration or demolition is to be carried out in this area. Re-inspect every 12 months or earlier if disturbed or removed in accordance with the Victorian OH&S Regulation 2017.</p> <p>All remedial/removal repairs require a Clearance Inspection & Certificate to be recorded by an approved and competent assessor.</p>

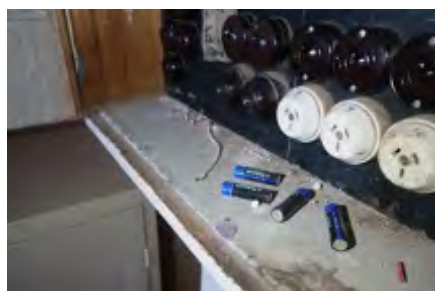
Area 1**LB77 Memorial Hall: Ground Floor Stage 6. The Electrical Cabinet (Debris) has Asbestos Containing Material (ACM) present.****RISK ASSESSMENT**

Type of Asbestos or Hazardous Material	Chrysotile Amosite Sample taken 62071-002	Condition	POOR	Likelihood of Damage	H (High) - almost certain
		Activity	Low		
		Sealed	No	Friability	Exposed Fibres
		Labelled	Y	Exposure Risk	High - Short term exposure risk
		Quantity

Debris on Ground

Priority	IMMEDIATE	Label Required	Yes	Re- Audit Date	27 Jan 2022
Action	Restrict access and target for imminent removal				
Recommendation	Debris on Ground - The Debris requires immediate cleanup and disposal with specialized equipment and with licenced removalist to safely remove the asbestos debris.				
Legislative Requirements Victorian Regulation 2007	ACM debris visible. Recommend cleanup by licensed Asbestos Removalist. Warning labels should be affixed. Avoid mechanical damage and abrasion. Remove if refurbishment, structural alteration or demolition is to be carried out in this area. Re-inspect every 12 months or earlier if disturbed or removed in accordance with the Victorian OH&S Regulation 2017. All remedial/removal repairs require a Clearance Inspection & Certificate to be recorded by an approved and competent assessor.

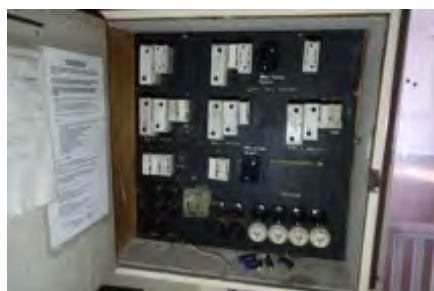
Area 15**LB77 Memorial Hall: Ground Floor Stage 6. The A: Electrical board; B: Ceramic Fuses (A: Zelemite; B: Cloth Inserts) has Asbestos Containing Material (ACM) present.****RISK ASSESSMENT**

Type of Asbestos or Hazardous Material	Chrysotile	Condition	GOOD	Likelihood of Damage	L (Low) – possible
	Sample taken 62071-003 (Zelemite)	Activity	Moderate		
		Sealed	Yes	Friability	Bonded (non-friable)
		Labelled	Y	Exposure Risk	Low - Negligible or low risk
		Quantity

Maintain paint or sealant

Priority	MEDIUM	Label Required	Yes	Re- Audit Date	27 Jan 2022
Action	No remedial action required, unless disturbed				
Recommendation	Maintain paint or sealant to ACM surfaces. Particular attention should be given to side edges, ensure paint/sealant covers ALL exposed ACM surfaces. Do not remove the fuses without asbestos controls - test for cloth inserts				
Legislative Requirements Victorian Regulation 2007	Warning labels should be affixed. Avoid mechanical damage and abrasion. Remove if refurbishment, structural alteration or demolition is to be carried out in this area. Re-inspect every 12 months or earlier if disturbed or removed in accordance with the Victorian OH&S Regulation 2017. All remedial/removal repairs require a Clearance Inspection & Certificate to be recorded by an approved and competent assessor.

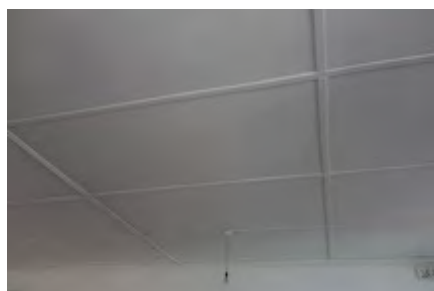
Area 18**LB77 Memorial Hall: Level 1 Open room 10. The Ceiling (F C Sheeting) has Asbestos Containing Material (ACM) present.****RISK ASSESSMENT**

Type of Asbestos or Hazardous Material	No sample taken - Visual ID	Condition	GOOD	Likelihood of Damage	L (Low) – possible
		Activity	Moderate		
		Sealed	Yes	Friability	Bonded (non-friable)
		Labelled	Y	Exposure Risk	Low - Negligible or low risk
		Quantity

Maintain paint or sealant

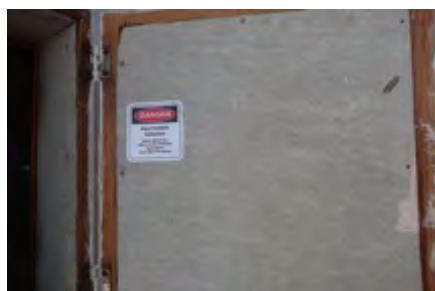
Type of Asbestos or Hazardous Material	No sample taken - Visual ID	Condition	AVERAGE	Likelihood of Damage	L (Low) – possible
		Activity	Moderate		
		Sealed	No	Friability	Bonded (non-friable)
		Labelled	Y	Exposure Risk	Medium - Moderate risk
		Quantity

Raw Material

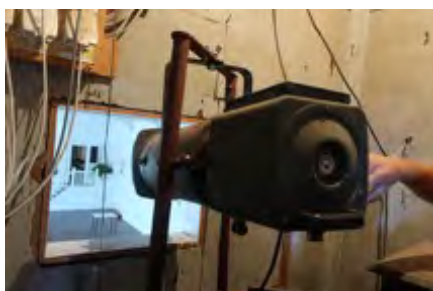
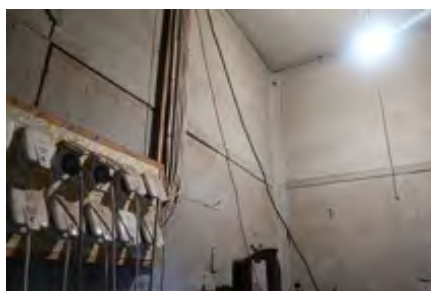
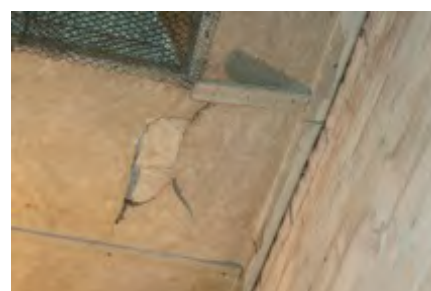
Area 3**LB77 Memorial Hall: Level 1 Projector room 11. The Walls and Ceiling (F C Sheeting) has Asbestos Containing Material (ACM) present.****RISK ASSESSMENT**

Type of Asbestos or Hazardous Material	No sample taken - Visual ID	Condition	POOR	Likelihood of Damage	L (Low) – possible
		Activity	Moderate		
		Sealed	Yes	Friability	Exposed Fibres
		Labelled	Y	Exposure Risk	High - Short term exposure risk
		Quantity

Damaged material

Damaged material - The damaged area requires immediate remedial repairs. It is recommended the asbestos sheeting be replaced.

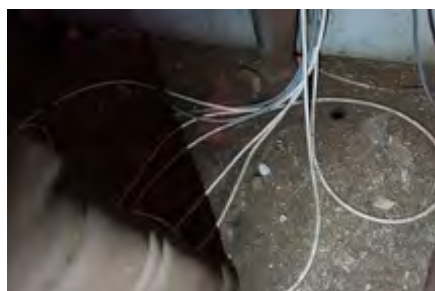
Area 2**LB77 Memorial Hall: Level 1 Projector room 11. The Debris - Broken (Debris) has Asbestos Containing Material (ACM) present.****RISK ASSESSMENT**

- 2 **LB77 Memorial Hall: Level 1 Projector room 11. The Debris - Broken (Debris) has Asbestos Containing Material (ACM) present.**

Type of Asbestos or Hazardous Material	No sample taken - Visual ID	Condition	POOR	Likelihood of Damage	H (High) - almost certain
		Activity	Moderate		
		Sealed	No	Friability	Exposed Fibres
		Labelled	No	Exposure Risk	High - Short term exposure risk
		Quantity

Debris on Surface

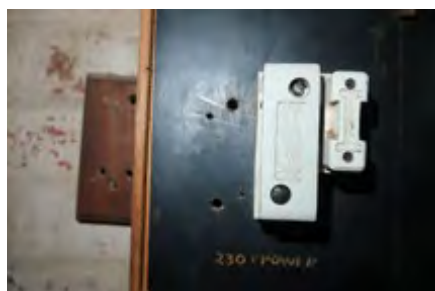
Area 8**LB77 Memorial Hall: Level 1 Projector room. The A: Electrical board; B: Ceramic Fuses (A: Zelemite; B: Cloth Inserts) has Asbestos Containing Material (ACM) present.****RISK ASSESSMENT**

Type of Asbestos or Hazardous Material	No sample taken - Visual ID	Condition	AVERAGE	Likelihood of Damage	L (Low) – possible
		Activity	Moderate		
		Sealed	Yes	Friability	Exposed Fibres
		Labelled	Y	Exposure Risk	Medium - Moderate risk
		Quantity

Penetration Holes

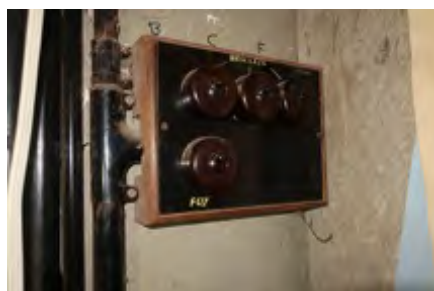
Area 19**LB77 Memorial Hall: Level 1 Projector room 11. The Electrical board (Backing Board (Zelemite)) has Asbestos Containing Material (ACM) present.****RISK ASSESSMENT**

Type of Asbestos or Hazardous Material	No sample taken - Visual ID	Condition	GOOD	Likelihood of Damage	L (Low) – possible
		Activity	Moderate		
		Sealed	Yes	Friability	Bonded (non-friable)
		Labelled	Y	Exposure Risk	Low - Negligible or low risk
		Quantity

Maintain paint or sealant
