Asbestos Report

YARRIAMBIACK SHIRE COUNCIL

PROPERTY ADDRESS:
LB119 RECREATION RESERVE
29 STRACHAN STREET
HOPETOUN VIC 3396

INSPECTION DATE: 27 JANUARY 2021
REFERENCE NUMBER: 62073

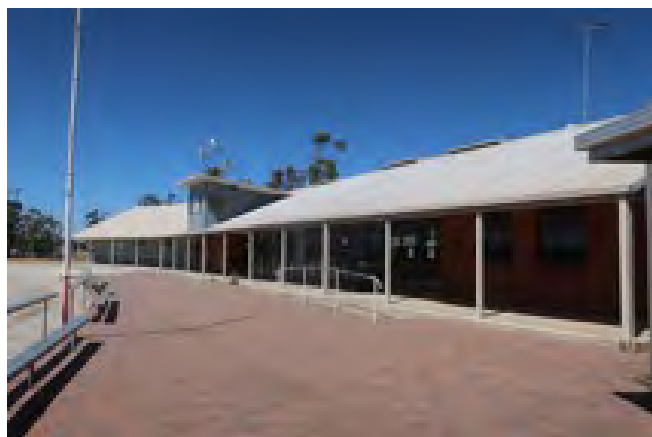
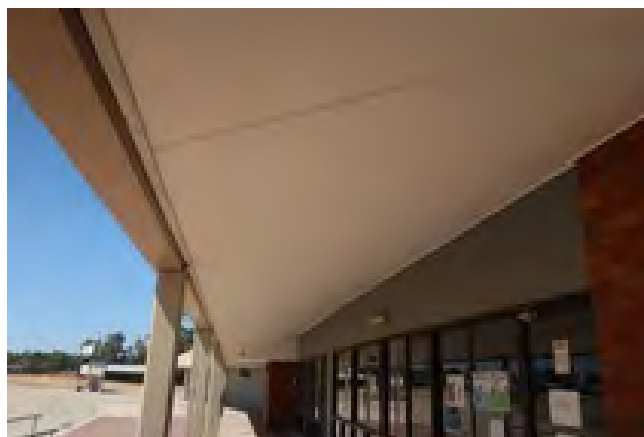
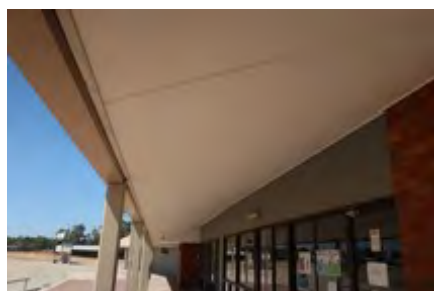
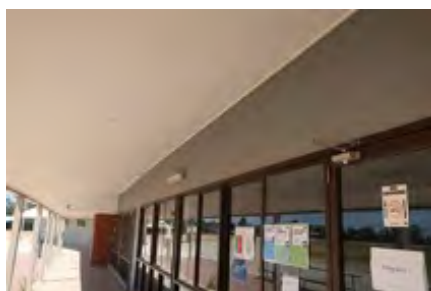
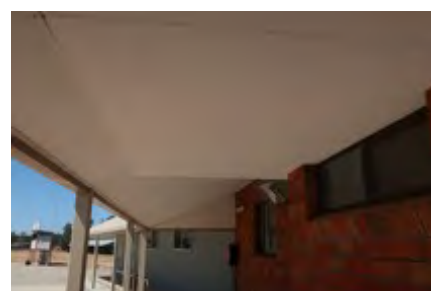
Area 9**Football Club - Clubrooms: front of building. The Ceiling (F C Sheeting) has Asbestos Containing Material (ACM) present.****RISK ASSESSMENT**

Type of Asbestos or Hazardous Material	Chrysotile Same as Sample - 62073 -001	Condition	GOOD	Likelihood of Damage	L (Low) – possible
		Activity	Moderate		
		Sealed	Yes	Friability	Bonded (non-friable)
		Labelled	Y	Exposure Risk	Low - Negligible or low risk
		Quantity

Priority	MEDIUM	Label Required	Yes	Re- Audit Date	27 Jan 2022
Action	No remedial action required, unless disturbed				
Recommendation	Maintain paint or sealant to ACM surfaces. Particular attention should be given to side edges, ensure paint/sealant covers ALL exposed ACM surfaces.				
Legislative Requirements Victorian Regulation 2007	Warning labels should be affixed. Avoid mechanical damage and abrasion. Remove if refurbishment, structural alteration or demolition is to be carried out in this area. Re-inspect every 12 months or earlier if disturbed or removed in accordance with the Victorian OH&S Regulation 2017. All remedial/removal repairs require a Clearance Inspection & Certificate to be recorded by an approved and competent assessor.

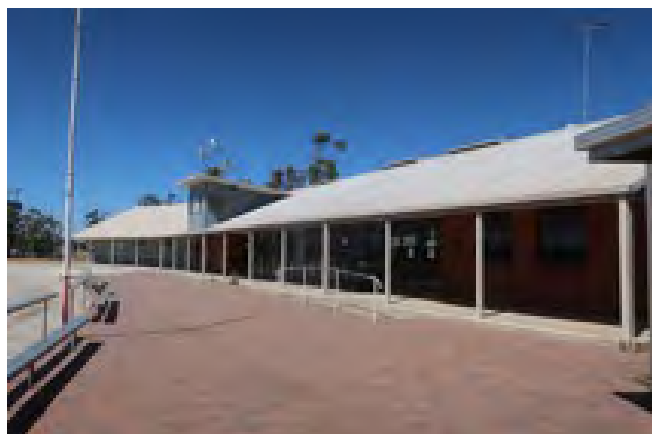
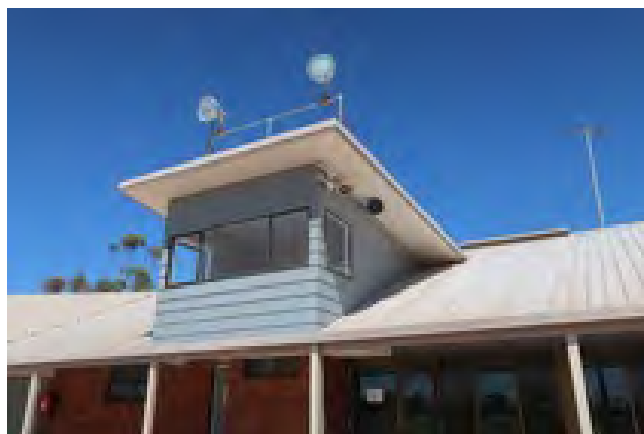
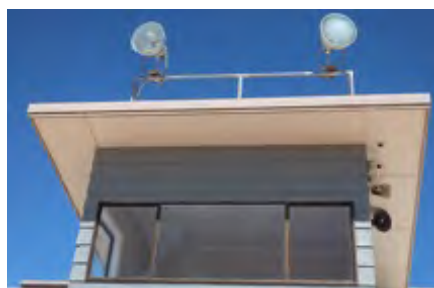
Area 8**Football Club - Clubrooms: front of building - commentators box. The Soffit (F C Sheeting) has Asbestos Containing Material (ACM) present.****RISK ASSESSMENT**

Type of Asbestos or Hazardous Material	No sample taken - Visual ID	Condition	GOOD	Likelihood of Damage	L (Low) – possible
		Activity	Moderate		
		Sealed	Yes	Friability	Bonded (non-friable)
		Labelled	Y	Exposure Risk	Low - Negligible or low risk
		Quantity

Priority	MEDIUM	Label Required	Yes	Re- Audit Date	27 Jan 2022
Action	No remedial action required, unless disturbed				
Recommendation	Maintain paint or sealant to ACM surfaces. Particular attention should be given to side edges, ensure paint/sealant covers ALL exposed ACM surfaces.				
Legislative Requirements Victorian Regulation 2007	Warning labels should be affixed. Avoid mechanical damage and abrasion. Remove if refurbishment, structural alteration or demolition is to be carried out in this area. Re-inspect every 12 months or earlier if disturbed or removed in accordance with the Victorian OH&S Regulation 2017. All remedial/removal repairs require a Clearance Inspection & Certificate to be recorded by an approved and competent assessor.

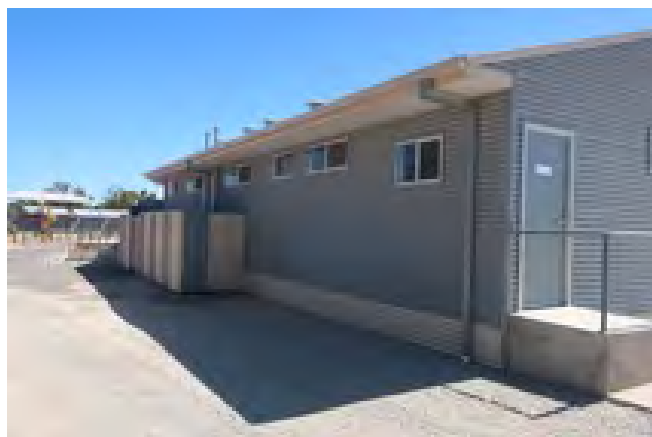
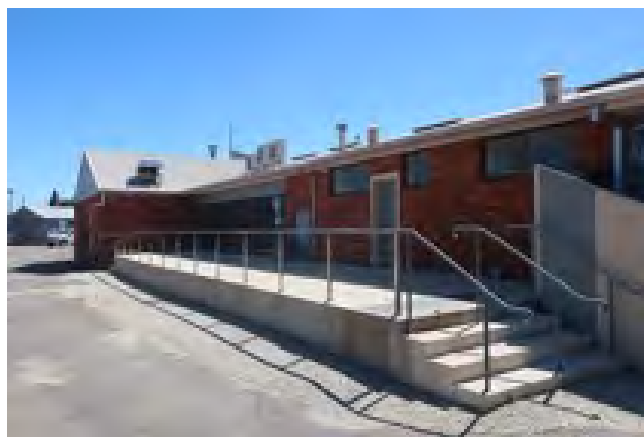
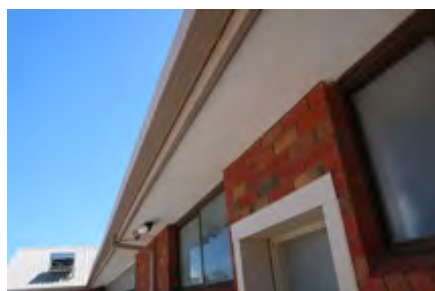
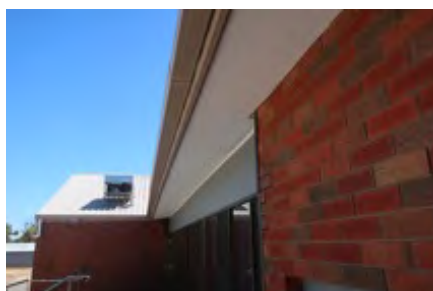
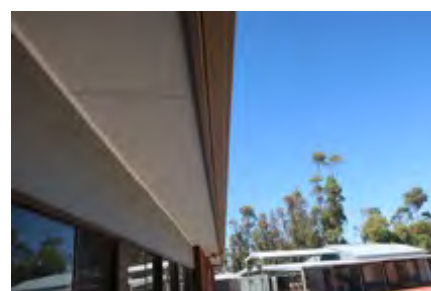
Area 10**Football Club - Clubrooms: rear of building. The Soffit (F C Sheeting) has Asbestos Containing Material (ACM) present.****RISK ASSESSMENT**

Type of Asbestos or Hazardous Material	Chrysotile	Condition	GOOD	Likelihood of Damage	L (Low) – possible
	Sample taken 62073-001	Activity	Moderate		
		Sealed	Yes	Friability	Bonded (non-friable)
		Labelled	Y	Exposure Risk	Low - Negligible or low risk
		Quantity

Priority	MEDIUM	Label Required	Yes	Re- Audit Date	27 Jan 2022
Action	No remedial action required, unless disturbed				
Recommendation	Maintain paint or sealant to ACM surfaces. Particular attention should be given to side edges, ensure paint/sealant covers ALL exposed ACM surfaces.				
Legislative Requirements Victorian Regulation 2007	Warning labels should be affixed. Avoid mechanical damage and abrasion. Remove if refurbishment, structural alteration or demolition is to be carried out in this area. Re-inspect every 12 months or earlier if disturbed or removed in accordance with the Victorian OH&S Regulation 2017. All remedial/removal repairs require a Clearance Inspection & Certificate to be recorded by an approved and competent assessor.

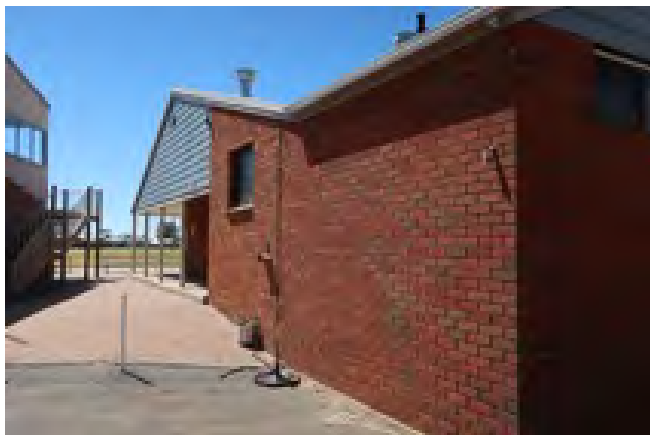
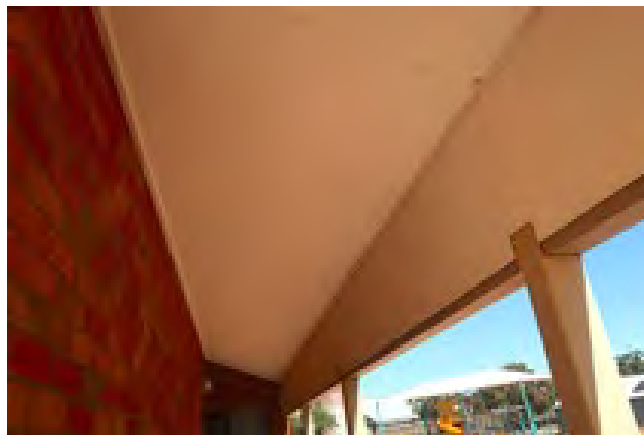
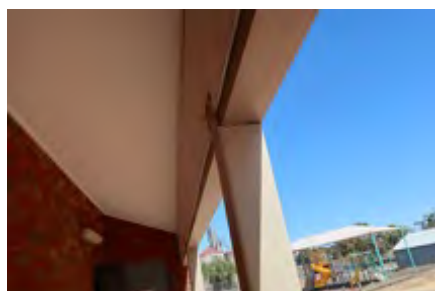
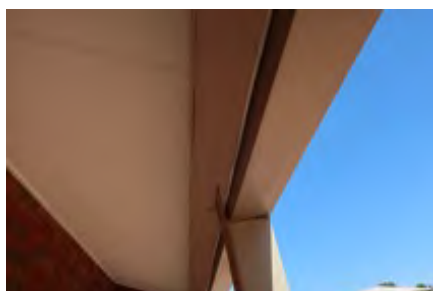
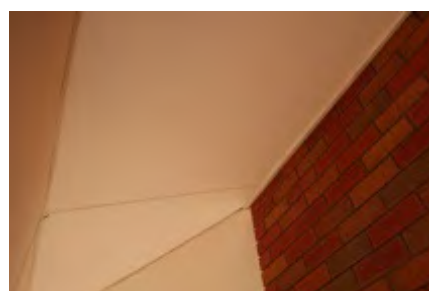
Area 7***Exhibition Shed (store shed): right side of building. The Ceiling (F C Sheeting) has Asbestos Containing Material (ACM) present.*****RISK ASSESSMENT**

Type of Asbestos or Hazardous Material	Chrysotile	Condition	GOOD	Likelihood of Damage	L (Low) – possible
	Same as Sample - 62073 -001	Activity	Moderate		
		Sealed	Yes	Friability	Bonded (non-friable)
		Labelled	Y	Exposure Risk	Low - Negligible or low risk
		Quantity

Priority	MEDIUM	Label Required	Yes	Re- Audit Date	27 Jan 2022
Action	No remedial action required, unless disturbed				
Recommendation	Maintain paint or sealant to ACM surfaces. Particular attention should be given to side edges, ensure paint/sealant covers ALL exposed ACM surfaces.				
Legislative Requirements Victorian Regulation 2007	Warning labels should be affixed. Avoid mechanical damage and abrasion. Remove if refurbishment, structural alteration or demolition is to be carried out in this area. Re-inspect every 12 months or earlier if disturbed or removed in accordance with the Victorian OH&S Regulation 2017. All remedial/removal repairs require a Clearance Inspection & Certificate to be recorded by an approved and competent assessor.

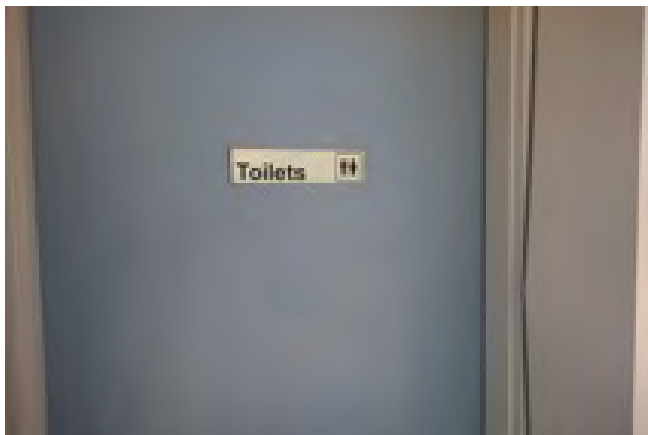
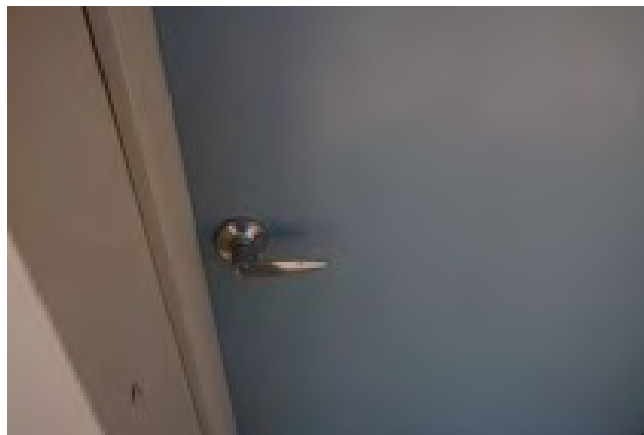
Type of Asbestos or Hazardous Material	No sample taken - No Access	Condition		Likelihood of Damage	
		Activity			
		Sealed		Friability	
		Labelled	No	Exposure Risk	
		Quantity

Priority	HIGH	Label Required	Yes	Re- Audit Date	27 Jan 2022
Action					
Recommendation					
Legislative Requirements Victorian Regulation 2007	Unable to Gain Access. Assume asbestos in area and provide monitoring if work undertaken in these areas. If access is made available, contact Global Asbestos Audits for re-inspection

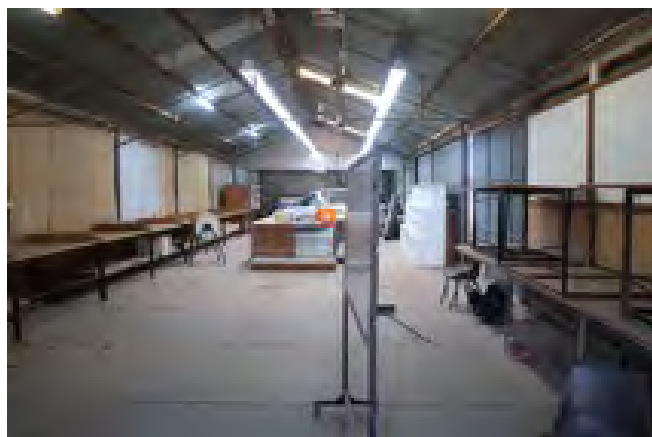
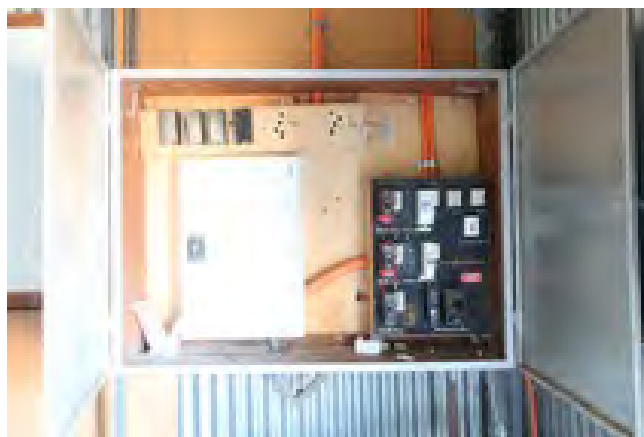
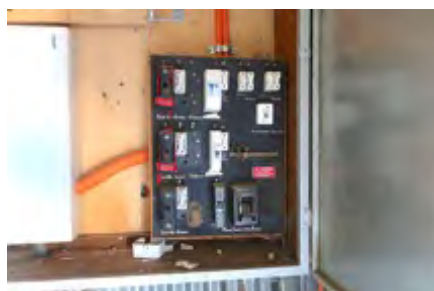
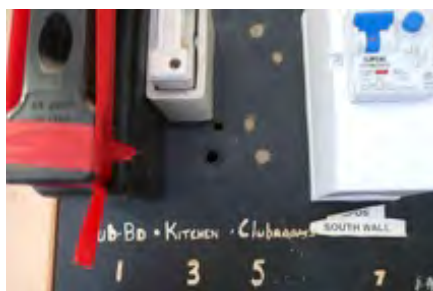
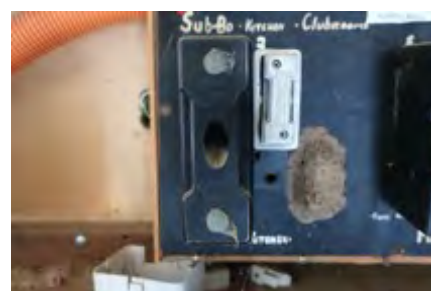
Area 1**Farmers Shed (Ag Society): Shed 1. The A: Electrical board; B: Ceramic Fuses (A: Zelemite; B: Cloth Inserts) has Asbestos Containing Material (ACM) present.****RISK ASSESSMENT**

Type of Asbestos or Hazardous Material	No sample taken - Visual ID	Condition	GOOD	Likelihood of Damage	L (Low) – possible
		Activity	Moderate		
		Sealed	Yes	Friability	Bonded (non-friable)
		Labelled	Y	Exposure Risk	Low - Negligible or low risk
		Quantity

Priority	HIGH	Label Required	Yes	Re- Audit Date	27 Jan 2022
Action	Remedial repairs required - seal raw material / edges				
Recommendation	Penetration holes (purpose) -The exposed edges require approved sealant. It is further recommended the gaps be filled with sealant. Do not remove the fuses without asbestos controls - test for cloth inserts				
Legislative Requirements Victorian Regulation 2007	Damaged ACM visible in area. Requires IMMEDIATE ATTENTION. WARNING labels should be affixed. Avoid mechanical damage and abrasion. Remove if refurbishment, structural alteration or demolition is to be carried out in this area. Re-inspect every 12 months or earlier if disturbed or removed in accordance with the Victorian OH&S Regulation 2017. All remedial/removal repairs require a Clearance Inspection & Certificate to be recorded by an approved and competent assessor.

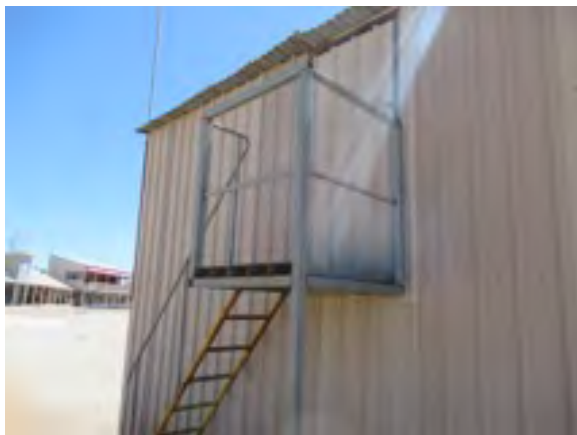
Area 4***Pergola/ score box: . Until the area is inspected, it should be managed as if it Asbestos Containing Material (ACM) is present.*****RISK ASSESSMENT**

Type of Asbestos or Hazardous Material	No sample taken - No Access	Condition		Likelihood of Damage	
		Activity			
		Sealed		Friability	
		Labelled	No	Exposure Risk	
		Quantity

Priority	HIGH	Label Required	Yes	Re- Audit Date	27 Jan 2022
Action					
Recommendation					
Legislative Requirements Victorian Regulation 2007	Unable to Gain Access. Assume asbestos in area and provide monitoring if work undertaken in these areas. If access is made available, contact Global Asbestos Audits for re-inspection

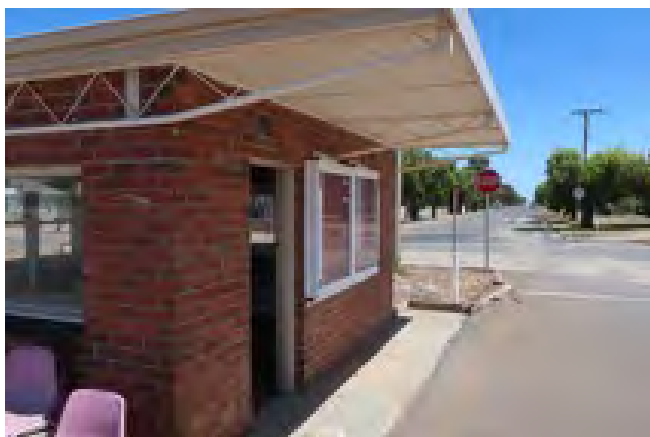
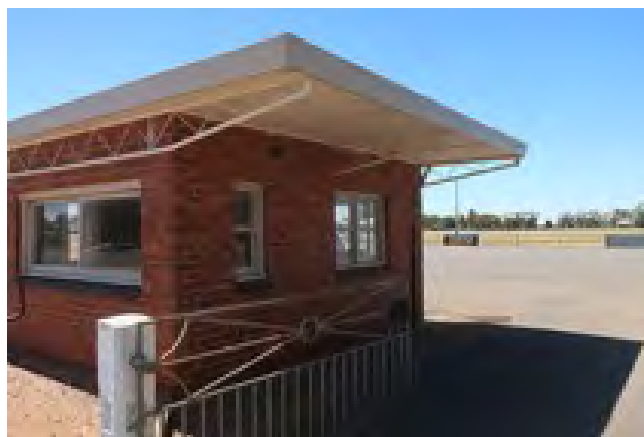
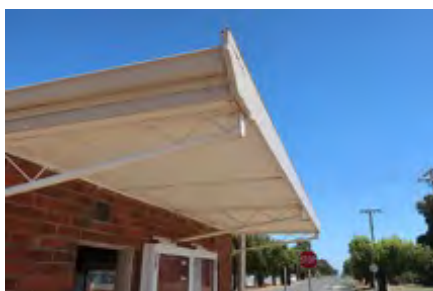
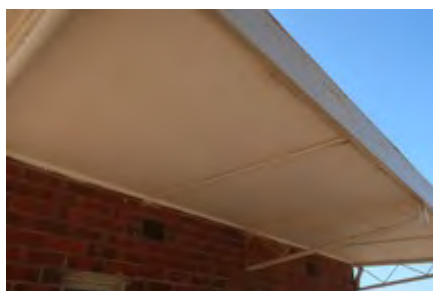
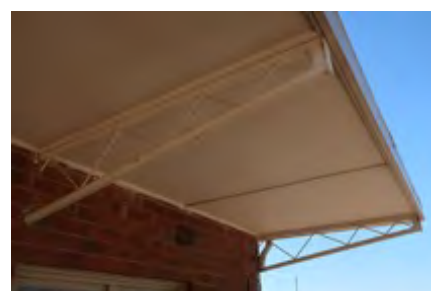
Area 11***Ticket Office: front & rear of building. The Ceiling/ soffit (F C Sheeting) has Asbestos Containing Material (ACM) present.*****RISK ASSESSMENT**

Type of Asbestos or Hazardous Material	Chrysotile Amosite Sample taken 62073-003	Condition	GOOD	Likelihood of Damage	L (Low) – possible
		Activity	Moderate		
		Sealed	Yes	Friability	Bonded (non-friable)
		Labelled	Y	Exposure Risk	Low - Negligible or low risk
		Quantity

Priority	MEDIUM	Label Required	Yes	Re- Audit Date	27 Jan 2022
Action	No remedial action required, unless disturbed				
Recommendation	Maintain paint or sealant to ACM surfaces. Particular attention should be given to side edges, ensure paint/sealant covers ALL exposed ACM surfaces.				
Legislative Requirements Victorian Regulation 2007	Warning labels should be affixed. Avoid mechanical damage and abrasion. Remove if refurbishment, structural alteration or demolition is to be carried out in this area. Re-inspect every 12 months or earlier if disturbed or removed in accordance with the Victorian OH&S Regulation 2017. All remedial/removal repairs require a Clearance Inspection & Certificate to be recorded by an approved and competent assessor.

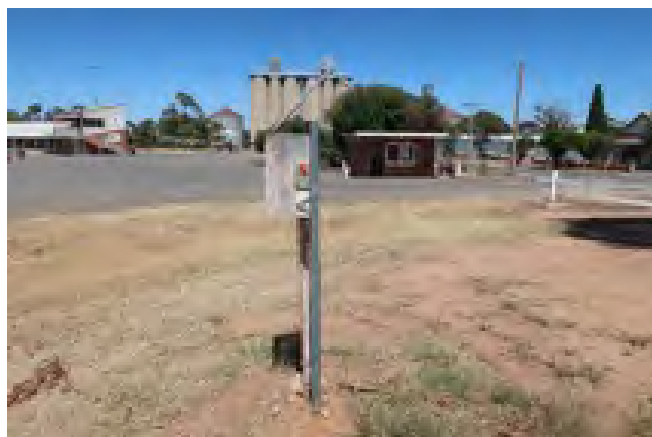
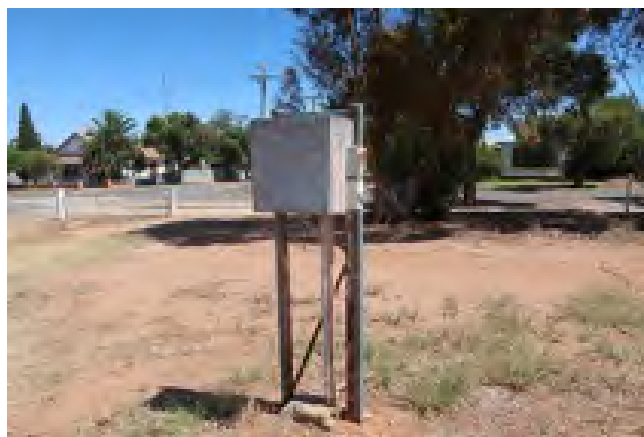
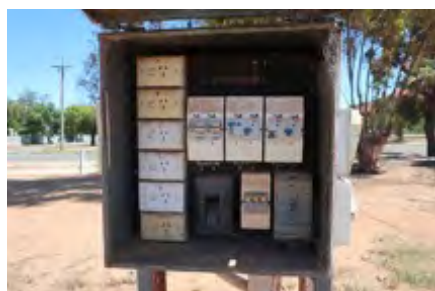
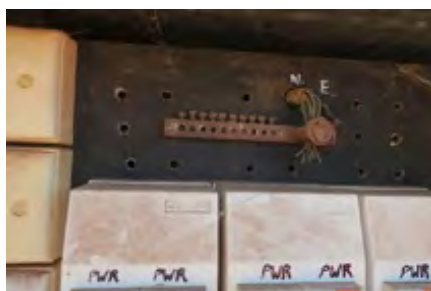
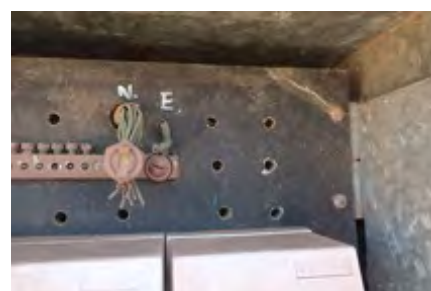
Area 3**Grounds: near ticket office. The Electrical board (Backing Board (Zelemite)) has Asbestos Containing Material (ACM) present.****RISK ASSESSMENT**

Type of Asbestos or Hazardous Material	No sample taken - Visual ID	Condition	AVERAGE	Likelihood of Damage	L (Low) – possible
		Activity	Moderate		
		Sealed	Yes	Friability	Exposed Fibres
		Labelled	Y	Exposure Risk	Medium - Moderate risk
		Quantity

Priority	HIGH	Label Required	Yes	Re- Audit Date	27 Jan 2022
Action	Remedial repairs required - seal raw material / edges				
Recommendation	Penetration Holes - The exposed edges require approved sealant. It is further recommended the gaps be filled with sealant.				
Legislative Requirements Victorian Regulation 2007	<p>Damaged ACM visible in area. Requires IMMEDIATE ATTENTION. WARNING labels should be affixed. Avoid mechanical damage and abrasion. Remove if refurbishment, structural alteration or demolition is to be carried out in this area. Re-inspect every 12 months or earlier if disturbed or removed in accordance with the Victorian OH&S Regulation 2017.</p> <p>All remedial/removal repairs require a Clearance Inspection & Certificate to be recorded by an approved and competent assessor.</p>

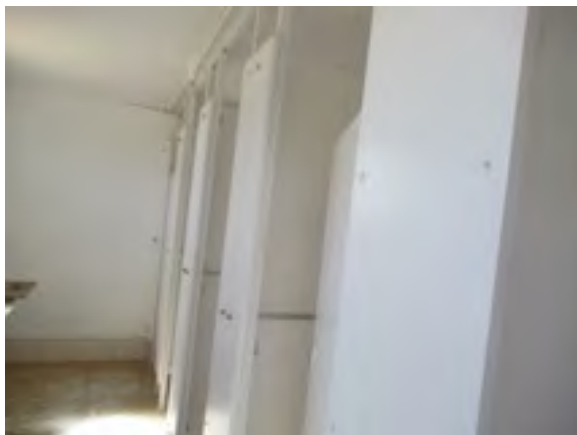
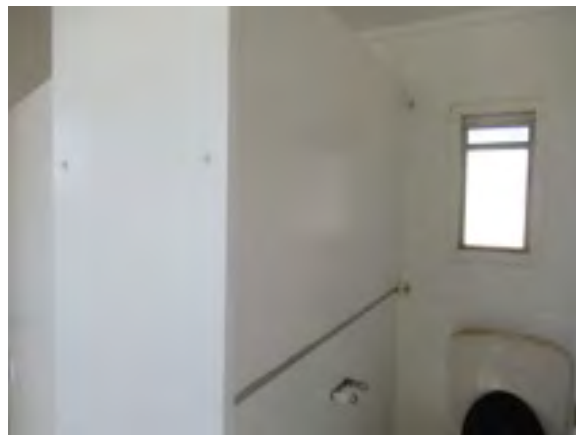
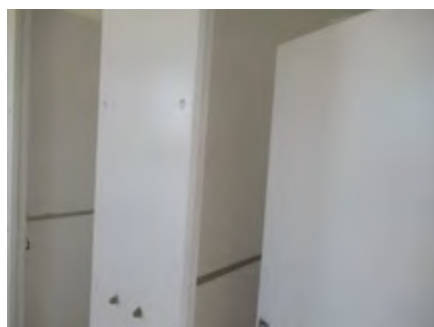
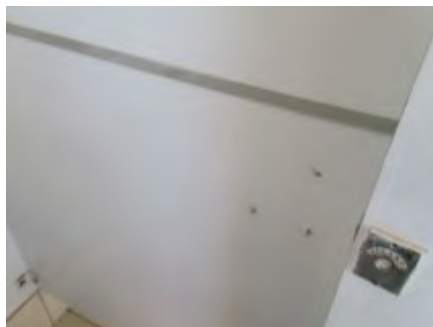
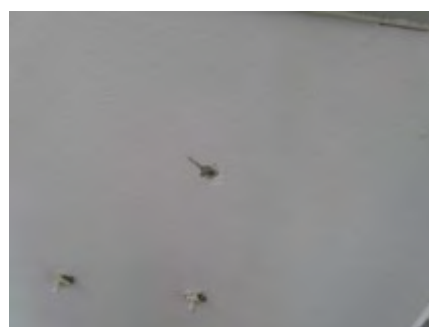
Area 5**Toilet block: Female bathroom 1. The Cubical Walls (F C Sheet) has Asbestos Containing Material (ACM) present.****RISK ASSESSMENT**

Type of Asbestos or Hazardous Material	Chrysotile	Condition	AVERAGE	Likelihood of Damage	L (Low) – possible
	Sample taken 62073-007	Activity	Moderate		
		Sealed	Yes	Friability	Exposed Fibres
		Labelled	Y	Exposure Risk	Medium - Moderate risk
		Quantity

Priority	HIGH	Label Required	Yes	Re- Audit Date	27 Jan 2022
Action	Remedial repairs required - seal raw material / edges				
Recommendation	Penetration Holes - The exposed edges require approved sealant. It is further recommended the gaps be filled with sealant.				
Legislative Requirements Victorian Regulation 2007	<p>Damaged ACM visible in area. Requires IMMEDIATE ATTENTION. WARNING labels should be affixed. Avoid mechanical damage and abrasion. Remove if refurbishment, structural alteration or demolition is to be carried out in this area. Re-inspect every 12 months or earlier if disturbed or removed in accordance with the Victorian OH&S Regulation 2017.</p> <p>All remedial/removal repairs require a Clearance Inspection & Certificate to be recorded by an approved and competent assessor.</p>

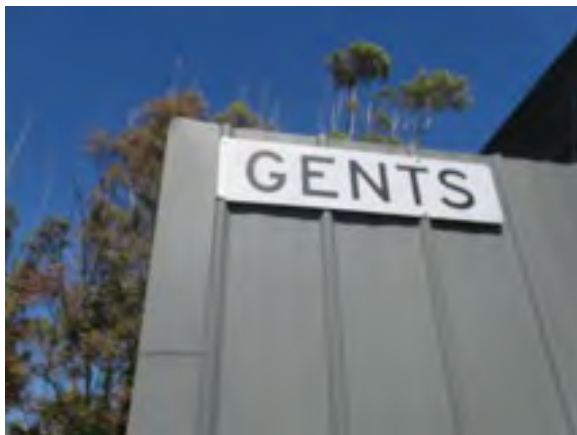
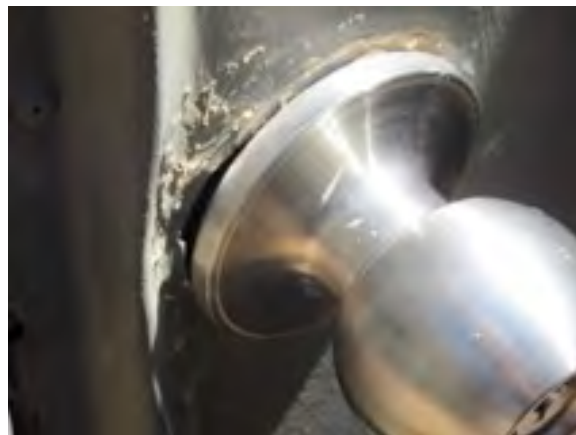
Type of Asbestos or Hazardous Material	No sample taken - No Access	Condition		Likelihood of Damage	
		Activity			
		Sealed		Friability	
		Labelled	No	Exposure Risk	
		Quantity

Priority	HIGH	Label Required	Yes	Re- Audit Date	27 Jan 2022
Action					
Recommendation					
Legislative Requirements Victorian Regulation 2007	Unable to Gain Access. Assume asbestos in area and provide monitoring if work undertaken in these areas. If access is made available, contact Global Asbestos Audits for re-inspection
