# **Asbestos Report**

#### YARRIAMBIACK SHIRE COUNCIL

PROPERTY ADDRESS: LB60 SHIRE OFFICES 75 LASCELLES STREET HOPETOUN VIC 3396

INSPECTION DATE: 27 JANUARY 2021 REFERENCE NUMBER: 62079

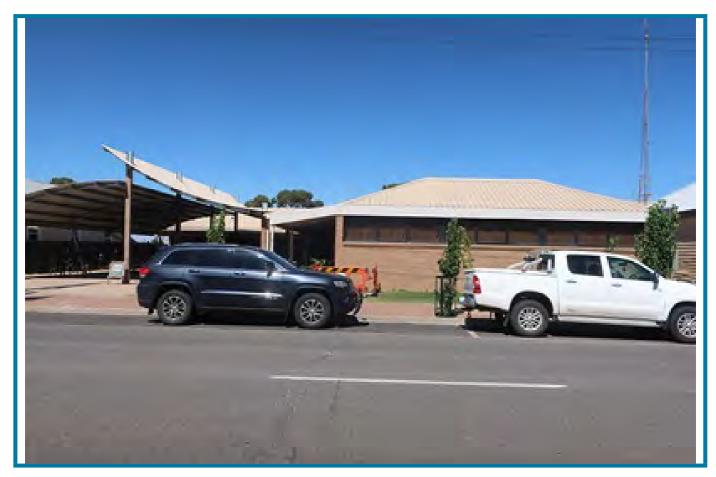
**ACM** Component Type Asbestos Signage Identified Location Area **Materials Assessment** ConditionPriority Required F C Sheeting No Asbestos Detected Main building -Ceiling No front of building. Sample taken 62079-001
