Asbestos Report

YARRIAMBIACK SHIRE COUNCIL

PROPERTY ADDRESS: LB11 BRIM BOWLING 7-15 SWANN STREET BRIM VIC 3391

INSPECTION DATE: 8 FEBRUARY 2021

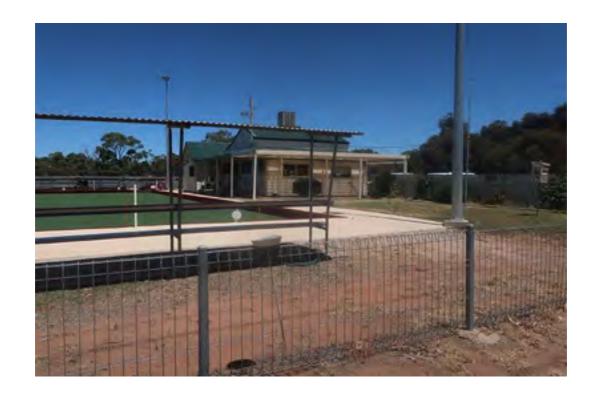
LB11 Brim Bowling: Subfloor. The Packers (F C Sheet) has Asbestos Containing Material (ACM) present.

RISK AS	RISK ASSESSMENT						
Type of Asbestos or	Chrysotile	Condition	_	_	L (Low) – possible		
	Sample taken 62087-002	Activity	Moderate	Damage			
		Sealed	No	Friability	Bonded (non-friable)		
		Labelled	No	Exposure Risk	Medium - Moderate risk		
		Quantity

RISK CONTROL						
Priority	HIGH		Label Required	Yes	Re- Audit Date	8 Feb 2022
Action		Remedial repairs r	equired - seal raw r	material / edges		
Recommendation		Raw material sheeting - The area requires immediate remedial repairs. It is recommended the asbestos material be sealed with an approved membrane.				
Legislative Requirements Victorian Regulation 2007		Avoid mechanical be carried out in the removed in a All remedial	damage and abras nis area. Re-insp accordance wit L/removal re	ion. Remove if refurbi ect every 12 m h the Victorian epairs require	ishment, structural onths or earli OH&S Regula a Clearance	IG labels should be affixed. alteration or demolition is to er if disturbed or ation 2017. Inspection & npetent assessor.

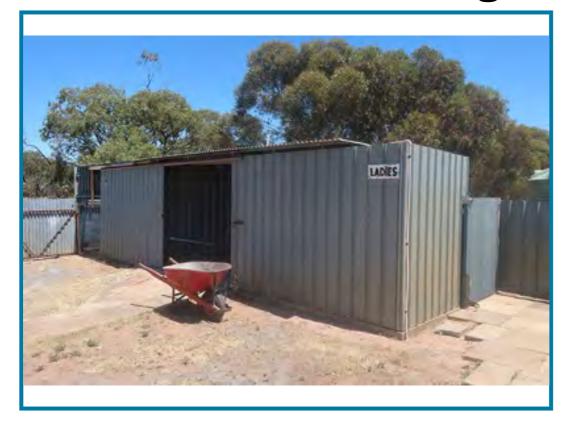
Location	Area	Component Materials	ACM Identified	Type Asbesto Assessment	s ConditionPriority	Signage Required
Amenities Building - entire perimeter of building.		No Asbestos Materials	No	No sample take	en - Visual ID

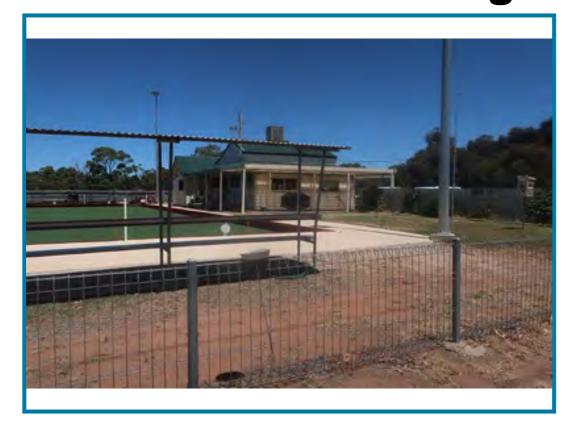
LB11 Brim Bowling

Component **ACM Type Asbestos** Signage Assessment Location Area Materials Identified **ConditionPriority** Required LB11 Brim Walls - planking F C Sheeting No No Asbestos Detected Bowling - entire
