## **Asbestos Report**

YARRIAMBIACK SHIRE COUNCIL

PROPERTY ADDRESS: LB30B DEPOT 32 MILL STREET MINYIP VIC 3392

INSPECTION DATE: 10 FEBRUARY 2021

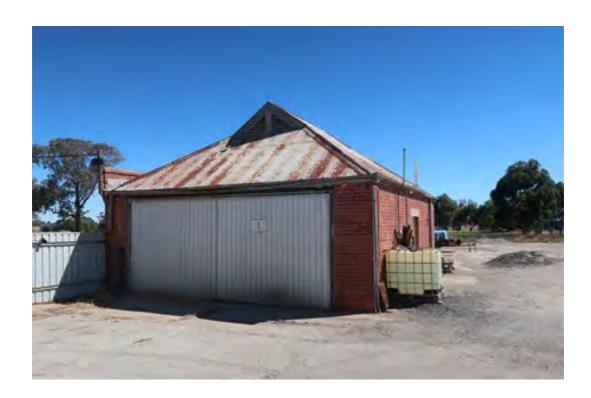
## **Store Shed**

RISK ASSESSMENT							
Type of Asbestos or Hazardous Material	No sample taken - Visual ID	Condition	AVERAGE	Likelihood of	L (Low) – possible		
		Activity	Moderate	Damage			
		Sealed	Yes	Friability	Exposed Fibres		
		Labelled	Υ	Exposure Risk	High - Short term exposure risk		
		Quantity

RISK C	DNTR	OL						
Priority	HIGH		Label Required	Yes	Re- Audit Date	10 Feb 2022		
Action		Remedial repairs re	equired - seal expo	sed edges or replace	or laminate over d	amaged material		
Recommendation		sheeting be replace	Holes (impact) - The damaged area requires immediate remedial repairs. It is recommended the asbestos sheeting be replaced (preferred) or edges sealed with approved sealant and then the area be concealed by laminating (sheeting.					
Legislative Requirements Victorian Regulation 2007		Avoid mechanical be carried out in the accordance with All remedial/ren	Damaged ACM visible in area. Requires IMMEDIATE ATTENTION. WARNING labels should be affixed. Avoid mechanical damage and abrasion. Remove if refurbishment, structural alteration or demolition is to be carried out in this area. Re-inspect every 12 months or earlier if disturbed or removed in accordance with the Victorian OH&S Regulation 2017.  All remedial/removal repairs require a Clearance Inspection & Certificate to be recorded by an approved and competent assessor.

Holes (impact) - The damaged area requires immediate remedial repairs. It is recommended the asbestos sheeting be replaced (preferred) or edges sealed with approved sealant and then the area be concealed by laminating (sheeting.

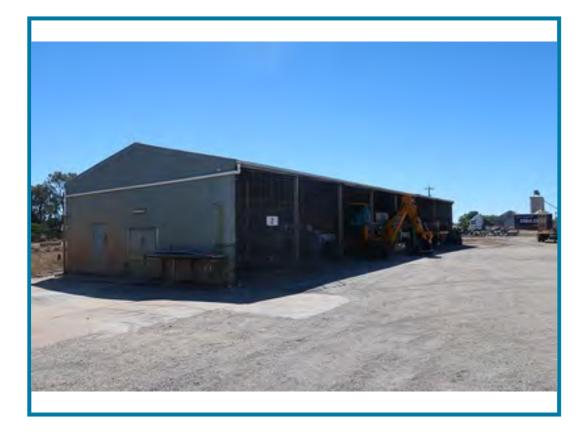
## **Machine Shed**

Component	ACM	Type Asbestos		Signage
Location	Area	Materials	Identified	Assessment	ConditionPriority	Required
Machine Shed - entire perimeter of building.		No Asbestos Materials	No	No sample tak	en - Visual ID

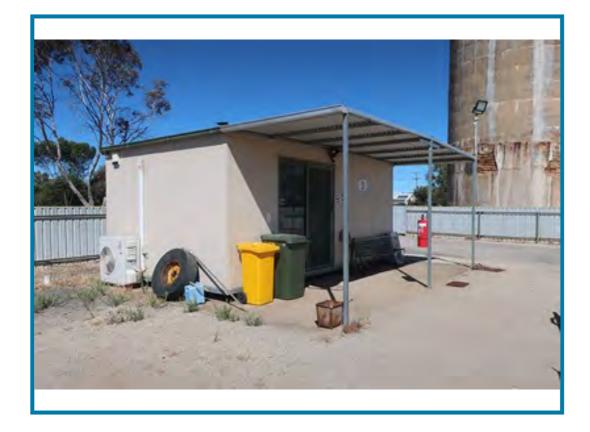
## Office

Component	ACM	Type Asbestos	Signage
Location	Area	Materials	Identified	Assessment ConditionPriority	Required
Office - entire		No Asbestos	No	No sample taken - Visual ID	
perimeter of		Materials			
building.

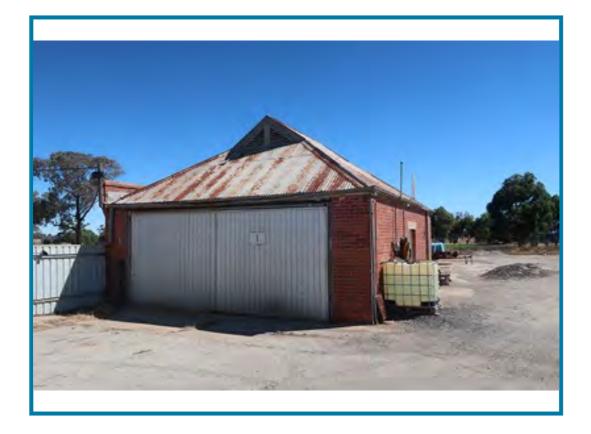
## Store Shed

**ACM** Component **Type Asbestos** Signage Identified Location Area **Materials** Assessment ConditionPriority Required Store Shed -No sample taken - Visual ID No Asbestos No entire perimeter Materials

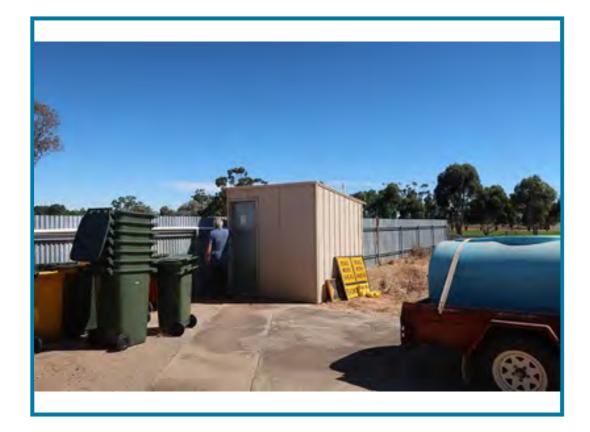
## **Toilet block**

Component	ACM	Type Asbestos		Signage
Location	Area	Materials	Identified	Assessment	ConditionPriority	Required
Toilet block -		No Asbestos	No	No sample tak	en - Visual ID	
entire perimeter		Materials				
of building.
