Asbestos Report

YARRIAMBIACK SHIRE COUNCIL

PROPERTY ADDRESS: LB57 UNIT 2 2/42 MCDONALD STREET MURTOA VIC 3390

INSPECTION DATE: 10 FEBRUARY 2021 REFERENCE NUMBER: 62104

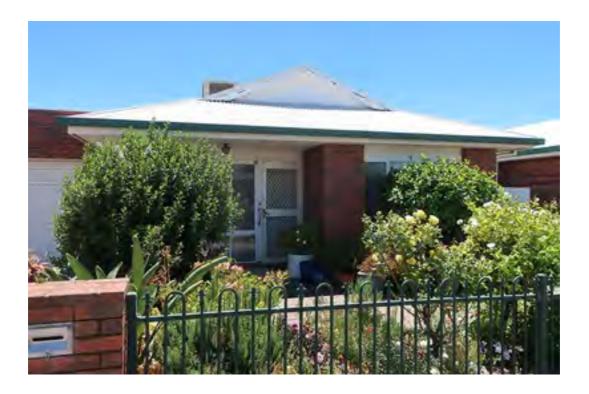
Dwelling LB57 Unit 2, 2/42 McDonald Street, Murtoa VIC 3390

1 Dwelling LB57 Unit 2: . Until the area is inspected, it should be managed as if it Asbestos Containing Material (ACM) is present.

RISK CONTROL						
Priority	HIGH		Label Required	Yes	Re- Audit Date	10 Feb 2022
Action						
Recommendation						
Legislative Requirements Victorian Regulation 2007				estos in area and prov ontact Global Asbesto		ork undertaken in these ection

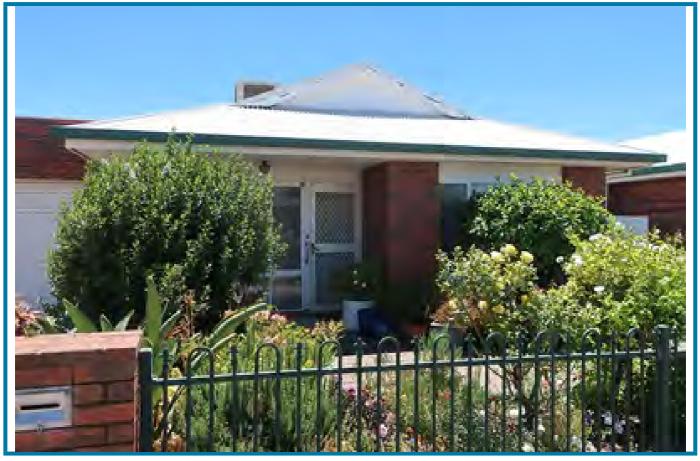
Location	Area	Component Materials	ACM Identified	Type Asbestos Assessment ConditionPriorit	Signage y Required
Dwelling LB57 Unit 2 - entire perimeter of building.	Soffit	F C Sheeting	No	No Asbestos Detected Sample taken 62104-001	
Dwelling LB57 Unit 2 - right side of buidling.	Electrical board	No Asbestos Materials	No	No sample taken - Visual ID	
Dwelling LB57 Unit 2 - roof.	Gable Ends	F C Sheeting	No	No sample taken - Visual ID	
Dwelling LB57 Unit 2		No Asbestos Materials	Yes	No sample taken - No Access	
				HIGH	Yes
				Refer to the Abestos Register information.
