Asbestos Report

YARRIAMBIACK SHIRE COUNCIL

PROPERTY ADDRESS: LR6 PUBLIC PARK - JACK EMMETT 89 WIMMERA HIGHWAY RUPANYUP VIC 3388

INSPECTION DATE: 10 FEBRUARY 2021 REFERENCE NUMBER: 62111

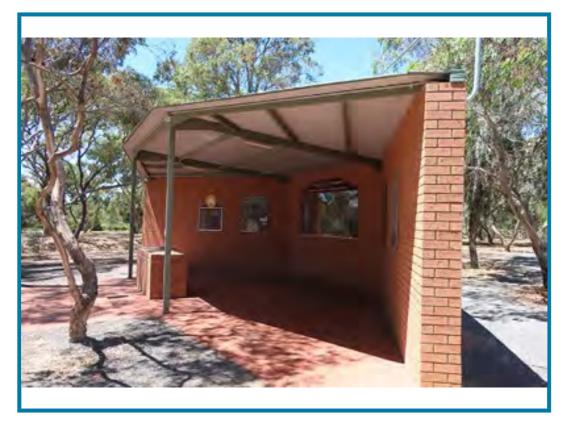
Component	ACM	Type Asbestos	5	Signage
Location	Area	Materials	Identified	Assessment	ConditionPriority	Required
Shelter - entire		No Asbestos	No	No sample take	en - Visual ID	
perimeter of		Materials				
building.

No

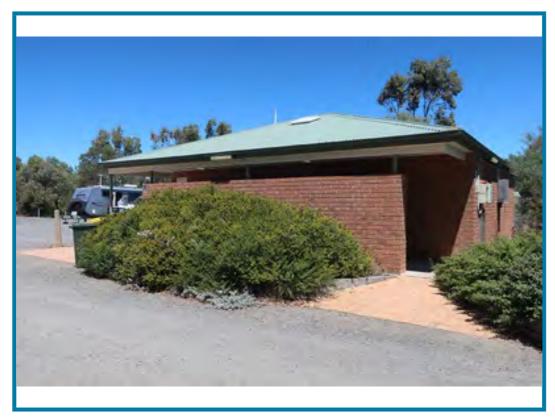
ASBESTOS SURVEY: Lr6 Public Park - Jack Emmett, 89 Wimmera Highway, Rupanyup Vic 3388					
Location	Area	Component Materials	ACM Identified	Type Asbestos Assessment ConditionPriority	Signage Required
Toilet - entire perimeter of building.	Soffit	F C Sheeting	No	No sample taken - Visual ID	
Toilet - Male bathroom.		No Asbestos Materials	No	No sample taken - Visual ID	
			Image not avalible		
Toilet - Unisex bathroom.		No Asbestos Materials	No	No sample taken - Visual ID	
Toilet - Female bathroom.		No Asbestos Materials	No	No sample taken - Visual ID
