Asbestos Report

YARRIAMBIACK SHIRE COUNCIL

PROPERTY ADDRESS:
LB28 RECREATION RESERVE
GIBSON STREET
RUPANYUP VIC 3388

INSPECTION DATE: 10 FEBRUARY 2021
REFERENCE NUMBER: 62112

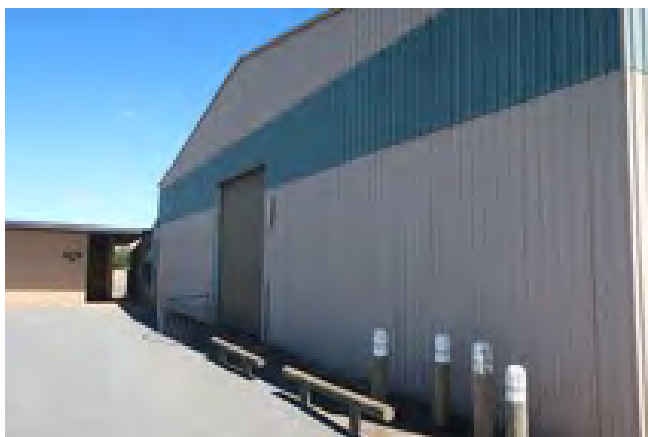
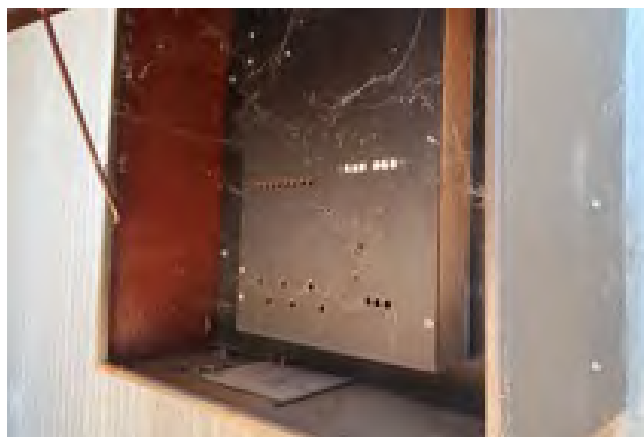
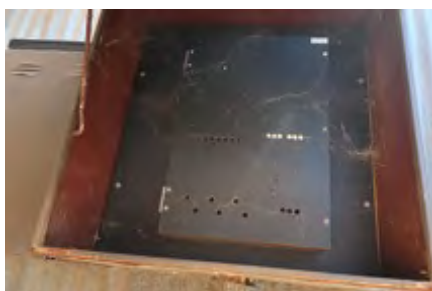
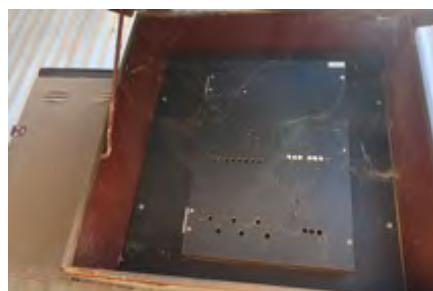
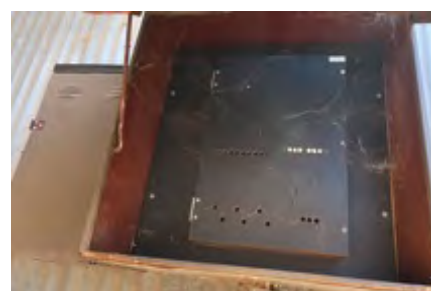
Area 9**Net ball: Front of building. The Electrical Board (Zelemite backing board) has Asbestos Containing Material (ACM) present.****RISK ASSESSMENT**

Type of Asbestos or Hazardous Material	No sample taken - Visual ID	Condition	AVERAGE	Likelihood of Damage	L (Low) – possible
		Activity	Low		
		Sealed	Yes	Friability	Exposed Fibres
		Labelled	Y	Exposure Risk	Low - Negligible or low risk
		Quantity

Priority	HIGH	Label Required		Re- Audit Date	10 Feb 2022
Action	Remedial repairs required - seal raw material / edges				
Recommendation	Penetration Holes - The exposed edges require approved sealant. It is further recommended the gaps be filled with sealant.				
Legislative Requirements Victorian Regulation 2007	Damaged ACM visible in area. Requires IMMEDIATE ATTENTION. WARNING labels should be affixed. Avoid mechanical damage and abrasion. Remove if refurbishment, structural alteration or demolition is to be carried out in this area. Re-inspect every 12 months or earlier if disturbed or removed in accordance with the Victorian OH&S Regulation 2017. All remedial/removal repairs require a Clearance Inspection & Certificate to be recorded by an approved and competent assessor.

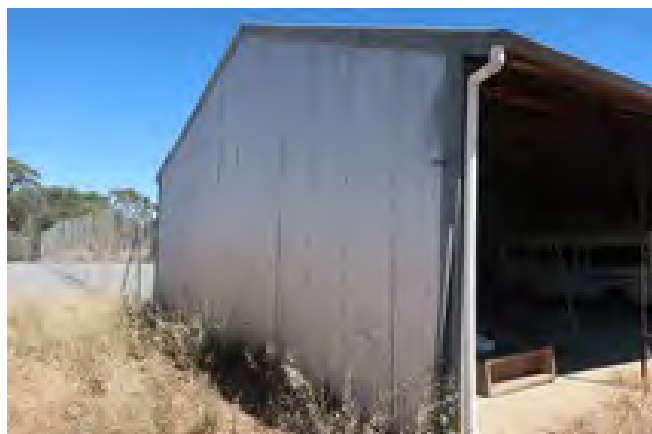
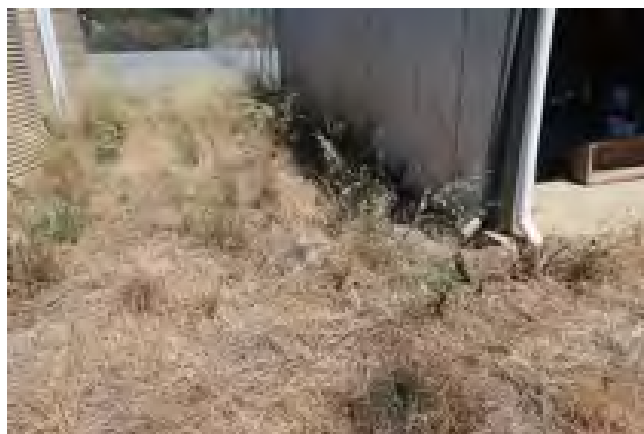
Area 2**Charle Ayrey Pavlion: left side of building. The Pipe(s) (F C Sheeting) has Asbestos Containing Material (ACM) present.****RISK ASSESSMENT**

Type of Asbestos or Hazardous Material	Crocidolite Chrysotile Sample taken 62112-004	Condition	POOR	Likelihood of Damage	L (Low) – possible
		Activity	Low		
		Sealed	No	Friability	Exposed Fibres
		Labelled	No	Exposure Risk	Medium - Moderate risk
		Quantity

Priority	IMMEDIATE	Label Required	Yes	Re- Audit Date	10 Feb 2022
Action	Restrict access and target for imminent removal				
Recommendation	Debris/loose pipes on ground - The Debris requires immediate cleanup and disposal with specialised equipment and with licensed removalist to safely remove the asbestos debris.				
Legislative Requirements Victorian Regulation 2007	ACM debris visible. Recommend cleanup by licensed Asbestos Removalist. Warning labels should be affixed. Avoid mechanical damage and abrasion. Remove if refurbishment, structural alteration or demolition is to be carried out in this area. Re-inspect every 12 months or earlier if disturbed or removed in accordance with the Victorian OH&S Regulation 2017. All remedial/removal repairs require a Clearance Inspection & Certificate to be recorded by an approved and competent assessor.

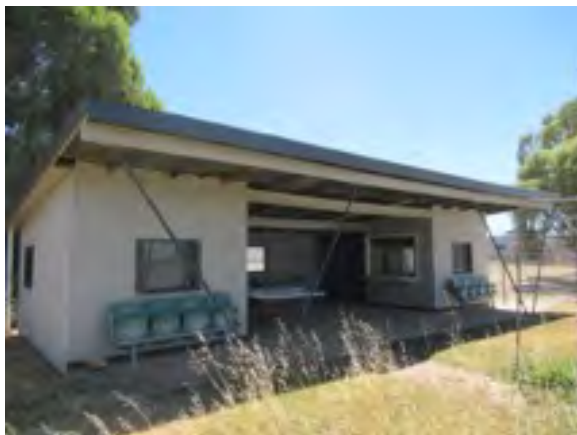
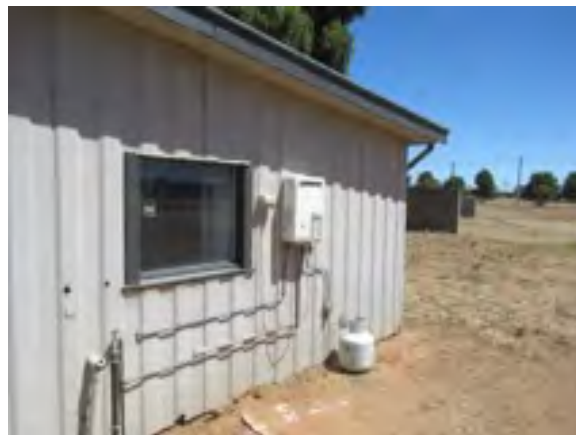
Area 17***Tennis: entire perimeter of building. The Walls (F C Sheeting) has Asbestos Containing Material (ACM) present.*****RISK ASSESSMENT**

Type of Asbestos or Hazardous Material	No sample taken - Visual ID	Condition	GOOD	Likelihood of Damage	L (Low) – possible
		Activity	Moderate		
		Sealed	Yes	Friability	Bonded (non-friable)
		Labelled	Y	Exposure Risk	Low - Negligible or low risk
		Quantity

Priority	MEDIUM	Label Required	Yes	Re- Audit Date	10 Feb 2022
Action	No remedial action required, unless disturbed				
Recommendation	Maintain paint or sealant to ACM surfaces. Particular attention should be given to side edges, ensure paint/sealant covers ALL exposed ACM surfaces.				
Legislative Requirements Victorian Regulation 2007	Warning labels should be affixed. Avoid mechanical damage and abrasion. Remove if refurbishment, structural alteration or demolition is to be carried out in this area. Re-inspect every 12 months or earlier if disturbed or removed in accordance with the Victorian OH&S Regulation 2017. All remedial/removal repairs require a Clearance Inspection & Certificate to be recorded by an approved and competent assessor.

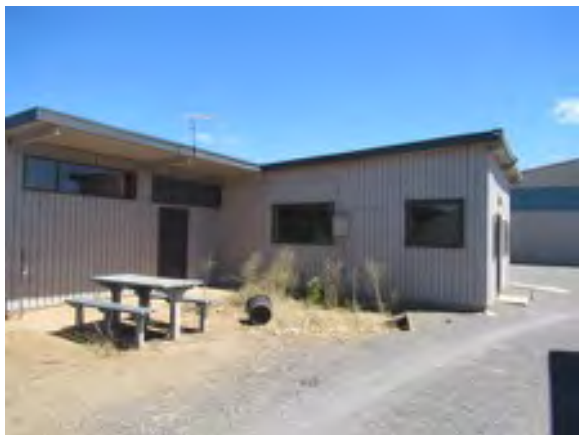
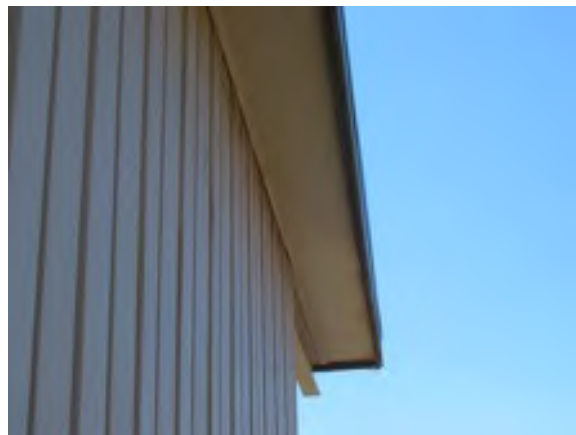
Area 14***Canteen: entire perimeter of building The Soffit (F C Sheeting) has Asbestos Containing Material (ACM) present.*****RISK ASSESSMENT**

Type of Asbestos or Hazardous Material	No sample taken - Visual ID	Condition	GOOD	Likelihood of Damage	L (Low) – possible
		Activity	Moderate		
		Sealed	Yes	Friability	Bonded (non-friable)
		Labelled	Y	Exposure Risk	Low - Negligible or low risk
		Quantity

Priority	MEDIUM	Label Required	Yes	Re- Audit Date	10 Feb 2022
Action	No remedial action required, unless disturbed				
Recommendation	Maintain paint or sealant to ACM surfaces. Particular attention should be given to side edges, ensure paint/sealant covers ALL exposed ACM surfaces.				
Legislative Requirements Victorian Regulation 2007	Warning labels should be affixed. Avoid mechanical damage and abrasion. Remove if refurbishment, structural alteration or demolition is to be carried out in this area. Re-inspect every 12 months or earlier if disturbed or removed in accordance with the Victorian OH&S Regulation 2017. All remedial/removal repairs require a Clearance Inspection & Certificate to be recorded by an approved and competent assessor.

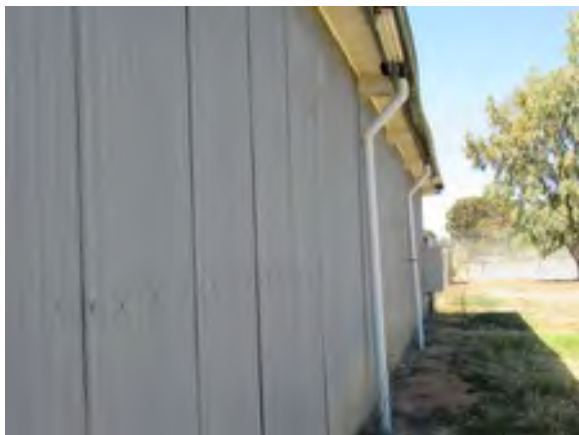
Area 1***Canteen: rear of building. The Debris - Broken (Contaminated Soil) has Asbestos Containing Material (ACM) present.*****RISK ASSESSMENT**

Type of Asbestos or Hazardous Material	No sample taken - Visual ID	Condition	POOR	Likelihood of Damage	H (High) - almost certain
		Activity	Moderate		
		Sealed	No	Friability	Exposed Fibres
		Labelled	No	Exposure Risk	Medium - Moderate risk
		Quantity

Debris/loose pipes on ground - The Debris requires immediate cleanup and disposal with specialised equipment and with licensed removalist to safely remove the asbestos debris.

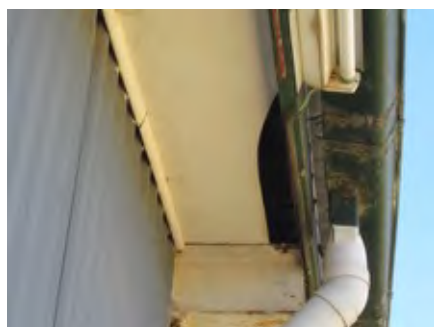
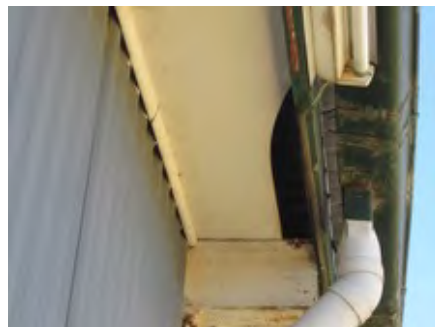
Type of Asbestos or Hazardous Material	No sample taken - Visual ID	Condition	POOR	Likelihood of Damage	L (Low) – possible
		Activity	Moderate		
		Sealed	Yes	Friability	Exposed Fibres
		Labelled	Y	Exposure Risk	Medium - Moderate risk
		Quantity

Damaged material

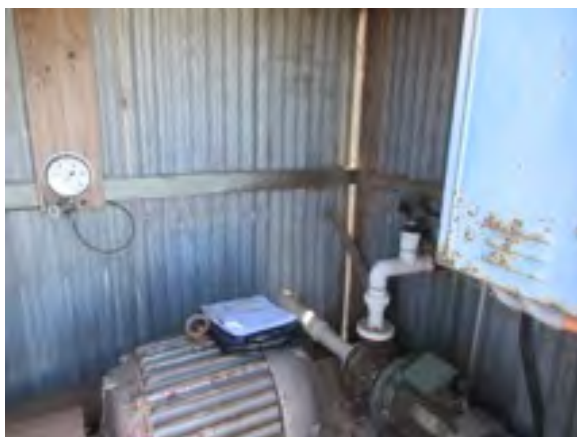
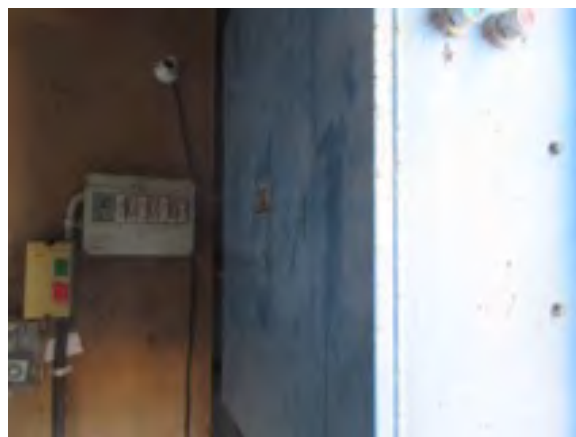
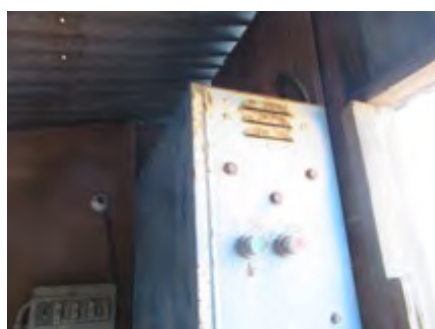
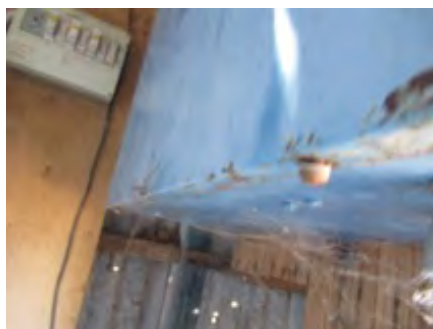
Area 11***Pump Shed & Power Pole: Pump Shed. Until the area is inspected, it should be managed as if it Asbestos Containing Material (ACM) is present.*****RISK ASSESSMENT**

Type of Asbestos or Hazardous Material	No sample taken - No Access	Condition		Likelihood of Damage	H (High) - almost certain
		Activity	Low		
		Sealed		Friability	
		Labelled	Y	Exposure Risk	
		Quantity

Priority	HIGH	Label Required	Yes	Re- Audit Date	10 Feb 2022
Action					
Recommendation					
Legislative Requirements Victorian Regulation 2007	Unable to Gain Access. Assume asbestos in area and provide monitoring if work undertaken in these areas. If access is made available, contact Global Asbestos Audits for re-inspection

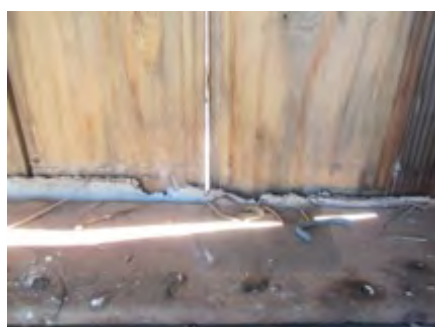
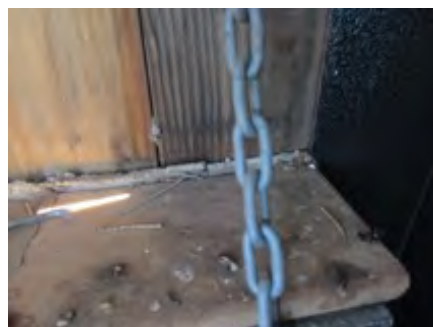
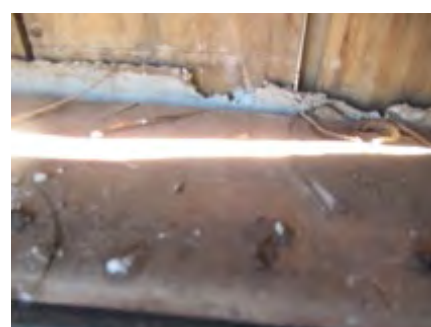
Type of Asbestos or Hazardous Material	Chrysotile	Condition	POOR	Likelihood of Damage	H (High) - almost certain
	Sample taken 62112-011	Activity	Moderate		
		Sealed	No	Friability	Friable
		Labelled	Y	Exposure Risk	High - Short term exposure risk
		Quantity

Damaged material
