# Asbestos Report

YARRIAMBIACK SHIRE COUNCIL

PROPERTY ADDRESS:  
LB54A SHIRE OFFICES  
59 CROMIE STREET  
RUPANYUP VIC 3388

INSPECTION DATE: 10 FEBRUARY 2021  
REFERENCE NUMBER: 62115

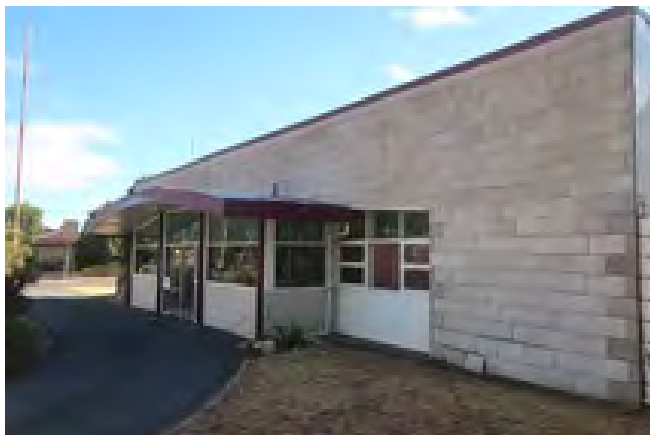
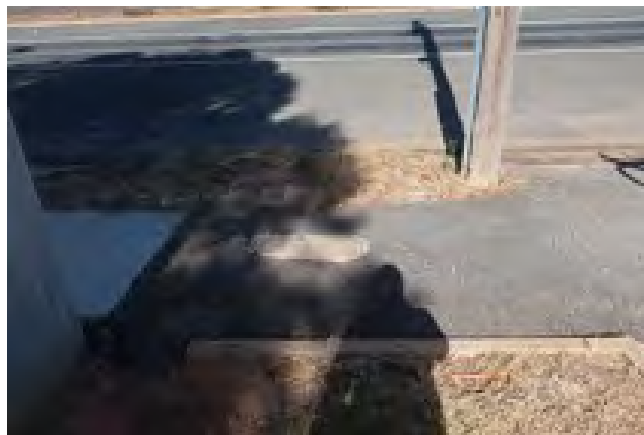
**Area 4****Office Block LB54A Shire Offices: front of building. The Service pit (Fibrous Cement Product) has Asbestos Containing Material (ACM) present.****RISK ASSESSMENT**

<b>Type of Asbestos or Hazardous Material</b>	Chrysotile	<b>Condition</b>	AVERAGE	<b>Likelihood of Damage</b>	M (Medium) - likely
	Amosite	<b>Activity</b>	Moderate		
	Same as Sample - 62115 -007	<b>Sealed</b>	No	<b>Friability</b>	Bonded (non-friable)
		<b>Labelled</b>	Y	<b>Exposure Risk</b>	Medium - Moderate risk
		<b>Quantity</b>

<b>Priority</b>	HIGH	<b>Label Required</b>	Yes	<b>Re- Audit Date</b>	10 Feb 2022
<b>Action</b>	Remedial repairs required - seal raw material / edges				
<b>Recommendation</b>	Raw material sheeting - The area requires immediate remedial repairs. It is recommended the asbestos material be sealed with an approved membrane.				
<b>Legislative Requirements Victorian Regulation 2007</b>	Damaged ACM visible in area. Requires IMMEDIATE ATTENTION. WARNING labels should be affixed. Avoid mechanical damage and abrasion. Remove if refurbishment, structural alteration or demolition is to be carried out in this area. Re-inspect every 12 months or earlier if disturbed or removed in accordance with the Victorian OH&S Regulation 2017. <b>All remedial/removal repairs require a Clearance Inspection &amp; Certificate to be recorded by an approved and competent assessor.</b>

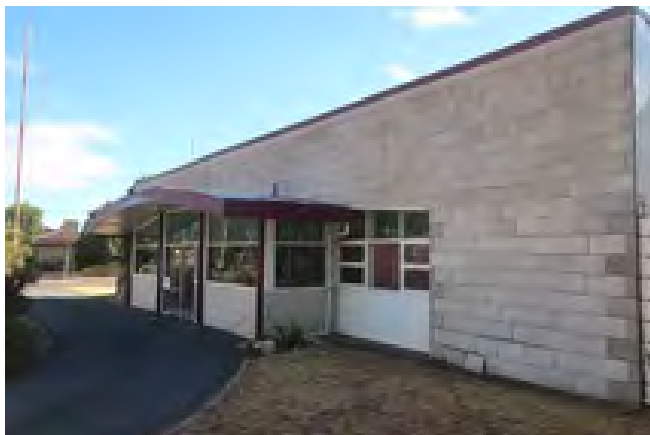
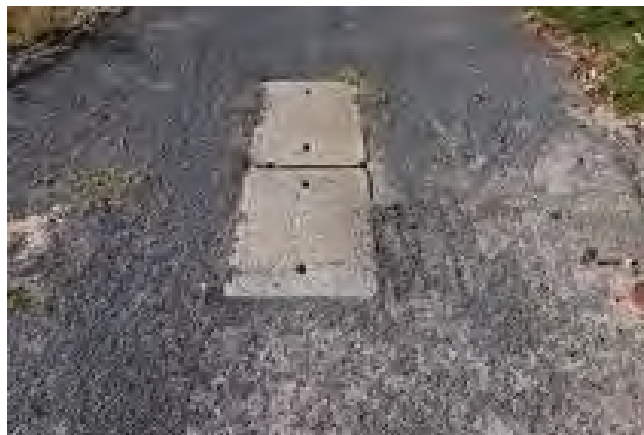
**Area 5****Office Block LB54A Shire Offices: front of building. The Service pit (Fibrous Cement Product) has Asbestos Containing Material (ACM) present.****RISK ASSESSMENT**

<b>Type of Asbestos or Hazardous Material</b>	Chrysotile Amosite  Sample taken 62115-007	<b>Condition</b>	AVERAGE	<b>Likelihood of Damage</b>	M (Medium) - likely
		<b>Activity</b>	Moderate		
		<b>Sealed</b>	No	<b>Friability</b>	Bonded (non-friable)
		<b>Labelled</b>	Y	<b>Exposure Risk</b>	Medium - Moderate risk
		<b>Quantity</b>

<b>Priority</b>	HIGH	<b>Label Required</b>	Yes	<b>Re- Audit Date</b>	10 Feb 2022
<b>Action</b>	Remedial repairs required - seal raw material / edges				
<b>Recommendation</b>	Raw material sheeting - The area requires immediate remedial repairs. It is recommended the asbestos material be sealed with an approved membrane.				
<b>Legislative Requirements Victorian Regulation 2007</b>	<p>Damaged ACM visible in area. Requires IMMEDIATE ATTENTION. WARNING labels should be affixed. Avoid mechanical damage and abrasion. Remove if refurbishment, structural alteration or demolition is to be carried out in this area. Re-inspect every 12 months or earlier if disturbed or removed in accordance with the Victorian OH&amp;S Regulation 2017.</p> <p><b>All remedial/removal repairs require a Clearance Inspection &amp; Certificate to be recorded by an approved and competent assessor.</b></p>

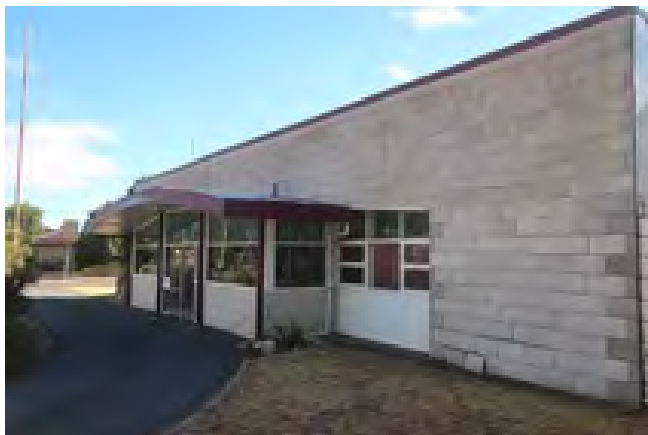
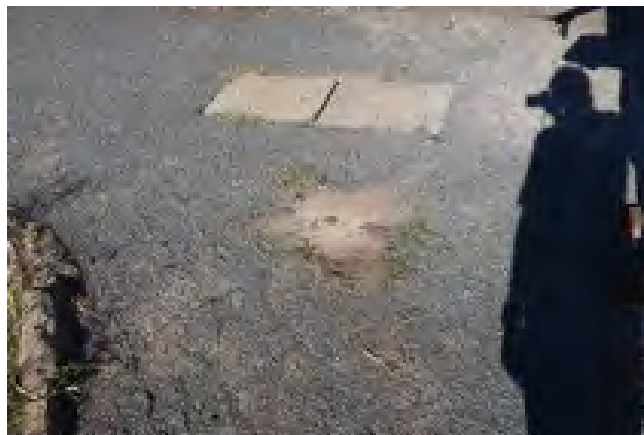
**Area 6****Office Block LB54A Shire Offices: front of building. The Service pit (Fibrous Cement Product) has Asbestos Containing Material (ACM) present.****RISK ASSESSMENT**

<b>Type of Asbestos or Hazardous Material</b>	Chrysotile	<b>Condition</b>	AVERAGE	<b>Likelihood of Damage</b>	M (Medium) - likely
	Sample taken 62115-006	<b>Activity</b>	Moderate		
		<b>Sealed</b>	No	<b>Friability</b>	Bonded (non-friable)
		<b>Labelled</b>	Y	<b>Exposure Risk</b>	Medium - Moderate risk
		<b>Quantity</b>

<b>Priority</b>	HIGH	<b>Label Required</b>	Yes	<b>Re- Audit Date</b>	10 Feb 2022
<b>Action</b>	Remedial repairs required - seal raw material / edges				
<b>Recommendation</b>	Raw material sheeting - The area requires immediate remedial repairs. It is recommended the asbestos material be sealed with an approved membrane.				
<b>Legislative Requirements Victorian Regulation 2007</b>	<p>Damaged ACM visible in area. Requires IMMEDIATE ATTENTION. WARNING labels should be affixed. Avoid mechanical damage and abrasion. Remove if refurbishment, structural alteration or demolition is to be carried out in this area. Re-inspect every 12 months or earlier if disturbed or removed in accordance with the Victorian OH&amp;S Regulation 2017.</p> <p><b>All remedial/removal repairs require a Clearance Inspection &amp; Certificate to be recorded by an approved and competent assessor.</b></p>

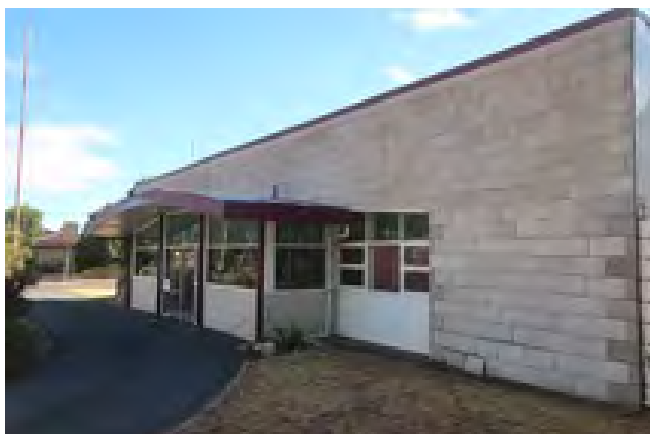
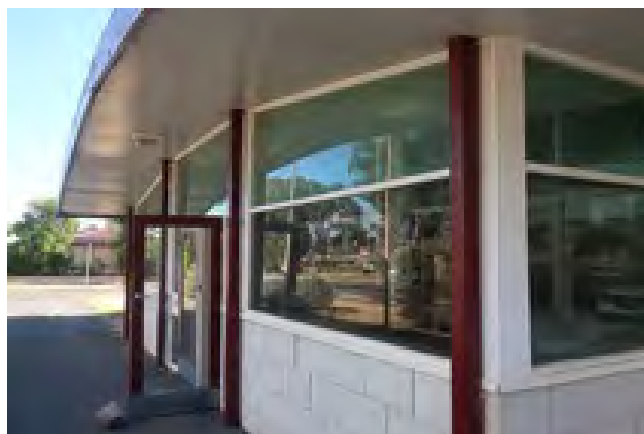
**Area 16****Office Block LB54A Shire Offices: front of building. The Window infill panels (F C Sheeting) has Asbestos Containing Material (ACM) present.****RISK ASSESSMENT**

<b>Type of Asbestos or Hazardous Material</b>	Chrysotile	<b>Condition</b>	GOOD	<b>Likelihood of Damage</b>	L (Low) – possible
	Sample taken 62115-008	<b>Activity</b>	Moderate		
		<b>Sealed</b>	Yes	<b>Friability</b>	Bonded (non-friable)
		<b>Labelled</b>	Y	<b>Exposure Risk</b>	Low - Negligible or low risk
		<b>Quantity</b>

<b>Priority</b>	MEDIUM	<b>Label Required</b>	Yes	<b>Re- Audit Date</b>	10 Feb 2022
<b>Action</b>	No remedial action required, unless disturbed				
<b>Recommendation</b>	Maintain paint or sealant to ACM surfaces. Particular attention should be given to side edges, ensure paint/sealant covers ALL exposed ACM surfaces.				
<b>Legislative Requirements Victorian Regulation 2007</b>	Warning labels should be affixed. Avoid mechanical damage and abrasion. Remove if refurbishment, structural alteration or demolition is to be carried out in this area. Re-inspect every 12 months or earlier if disturbed or removed in accordance with the Victorian OH&S Regulation 2017. <b>All remedial/removal repairs require a Clearance Inspection &amp; Certificate to be recorded by an approved and competent assessor.</b>

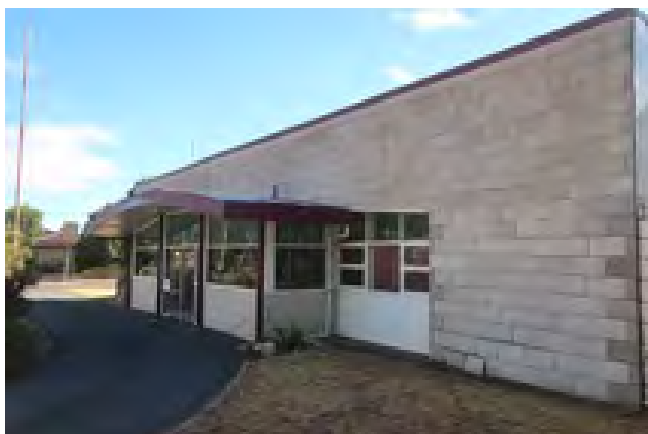
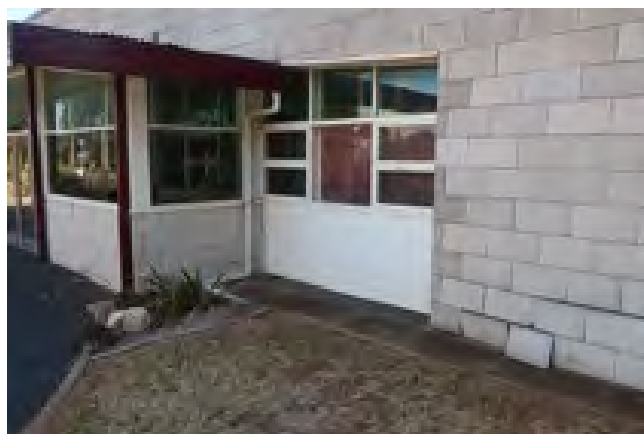
**Area 14****Office Block LB54A Shire Offices: front of building. The Infill panel/s below windows (F C Sheeting) has Asbestos Containing Material (ACM) present.****RISK ASSESSMENT**

Type of Asbestos or Hazardous Material	No sample taken - Visual ID	Condition	GOOD	Likelihood of Damage	L (Low) – possible
		Activity	Moderate		
		Sealed	Yes	Friability	Bonded (non-friable)
		Labelled	Y	Exposure Risk	Low - Negligible or low risk
		Quantity

Priority	MEDIUM	Label Required	Yes	Re- Audit Date	10 Feb 2022
Action	No remedial action required, unless disturbed				
Recommendation	Maintain paint or sealant to ACM surfaces. Particular attention should be given to side edges, ensure paint/sealant covers ALL exposed ACM surfaces.				
Legislative Requirements Victorian Regulation 2007	Warning labels should be affixed. Avoid mechanical damage and abrasion. Remove if refurbishment, structural alteration or demolition is to be carried out in this area. Re-inspect every 12 months or earlier if disturbed or removed in accordance with the Victorian OH&S Regulation 2017. <b>All remedial/removal repairs require a Clearance Inspection &amp; Certificate to be recorded by an approved and competent assessor.</b>

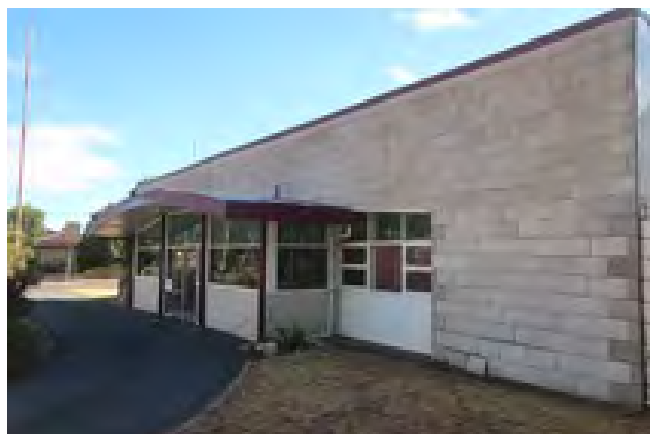
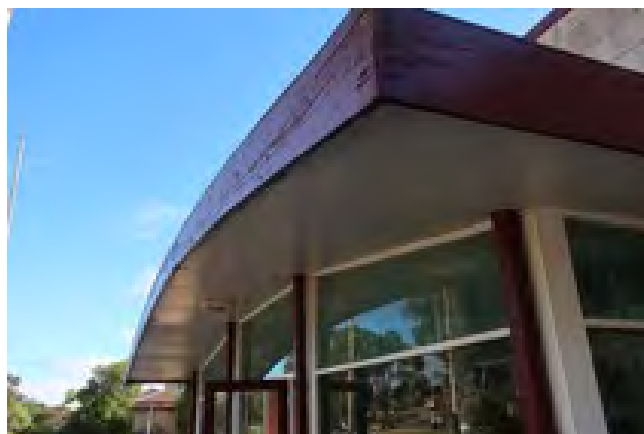
**Area 15****Office Block LB54A Shire Offices: front of building. The Soffit/ Ceiling (F C Sheeting) has Asbestos Containing Material (ACM) present.****RISK ASSESSMENT**

Type of Asbestos or Hazardous Material	No sample taken - Visual ID	Condition	GOOD	Likelihood of Damage	L (Low) – possible
		Activity	Moderate		
		Sealed	Yes	Friability	Bonded (non-friable)
		Labelled	Y	Exposure Risk	Low - Negligible or low risk
		Quantity

Priority	MEDIUM	Label Required	Yes	Re- Audit Date	10 Feb 2022
Action	No remedial action required, unless disturbed				
Recommendation	Maintain paint or sealant to ACM surfaces. Particular attention should be given to side edges, ensure paint/sealant covers ALL exposed ACM surfaces.				
Legislative Requirements Victorian Regulation 2007	Warning labels should be affixed. Avoid mechanical damage and abrasion. Remove if refurbishment, structural alteration or demolition is to be carried out in this area. Re-inspect every 12 months or earlier if disturbed or removed in accordance with the Victorian OH&S Regulation 2017. <b>All remedial/removal repairs require a Clearance Inspection &amp; Certificate to be recorded by an approved and competent assessor.</b>

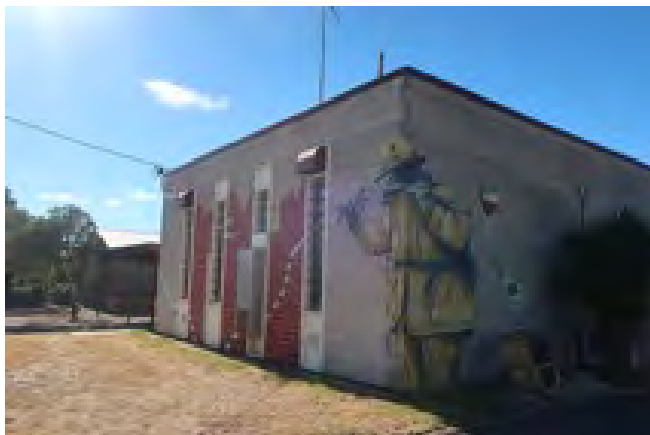
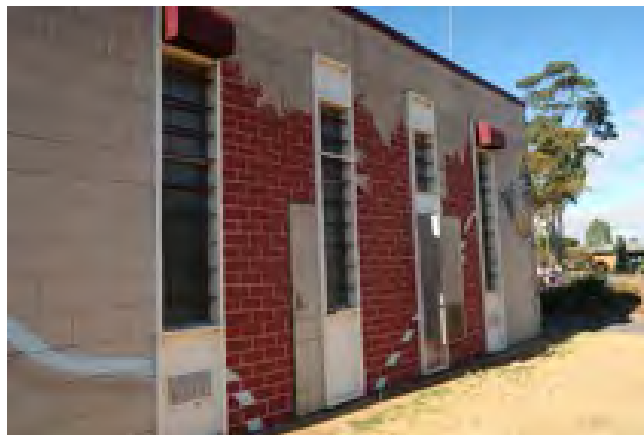
**Area 24****Office Block LB54A Shire Offices: left side of building. The Infill panels above & below windows (F C Sheeting) has Asbestos Containing Material (ACM) present.****RISK ASSESSMENT**

<b>Type of Asbestos or Hazardous Material</b>	Chrysotile	<b>Condition</b>	GOOD	<b>Likelihood of Damage</b>	L (Low) – possible
	Sample taken 62115-001	<b>Activity</b>	Moderate		
		<b>Sealed</b>	Yes	<b>Friability</b>	Bonded (non-friable)
		<b>Labelled</b>	Y	<b>Exposure Risk</b>	Low - Negligible or low risk
		<b>Quantity</b>

<b>Priority</b>	MEDIUM	<b>Label Required</b>	Yes	<b>Re- Audit Date</b>	10 Feb 2022
<b>Action</b>	No remedial action required, unless disturbed				
<b>Recommendation</b>	Maintain paint or sealant to ACM surfaces. Particular attention should be given to side edges, ensure paint/sealant covers ALL exposed ACM surfaces.				
<b>Legislative Requirements Victorian Regulation 2007</b>	Warning labels should be affixed. Avoid mechanical damage and abrasion. Remove if refurbishment, structural alteration or demolition is to be carried out in this area. Re-inspect every 12 months or earlier if disturbed or removed in accordance with the Victorian OH&S Regulation 2017. <b>All remedial/removal repairs require a Clearance Inspection &amp; Certificate to be recorded by an approved and competent assessor.</b>

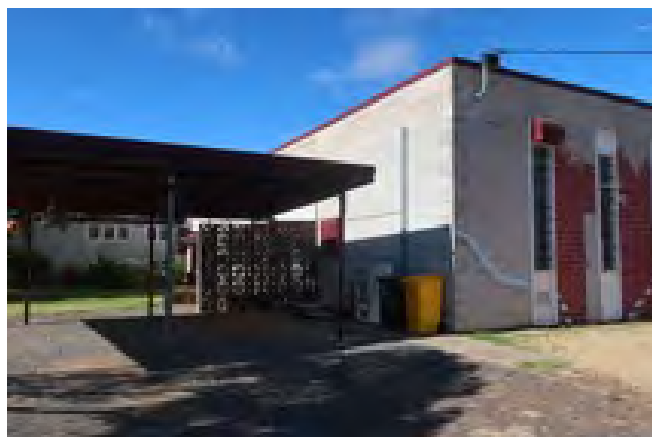
**Area 2****Office Block LB54A Shire Offices: rear of building. The Electrical Cabinet (Debris) has Asbestos Containing Material (ACM) present.****RISK ASSESSMENT**

<b>Type of Asbestos or Hazardous Material</b>	Chrysotile	<b>Condition</b>	POOR	<b>Likelihood of Damage</b>	H (High) - almost certain
	Sample taken 62115-002	<b>Activity</b>	Low		
		<b>Sealed</b>	No	<b>Friability</b>	Friable
		<b>Labelled</b>	No	<b>Exposure Risk</b>	High - Short term exposure risk
		<b>Quantity</b>

<b>Priority</b>	IMMEDIATE	<b>Label Required</b>	Yes	<b>Re- Audit Date</b>	10 Feb 2022
<b>Action</b>	Restrict access and target for imminent removal				
<b>Recommendation</b>	Debris on Surface - The Debris requires immediate cleanup and disposal with specialised equipment and with licensed removalist to safely remove the asbestos debris. Clearance Inspection will be required.				
<b>Legislative Requirements Victorian Regulation 2007</b>	ACM debris visible. Recommend cleanup by licensed Asbestos Removalist. Warning labels should be affixed. Avoid mechanical damage and abrasion. Remove if refurbishment, structural alteration or demolition is to be carried out in this area. Re-inspect every 12 months or earlier if disturbed or removed in accordance with the Victorian OH&S Regulation 2017. <b>All remedial/removal repairs require a Clearance Inspection &amp; Certificate to be recorded by an approved and competent assessor.</b>

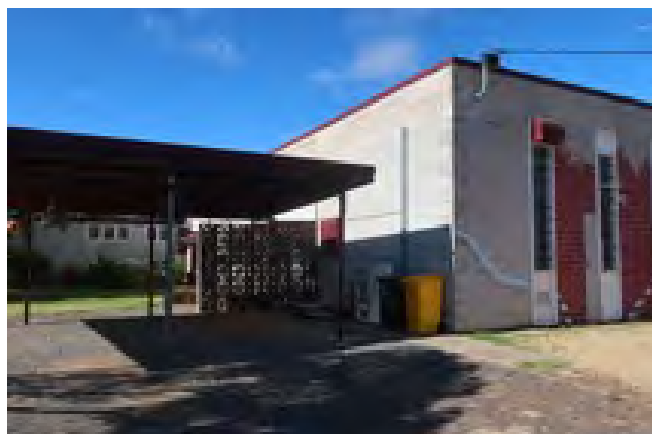
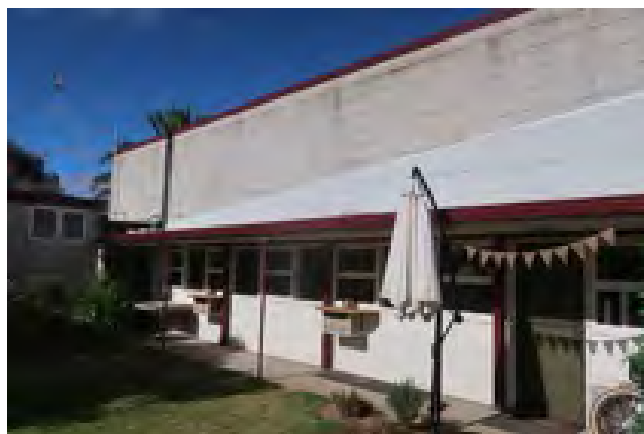
**Area 26****Office Block LB54A Shire Offices: rear of building. The Infill panel/s below windows (F C Sheeting) has Asbestos Containing Material (ACM) present.****RISK ASSESSMENT**

Type of Asbestos or Hazardous Material	No sample taken - Visual ID	Condition	GOOD	Likelihood of Damage	L (Low) – possible
		Activity	Moderate		
		Sealed	Yes	Friability	Bonded (non-friable)
		Labelled	Y	Exposure Risk	Low - Negligible or low risk
		Quantity

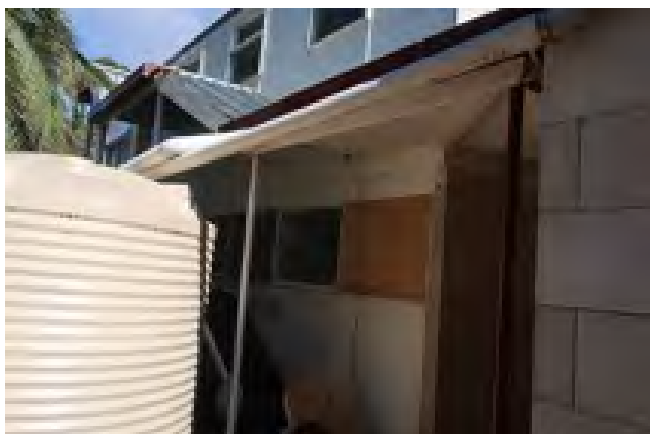
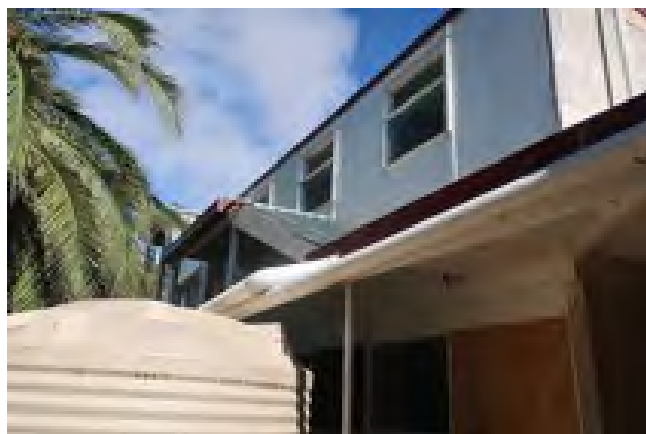
**Area 12****Office Block LB54A Shire Offices: right side of building. The Wall (F C Sheeting) has Asbestos Containing Material (ACM) present.****RISK ASSESSMENT**

Type of Asbestos or Hazardous Material	No sample taken - Visual ID	Condition	AVERAGE	Likelihood of Damage	L (Low) – possible
		Activity	Moderate		
		Sealed	No	Friability	Bonded (non-friable)
		Labelled	Y	Exposure Risk	Medium - Moderate risk
		Quantity

- Raw material sheeting - The area requires immediate remedial repairs. It is recommended the asbestos material be sealed with an approved membrane.
- 12 Office Block LB54A Shire Offices: right side of building. The Wall (F C Sheeting) has Asbestos Containing Material (ACM) present.**

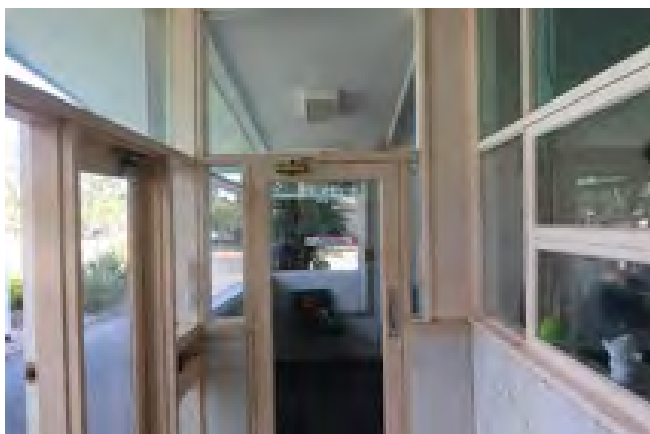
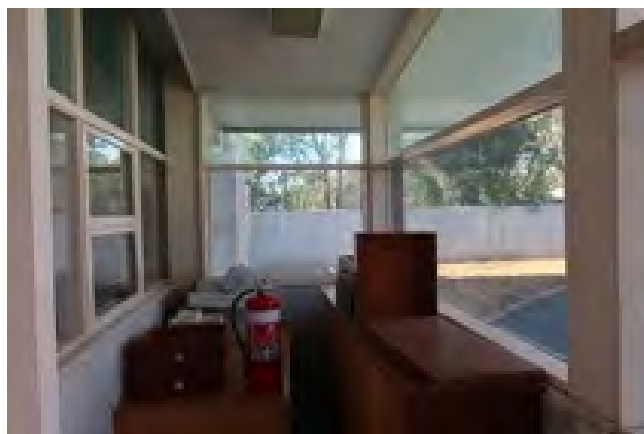
**Area 17****Office Block LB54A Shire Offices: Ground Floor Entrance 1. The Window Infill Panels (F C Sheeting) has Asbestos Containing Material (ACM) present.****RISK ASSESSMENT**

<b>Type of Asbestos or Hazardous Material</b>	Chrysotile Same as Sample - 62115-008	<b>Condition</b>	GOOD	<b>Likelihood of Damage</b>	L (Low) – possible
		<b>Activity</b>	Moderate		
		<b>Sealed</b>	Yes	<b>Friability</b>	Bonded (non-friable)
		<b>Labelled</b>	Y	<b>Exposure Risk</b>	Low - Negligible or low risk
		<b>Quantity</b>

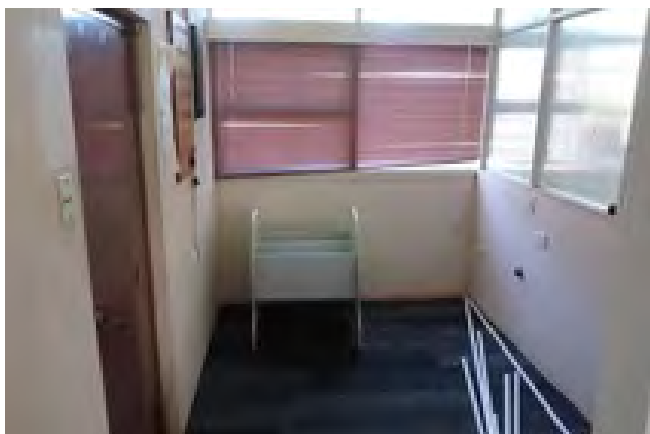
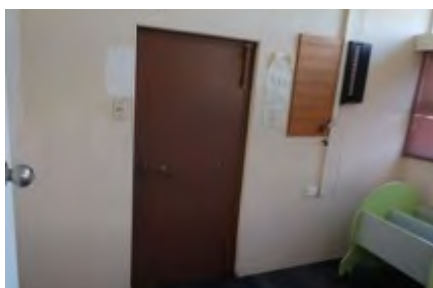
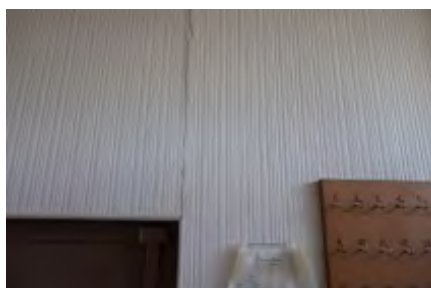
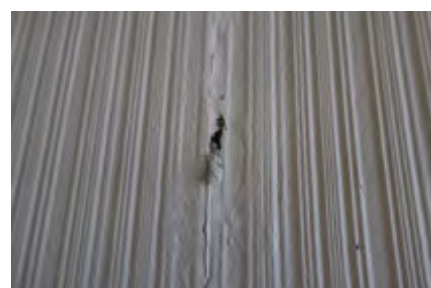
Type of Asbestos or Hazardous Material	No sample taken - Visual ID	Condition	AVERAGE	Likelihood of Damage	L (Low) – possible
		Activity	Moderate		
		Sealed	Yes	Friability	Exposed Fibres
		Labelled	Y	Exposure Risk	Medium - Moderate risk
		Quantity

Crack

Crack - The damaged area requires immediate remedial repairs. It is recommended the asbestos sheeting be replaced (preferred) or edges sealed with approved sealant and then the area be concealed by laminating (sheeting).

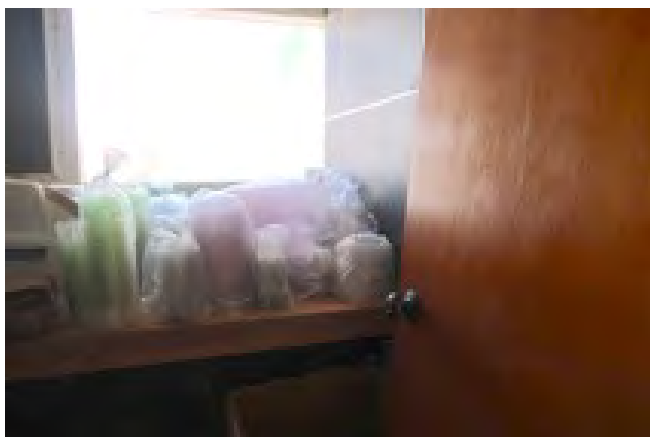
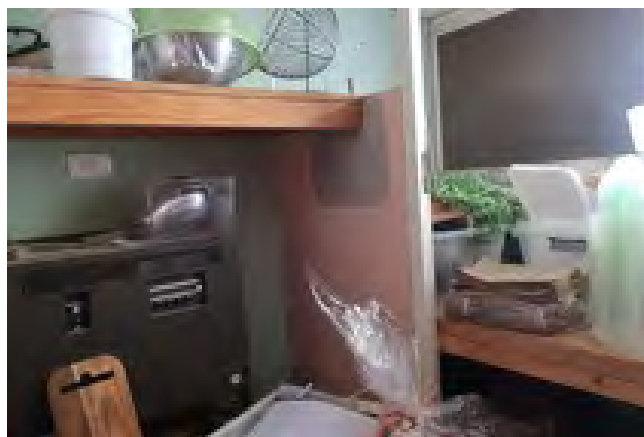
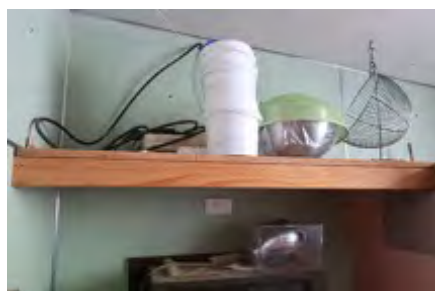
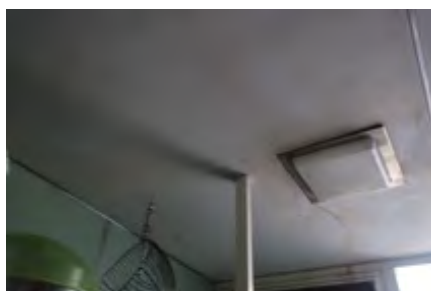
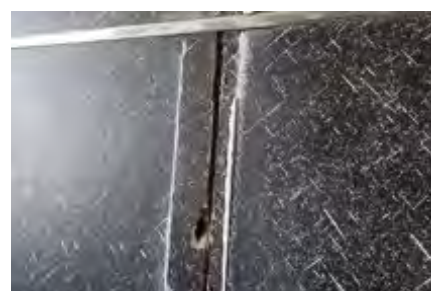
<b>Type of Asbestos or Hazardous Material</b>	No sample taken - Visual ID	<b>Condition</b>	POOR	<b>Likelihood of Damage</b>	L (Low) – possible
		<b>Activity</b>	Moderate		
		<b>Sealed</b>	Yes	<b>Friability</b>	Exposed Fibres
		<b>Labelled</b>	Y	<b>Exposure Risk</b>	Medium - Moderate risk
		<b>Quantity</b>

Damaged material

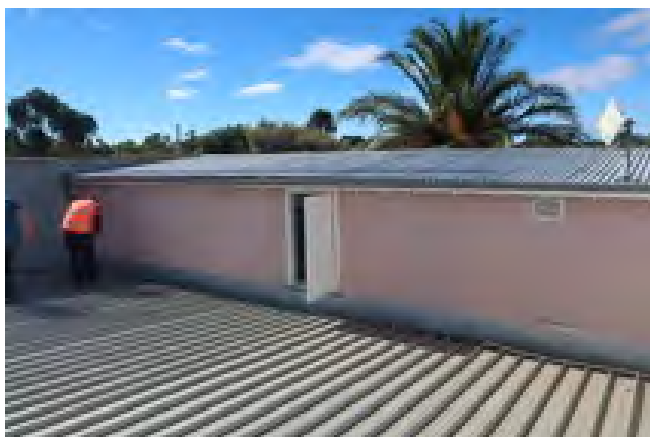
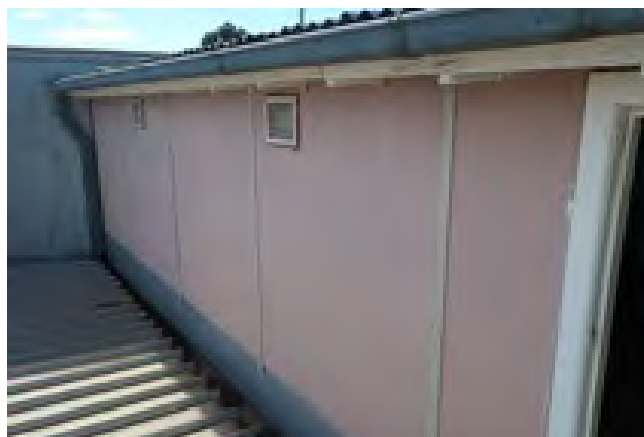
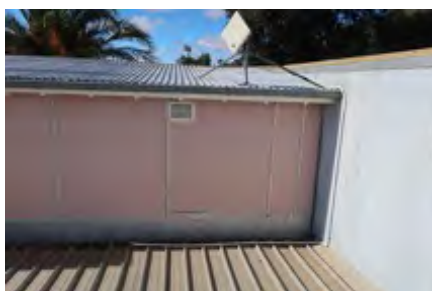
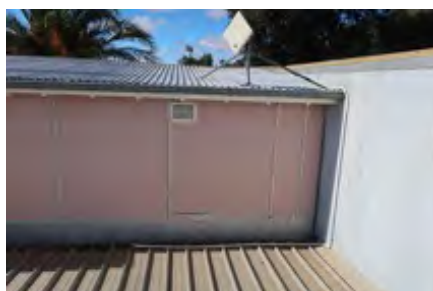
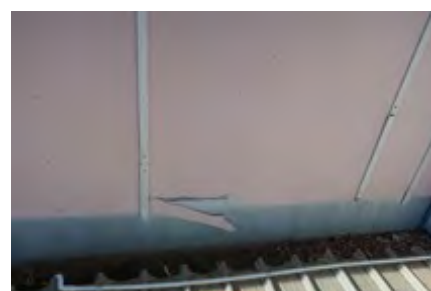
<b>Type of Asbestos or Hazardous Material</b>	Chrysotile	<b>Condition</b>	POOR	<b>Likelihood of Damage</b>	L (Low) – possible
	Sample taken 62115-005	<b>Activity</b>	Moderate		
		<b>Sealed</b>	Yes	<b>Friability</b>	Exposed Fibres
		<b>Labelled</b>	Y	<b>Exposure Risk</b>	High - Short term exposure risk
		<b>Quantity</b>

Damaged material

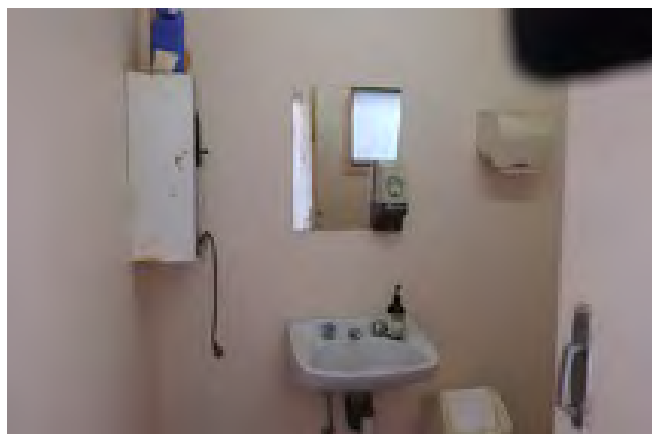
**Area 28****Toilet: Female bathroom 1. The Walls and Ceiling (F C Sheeting) has Asbestos Containing Material (ACM) present.****RISK ASSESSMENT**

Type of Asbestos or Hazardous Material	No sample taken - Visual ID	Condition	GOOD	Likelihood of Damage	L (Low) – possible
		Activity	Moderate		
		Sealed	Yes	Friability	Bonded (non-friable)
		Labelled	Y	Exposure Risk	Low - Negligible or low risk
		Quantity
