# **Asbestos Report**

## YARRIAMBIACK SHIRE COUNCIL

PROPERTY ADDRESS: LB66 TENNIS SHED 2123 SUNRAYSIA HIGHWAY TURRIF VIC 3488

INSPECTION DATE: 11 FEBRUARY 2021 REFERENCE NUMBER: 62122

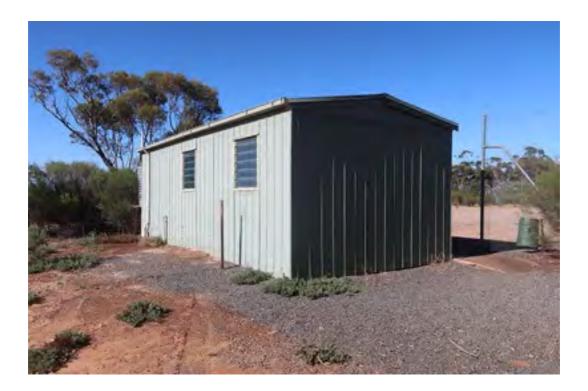
1 Tennis Shed: front of building. The Debris - Broken (Debris) has Asbestos Containing Material (ACM) present.

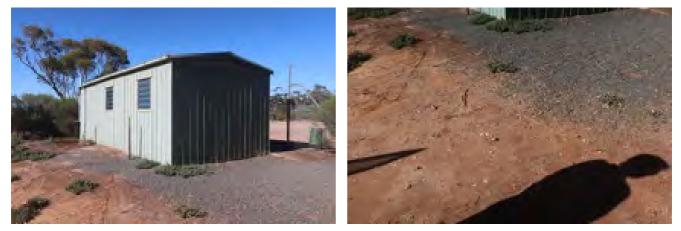
## Tennis Shed: front of building. The Debris - Broken (Debris) has Asbestos Containing Material (ACM) present.

RISKASSESSMENT					
Type of Asbestos or Hazardous	Amosite	Condition	POOR	Likelihood of Damage	H (High) - almost certain
		Activity	Moderate		
Material		Sealed	No	Friability	Exposed Fibres
		Labelled	No	Exposure Risk	High - Short term exposure risk
		Quantity

<b>RISK C</b>	ONTR	OL						
Priority	IMMED	DIATE	Label Required	Yes	Re- Audit Date	11 Feb 2022		
Action		Restrict access and target for imminent removal						
Recomme	ndation	Debris on Surface with licensed remo				n specialised equipment and		
Legislative Requirements Victorian Regulation 2007		ACM debris visible. Recommend cleanup by licensed Asbestos Removalist. Warning labels should be affixed. Avoid mechanical damage and abrasion. Remove if refurbishment, structural alteration or demolition is to be carried out in this area. <b>Re-inspect every 12 months or earlier if disturbed or removed in accordance with the Victorian OH&amp;S Regulation 2017.</b> All remedial/removal repairs require a Clearance Inspection & Certificate to be recorded by an approved and competent assessor.
