Asbestos Report

YARRIAMBIACK SHIRE COUNCIL

PROPERTY ADDRESS:
LB102 SHIRE DEPOT - SHIPPING CONTAINERS
X 3
9009 STAWELL WARRACKNABEAL ROAD
WARRACKNABEAL VIC 3393

INSPECTION DATE: 16 FEBRUARY 2021
REFERENCE NUMBER: 62140

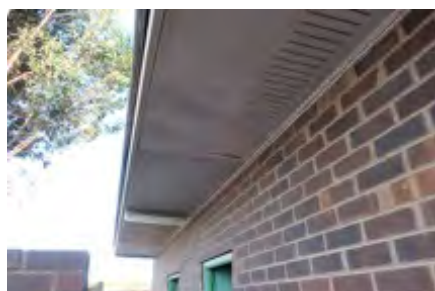
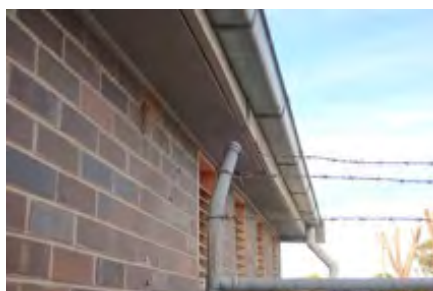
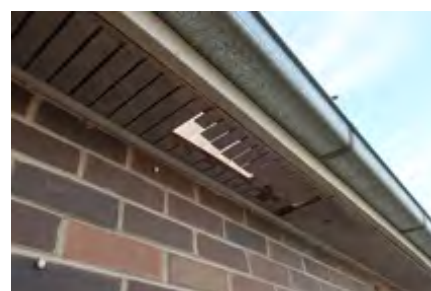
Type of Asbestos or Hazardous Material	No sample taken - Visual ID	Condition	POOR	Likelihood of Damage	L (Low) – possible
		Activity	Moderate		
		Sealed	Yes	Friability	Exposed Fibres
		Labelled	No	Exposure Risk	High - Short term exposure risk
		Quantity

Damaged material

Priority	IMMEDIATE	Label Required	Yes	Re- Audit Date	16 Feb 2022
Action	Remedial repairs required - seal exposed edges or replace or laminate over damaged material				
Recommendation	Damaged material - The damaged area requires immediate remedial repairs. It is recommended the asbestos sheeting be replaced.				
Legislative Requirements Victorian Regulation 2007	<p>URGENT - ACM visible in area. The ACM appears to be of a friable nature. The services of an "A" class Asbestos removal consultant are urgently required. Immediately cease any access to the area and affix warning signs to all entry points. Avoid physical and mechanical damage. Avoid mechanical damage and abrasion. Re-inspect every 12 months or earlier if disturbed or removed in accordance with the Victorian OH&S Regulation 2017.</p> <p>All remedial/removal repairs require a Clearance Inspection & Certificate to be recorded by an approved and competent assessor.</p>

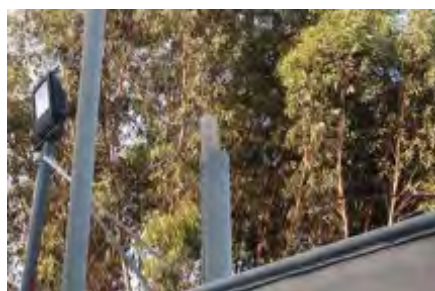
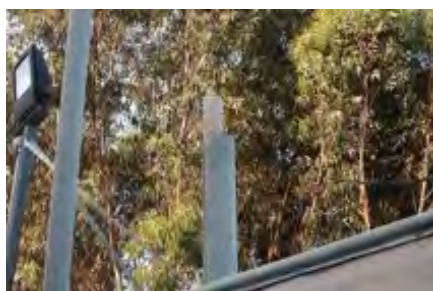
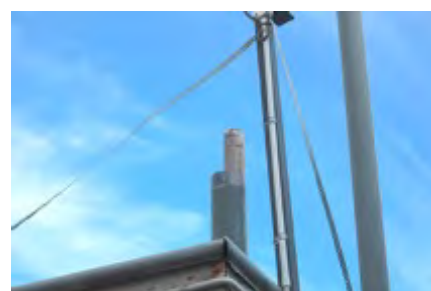
Type of Asbestos or Hazardous Material	No sample taken - Visual ID	Condition	AVERAGE	Likelihood of Damage	L (Low) – possible
		Activity	Low		
		Sealed	No	Friability	Bonded (non-friable)
		Labelled	No	Exposure Risk	Medium - Moderate risk
		Quantity

Raw Material

Priority	HIGH	Label Required	Yes	Re- Audit Date	16 Feb 2022
Action	Remedial repairs required - seal raw material / edges				
Recommendation	Raw material sheeting - The area requires immediate remedial repairs. It is recommended the asbestos material be sealed with an approved membrane.				
Legislative Requirements Victorian Regulation 2007	<p>Damaged ACM visible in area. Requires IMMEDIATE ATTENTION. WARNING labels should be affixed. Avoid mechanical damage and abrasion. Remove if refurbishment, structural alteration or demolition is to be carried out in this area. Re-inspect every 12 months or earlier if disturbed or removed in accordance with the Victorian OH&S Regulation 2017.</p> <p>All remedial/removal repairs require a Clearance Inspection & Certificate to be recorded by an approved and competent assessor.</p>

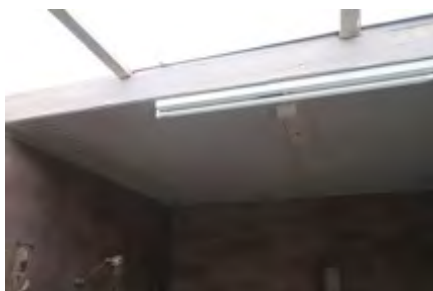
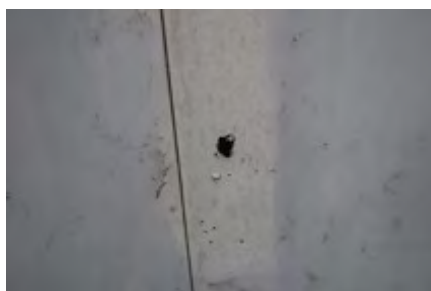
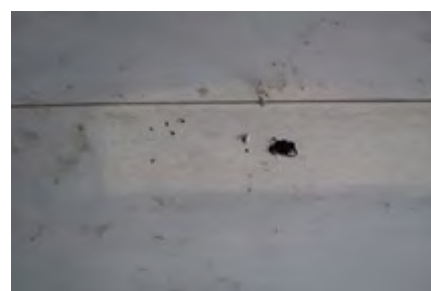
Type of Asbestos or Hazardous Material	Chrysotile	Condition	AVERAGE	Likelihood of Damage	L (Low) – possible
	Same as Sample - 62140 -001	Activity	Moderate		
		Sealed	Yes	Friability	Exposed Fibres
		Labelled	Y	Exposure Risk	Medium - Moderate risk
		Quantity

Holes (impact)

Priority	HIGH	Label Required	Yes	Re- Audit Date	16 Feb 2022
Action	Remedial repairs required - seal exposed edges or replace or laminate over damaged material				
Recommendation	Holes (impact) - The damaged area requires immediate remedial repairs. It is recommended the asbestos sheeting be replaced (preferred) or edges sealed with approved sealant and then the area be concealed by laminating (sheeting).				
Legislative Requirements Victorian Regulation 2007	<p>Damaged ACM visible in area. Requires IMMEDIATE ATTENTION. WARNING labels should be affixed. Avoid mechanical damage and abrasion. Remove if refurbishment, structural alteration or demolition is to be carried out in this area. Re-inspect every 12 months or earlier if disturbed or removed in accordance with the Victorian OH&S Regulation 2017.</p> <p>All remedial/removal repairs require a Clearance Inspection & Certificate to be recorded by an approved and competent assessor.</p>

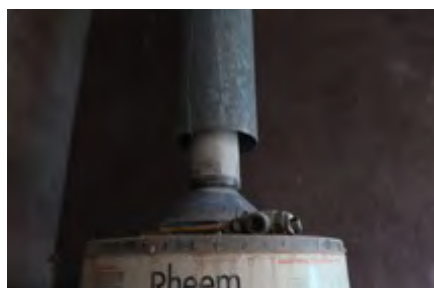
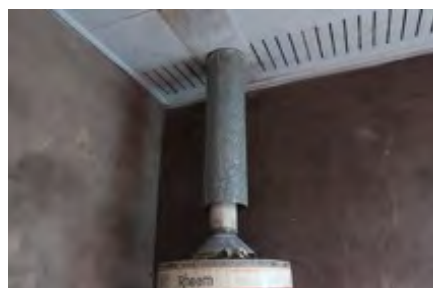
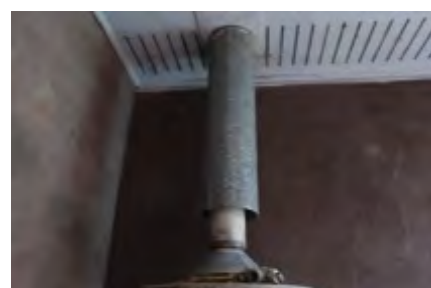
Type of Asbestos or Hazardous Material	No sample taken - Visual ID	Condition	AVERAGE	Likelihood of Damage	L (Low) – possible
		Activity	Low		
		Sealed	No	Friability	Bonded (non-friable)
		Labelled	No	Exposure Risk	Medium - Moderate risk
		Quantity

Raw Material

Priority	HIGH	Label Required	Yes	Re- Audit Date	16 Feb 2022
Action	Remedial repairs required - seal raw material / edges				
Recommendation	Raw material sheeting - The area requires immediate remedial repairs. It is recommended the asbestos material be sealed with an approved membrane.				
Legislative Requirements Victorian Regulation 2007	<p>Damaged ACM visible in area. Requires IMMEDIATE ATTENTION. WARNING labels should be affixed. Avoid mechanical damage and abrasion. Remove if refurbishment, structural alteration or demolition is to be carried out in this area. Re-inspect every 12 months or earlier if disturbed or removed in accordance with the Victorian OH&S Regulation 2017.</p> <p>All remedial/removal repairs require a Clearance Inspection & Certificate to be recorded by an approved and competent assessor.</p>

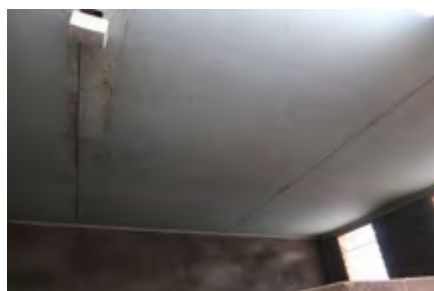
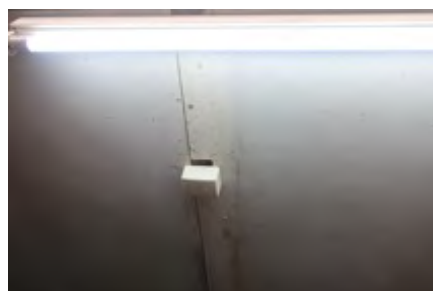
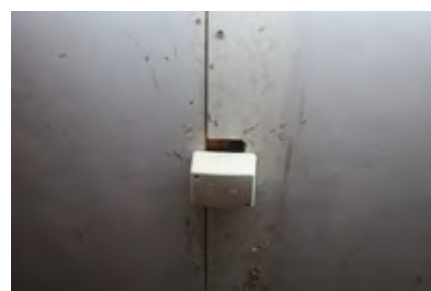
Type of Asbestos or Hazardous Material	Chrysotile	Condition	AVERAGE	Likelihood of Damage	L (Low) – possible
	Sample taken 62140-001	Activity	Moderate		
		Sealed	Yes	Friability	Exposed Fibres
		Labelled	Y	Exposure Risk	Medium - Moderate risk
		Quantity

Penetration Holes

Priority	HIGH	Label Required	Yes	Re- Audit Date	16 Feb 2022
Action	Remedial repairs required - seal raw material / edges				
Recommendation	Penetration Holes - The exposed edges require approved sealant. It is further recommended the gaps be filled with sealant.				
Legislative Requirements Victorian Regulation 2007	<p>Damaged ACM visible in area. Requires IMMEDIATE ATTENTION. WARNING labels should be affixed. Avoid mechanical damage and abrasion. Remove if refurbishment, structural alteration or demolition is to be carried out in this area. Re-inspect every 12 months or earlier if disturbed or removed in accordance with the Victorian OH&S Regulation 2017.</p> <p>All remedial/removal repairs require a Clearance Inspection & Certificate to be recorded by an approved and competent assessor.</p>

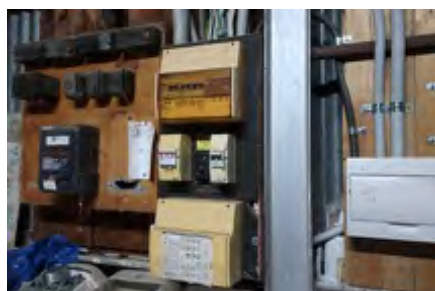
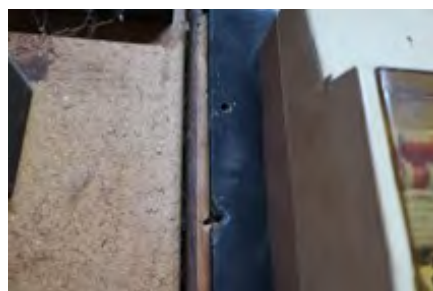
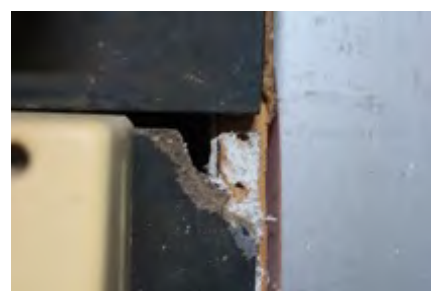
Type of Asbestos or Hazardous Material	No sample taken - Visual ID	Condition	AVERAGE	Likelihood of Damage	L (Low) – possible
		Activity	Moderate		
		Sealed	Yes	Friability	Exposed Fibres
		Labelled	Y	Exposure Risk	Medium - Moderate risk
		Quantity

Broken sections

Priority	HIGH	Label Required	Yes	Re- Audit Date	16 Feb 2022
Action	Remedial repairs required - seal exposed edges or replace or laminate over damaged material				
Recommendation	Broken sections - The damaged area requires immediate remedial repairs. It is recommended the asbestos sheeting be replaced (preferred) or edges sealed with approved sealant and then the area be concealed by laminating (sheeting).				
Legislative Requirements Victorian Regulation 2007	<p>Damaged ACM visible in area. Requires IMMEDIATE ATTENTION. WARNING labels should be affixed. Avoid mechanical damage and abrasion. Remove if refurbishment, structural alteration or demolition is to be carried out in this area. Re-inspect every 12 months or earlier if disturbed or removed in accordance with the Victorian OH&S Regulation 2017.</p> <p>All remedial/removal repairs require a Clearance Inspection & Certificate to be recorded by an approved and competent assessor.</p>

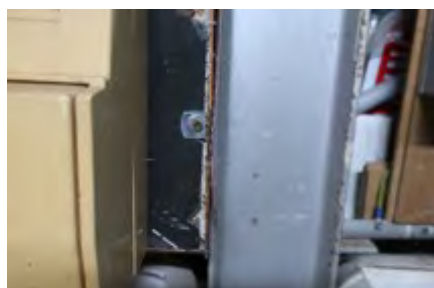
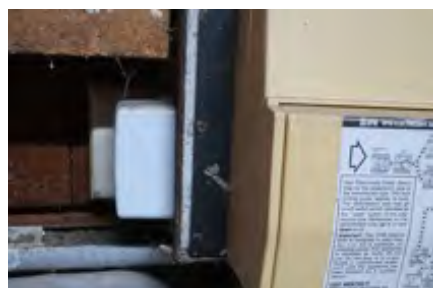
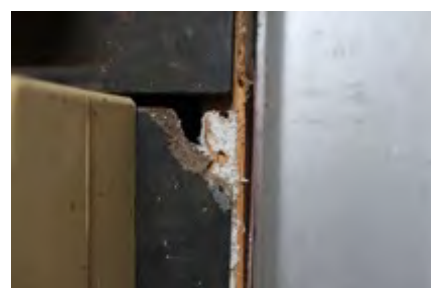
Type of Asbestos or Hazardous Material	Chrysotile	Condition	POOR	Likelihood of Damage	H (High) - almost certain
	Sample taken 62140-002	Activity	Moderate		
		Sealed	No	Friability	Friable
		Labelled	Y	Exposure Risk	High - Short term exposure risk
		Quantity

Unbonded surface

Priority	IMMEDIATE	Label Required	Yes	Re- Audit Date	16 Feb 2022
Action	Restrict access and enclose or encapsulate or seal				
Recommendation	Unbonded surface - The area requires immediate remedial repairs. It is recommended the asbestos sheeting be replaced (preferred) or the material be sealed with an approved membrane.				
Legislative Requirements Victorian Regulation 2007	<p>URGENT - ACM visible in area. The ACM appears to be of a friable nature. The services of an "A" class Asbestos removal consultant are urgently required. Immediately cease any access to the area and affix warning signs to all entry points. Avoid physical and mechanical damage. Avoid mechanical damage and abrasion. Re-inspect every 12 months or earlier if disturbed or removed in accordance with the Victorian OH&S Regulation 2017.</p> <p>All remedial/removal repairs require a Clearance Inspection & Certificate to be recorded by an approved and competent assessor.</p>

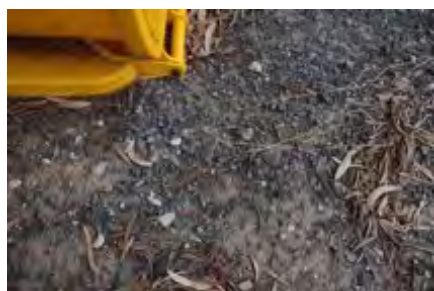
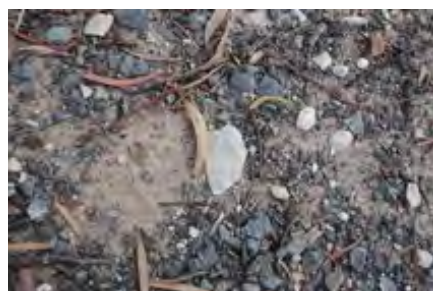
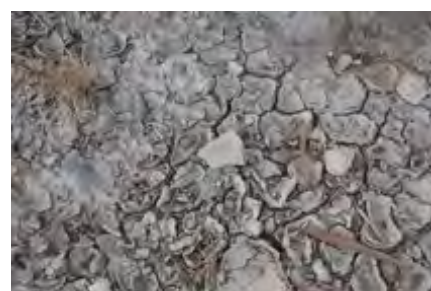
Asbestos Waste: entire perimeter of container. The Debris - Broken (Debris) has Asbestos Containing Material (ACM) present.

Type of Asbestos or Hazardous Material	No sample taken - Visual ID	Condition	POOR	Likelihood of Damage	H (High) - almost certain
		Activity	Moderate		
		Sealed	No	Friability	Exposed Fibres
		Labelled	Y	Exposure Risk	High - Short term exposure risk
		Quantity

Debris on Surface

Priority	IMMEDIATE	Label Required	Yes	Re- Audit Date	16 Feb 2022
Action	Restrict access and target for imminent removal				
Recommendation	Debris on Surface - The Debris requires immediate cleanup and disposal with specialised equipment and with licensed removalist to safely remove the asbestos debris. Recommend to place waste skip on Hard stand to prevent contamination of surrounding soil. Asbestos Disposal management/program should be documented and training provided.				
Legislative Requirements Victorian Regulation 2007	ACM debris visible. Recommend cleanup by licensed Asbestos Removalist. Warning labels should be affixed. Avoid mechanical damage and abrasion. Remove if refurbishment, structural alteration or demolition is to be carried out in this area. Re-inspect every 12 months or earlier if disturbed or removed in accordance with the Victorian OH&S Regulation 2017. All remedial/removal repairs require a Clearance Inspection & Certificate to be recorded by an approved and competent assessor.

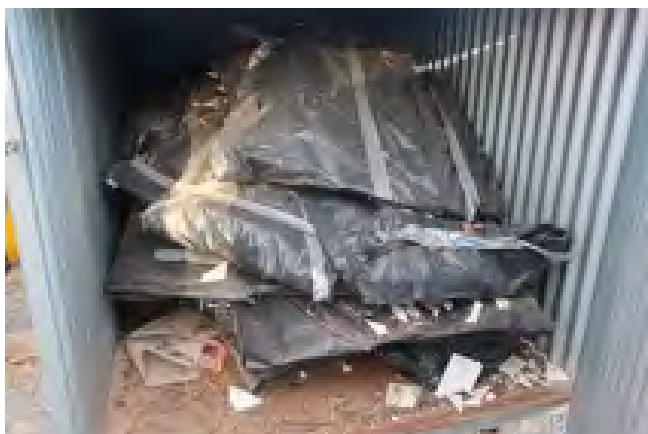
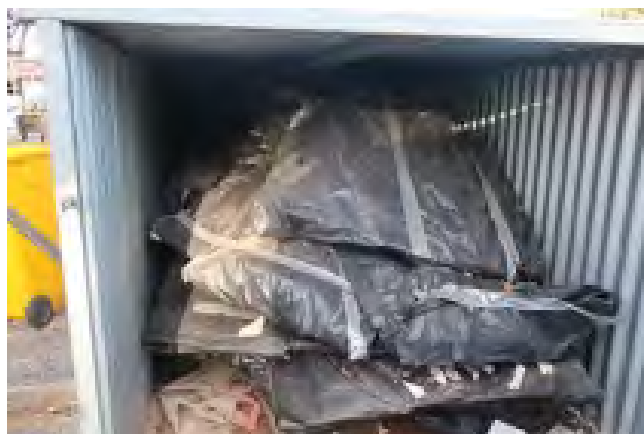
Type of Asbestos or Hazardous Material	No sample taken - Visual ID	Condition	GOOD	Likelihood of Damage	M (Medium) - likely
		Activity	Low		
		Sealed	Yes	Friability	Bonded (non-friable)
		Labelled	Y	Exposure Risk	Medium - Moderate risk
		Quantity

Priority	MEDIUM	Label Required	Yes	Re- Audit Date	16 Feb 2022
Action	No remedial action required, unless disturbed				
Recommendation	Maintain paint or sealant to ACM surfaces. Particular attention should be given to side edges, ensure paint/sealant covers ALL exposed ACM surfaces. Recommend to place waste skip on Hard stand to prevent contamination of surrounding soil. Asbestos Disposal management/program should be documented and training provided.				
Legislative Requirements Victorian Regulation 2007	Asbestos waste disposal and burial Practices should be reviewed for compliance. Avoid mechanical damage and abrasion. Re-inspect every 12 months or earlier if disturbed or removed in accordance with the Victorian OH&S Regulation 2017. All remedial/removal repairs require a Clearance Inspection & Certificate to be recorded by an approved and competent assessor.

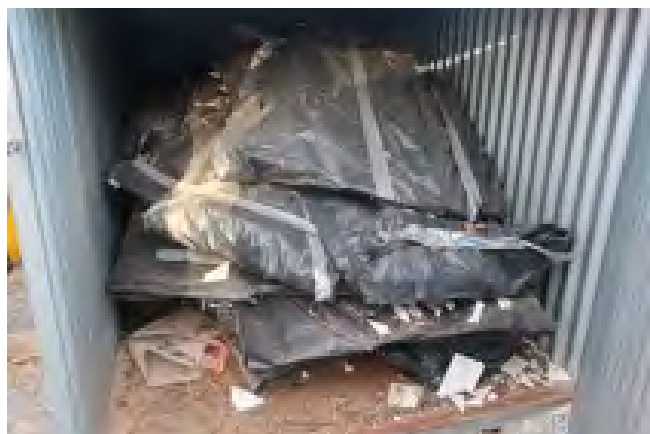
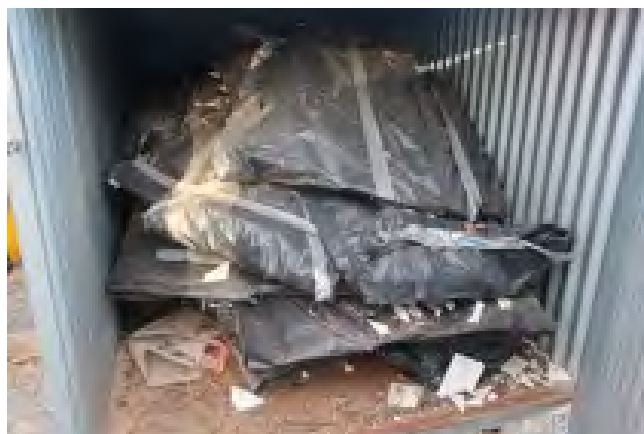
Type of Asbestos or Hazardous Material	No sample taken - Visual ID	Condition	POOR	Likelihood of Damage	H (High) - almost certain
		Activity	Low		
		Sealed	No	Friability	Exposed Fibres
		Labelled	Y	Exposure Risk	High - Short term exposure risk
		Quantity

Priority	IMMEDIATE	Label Required	Yes	Re- Audit Date	16 Feb 2022
Action	Restrict access and target for imminent removal				
Recommendation	Debris on Surface - The Debris requires immediate cleanup and disposal with specialised equipment and with licensed removalist to safely remove the asbestos debris. Recommend to place waste skip on Hard stand to prevent contamination of surrounding soil. Asbestos Disposal management/program should be documented and training provided.				
Legislative Requirements Victorian Regulation 2007	ACM debris visible. Recommend cleanup by licensed Asbestos Removalist. Warning labels should be affixed. Avoid mechanical damage and abrasion. Remove if refurbishment, structural alteration or demolition is to be carried out in this area. Re-inspect every 12 months or earlier if disturbed or removed in accordance with the Victorian OH&S Regulation 2017. All remedial/removal repairs require a Clearance Inspection & Certificate to be recorded by an approved and competent assessor.
