**Global
Asbestos
Audits**

Asbestos Report

YARRIAMBIACK SHIRE COUNCIL

PROPERTY ADDRESS:
LB1 SHIRE HALL
39 SCOTT STREET
WARRACKNABEAL VIC 3393

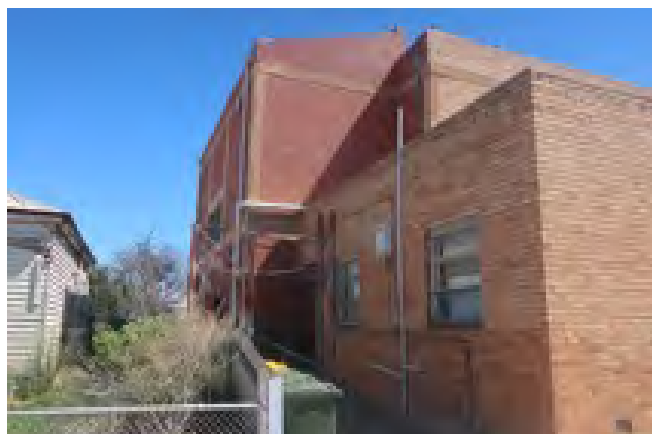
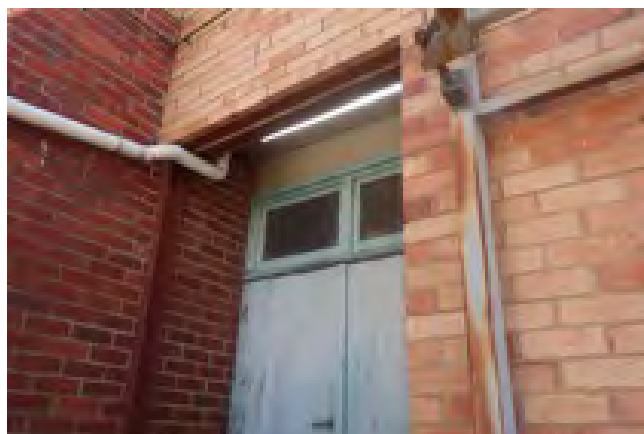
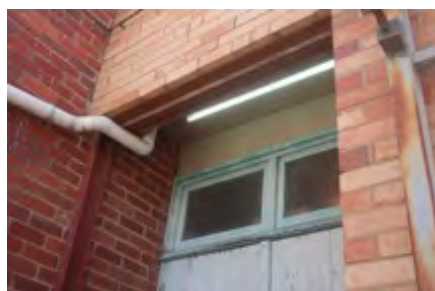
Area 20***LB1 Shire Hall: rear of building - entry. The Ceiling & infill above windows (F C Sheeting) has Asbestos Containing Material (ACM) present.*****RISK ASSESSMENT**

Type of Asbestos or Hazardous Material	No sample taken - Visual ID	Condition	AVERAGE	Likelihood of Damage	L (Low) – possible
		Activity	Moderate		
		Sealed	No	Friability	Bonded (non-friable)
		Labelled	Y	Exposure Risk	Medium - Moderate risk
		Quantity

- 20 LB1 Shire Hall: rear of building - entry. The Ceiling & infill above windows (F C Sheeting) has Asbestos Containing Material (ACM) present.**
- Raw material sheeting - The area requires immediate remedial repairs. It is recommended the asbestos material be sealed with an approved membrane.

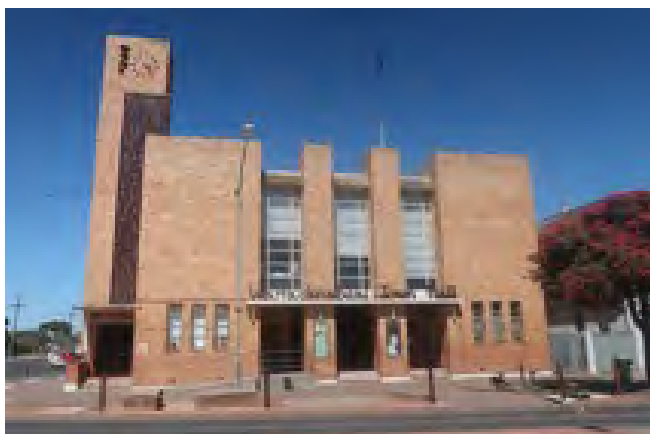
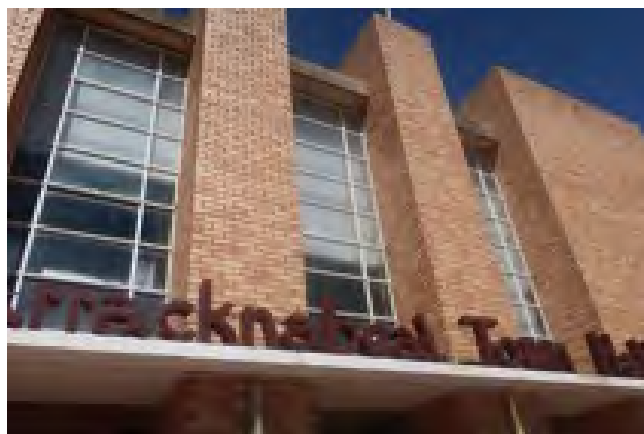
Area 21**LB1 Shire Hall: Exterior & Interior. The Windows - Steel framed (Putty) has Asbestos Containing Material (ACM) present.****RISK ASSESSMENT**

Type of Asbestos or Hazardous Material	No sample taken - Visual ID	Condition	GOOD	Likelihood of Damage	L (Low) – possible
		Activity	Moderate		
		Sealed	Yes	Friability	Bonded (non-friable)
		Labelled	Y	Exposure Risk	Low - Negligible or low risk
		Quantity

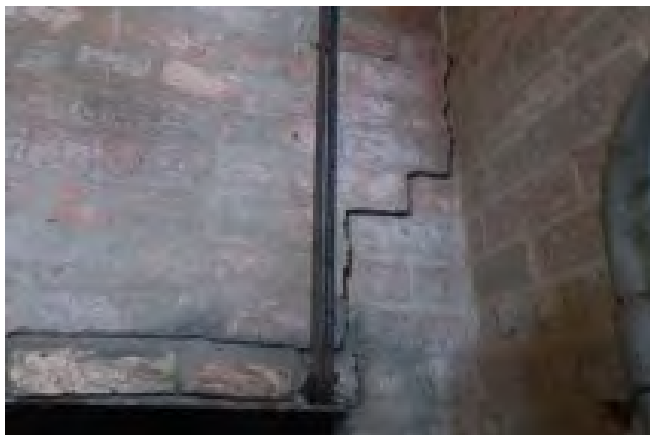
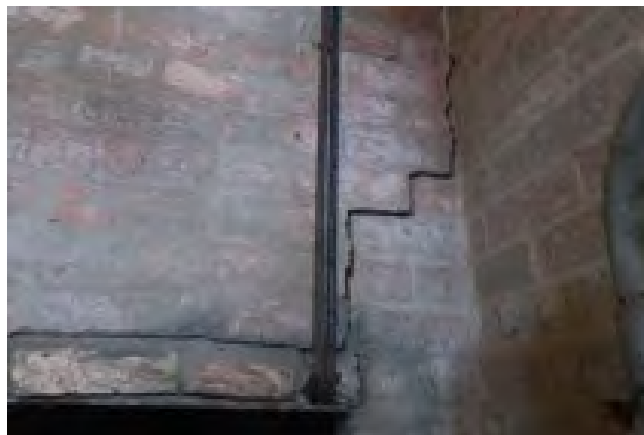
Area 26**LB1 Shire Hall: Interior - throughout. The Electrical conduit - wire cloth (Insulation) has Asbestos Containing Material (ACM) present.****RISK ASSESSMENT**

Type of Asbestos or Hazardous Material	No sample taken - Visual ID	Condition	GOOD	Likelihood of Damage	L (Low) – possible
		Activity	Moderate		
		Sealed	Yes	Friability	Bonded (non-friable)
		Labelled	Y	Exposure Risk	Low - Negligible or low risk
		Quantity

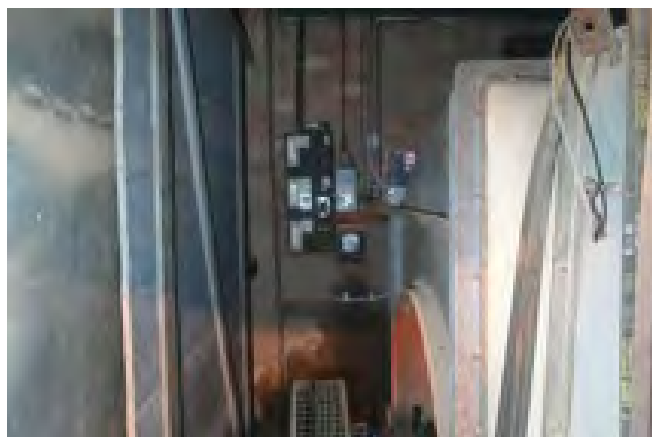
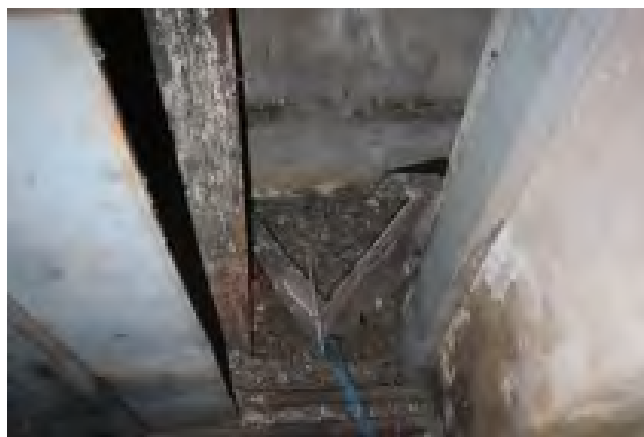
Area 6**LB1 Shire Hall: Plant room. The Debris - Broken (Millboard) has Asbestos Containing Material (ACM) present.****RISK ASSESSMENT**

Type of Asbestos or Hazardous Material	Chrysotile	Condition	POOR	Likelihood of Damage	H (High) - almost certain
	Sample taken 62141-002	Activity	Moderate		
		Sealed	No	Friability	Friable
		Labelled	No	Exposure Risk	High - Short term exposure risk
		Quantity

- 6 LB1 Shire Hall: Plant room. The Debris - Broken (Millboard) has Asbestos Containing Material (ACM) present.**
- Debris on Surface - The Debris requires immediate cleanup and disposal with specialised equipment and with licensed removalist to safely remove the asbestos debris.

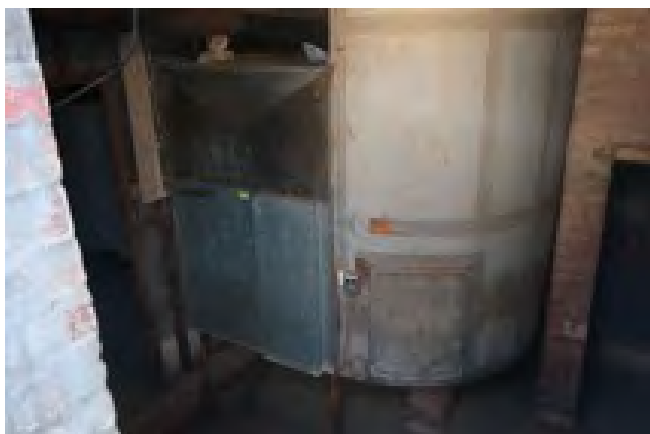
Area 31**LB1 Shire Hall: Level Basement 1 Plant room 1. The Air conditioning system - heater banks (Insulation - boards) has Asbestos Containing Material (ACM) present.****RISK ASSESSMENT**

Type of Asbestos or Hazardous Material	No sample taken - Visual ID	Condition	GOOD	Likelihood of Damage	L (Low) – possible
		Activity	Moderate		
		Sealed	Yes	Friability	Bonded (non-friable)
		Labelled	Y	Exposure Risk	Low - Negligible or low risk
		Quantity

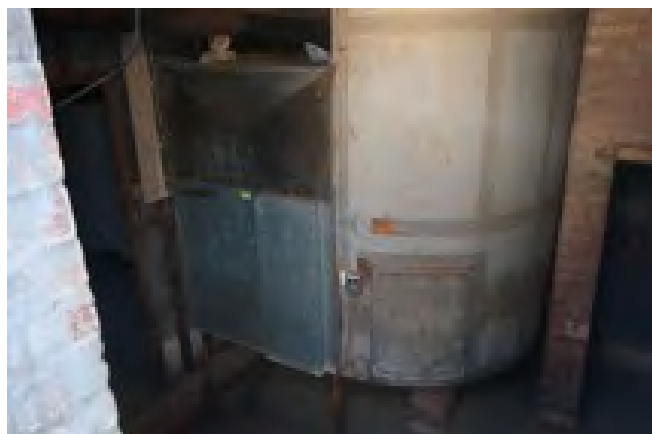
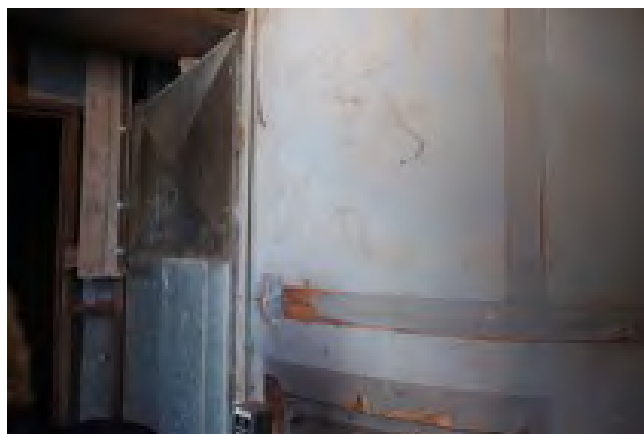
Area ¹**LB1 Shire Hall: Basement Plant room 1. The Air conditioning system - seals (Cloth) has Asbestos Containing Material (ACM) present.****RISK ASSESSMENT**

Type of Asbestos or Hazardous Material	Chrysotile	Condition	AVERAGE	Likelihood of Damage	M (Medium) – possible
	Sample taken 62141-001	Activity	Moderate		
		Sealed	No	Friability	Friable
		Labelled	Y	Exposure Risk	Medium - Moderate risk
		Quantity

Unbonded surface (Loose) - The area requires immediate remedial repairs. It is recommended the asbestos material be replaced (preferred) or the material be sealed with an approved membrane.

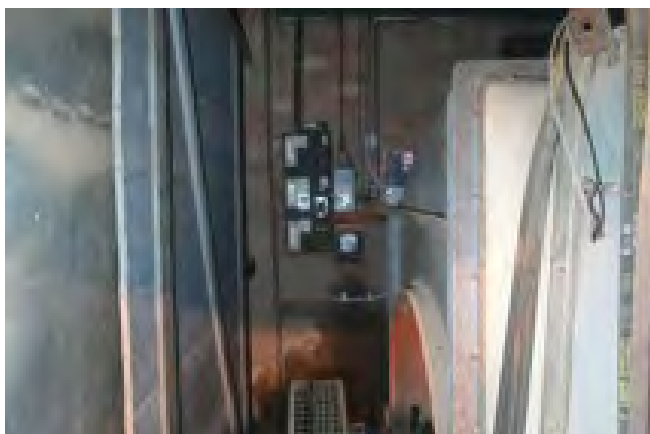
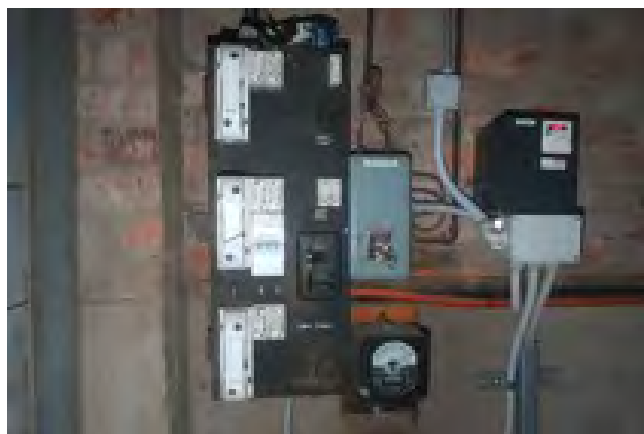
Area 18**LB1 Shire Hall: Level Basement 1 Plant room 1. The A: Electrical board; B: Ceramic Fuses (A: Zelemite; B: Cloth Inserts) has Asbestos Containing Material (ACM) present.****RISK ASSESSMENT**

Type of Asbestos or Hazardous Material	No sample taken - Visual ID	Condition	AVERAGE	Likelihood of Damage	L (Low) – possible
		Activity	Moderate		
		Sealed	Yes	Friability	Exposed Fibres
		Labelled	Y	Exposure Risk	Medium - Moderate risk
		Quantity

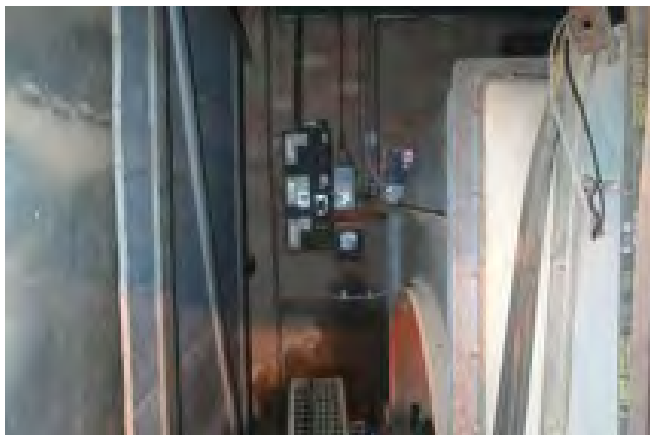
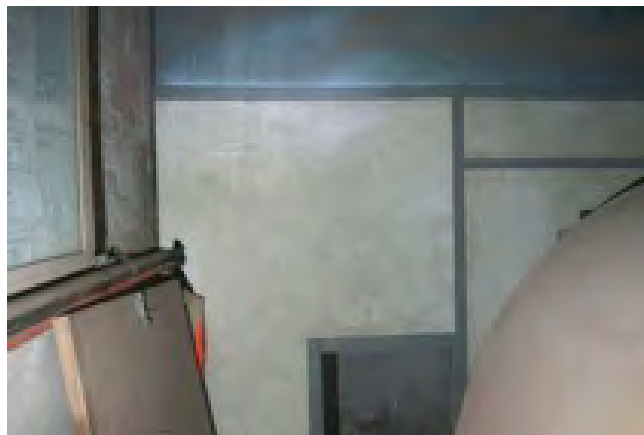
Area 19**LB1 Shire Hall: Level Basement 1 Plant room 1. The Dividing wall (F C Sheeting) has Asbestos Containing Material (ACM) present.****RISK ASSESSMENT**

Type of Asbestos or Hazardous Material	No sample taken - Visual ID	Condition	AVERAGE	Likelihood of Damage	L (Low) – possible
		Activity	Moderate		
		Sealed	No	Friability	Bonded (non-friable)
		Labelled	Y	Exposure Risk	Medium - Moderate risk
		Quantity

- 19 LB1 Shire Hall: Level Basement 1 Plant room 1. The Dividing wall (F C Sheeting) has Asbestos Containing Material (ACM) present.**
- Raw material sheeting - The area requires immediate remedial repairs. It is recommended the asbestos material be sealed with an approved membrane.

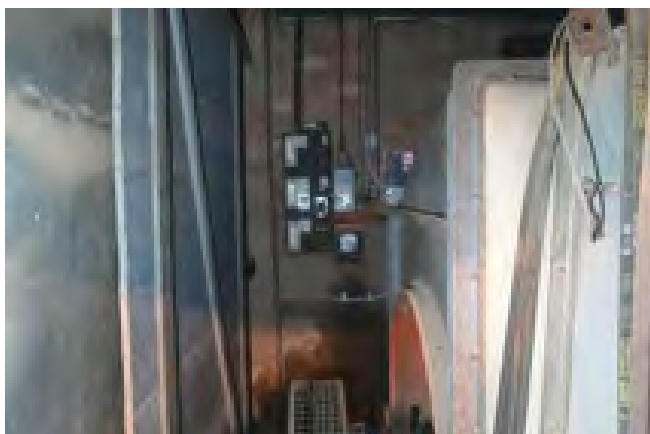
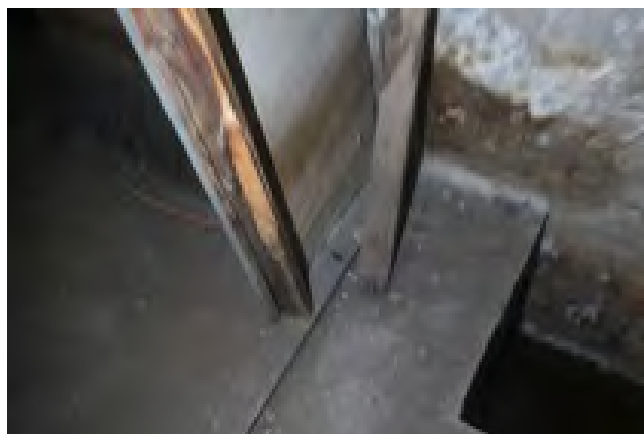
Area 2**LB1 Shire Hall: Basement Plant room 1. The Debris - Broken (Debris) has Asbestos Containing Material (ACM) present.****RISK ASSESSMENT**

Type of Asbestos or Hazardous Material	No sample taken - Visual ID	Condition	POOR	Likelihood of Damage	H (High) - almost certain
		Activity	Moderate		
		Sealed	No	Friability	Exposed Fibres
		Labelled	Y	Exposure Risk	High - Short term exposure risk
		Quantity

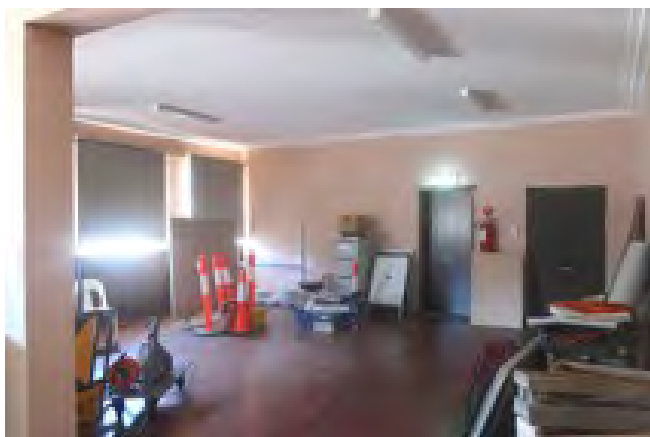
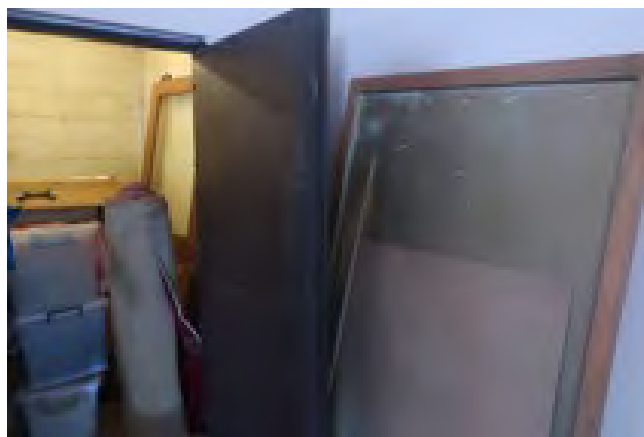
Area 22**LB1 Shire Hall: Ground Floor Office & Strong room 2 & 2.1. The Safe (Walls & Doors) (Fire Retardant core) has Asbestos Containing Material (ACM) present.****RISK ASSESSMENT**

Type of Asbestos or Hazardous Material	No sample taken - Visual ID	Condition	GOOD	Likelihood of Damage	L (Low) – possible
		Activity	Moderate		
		Sealed	Yes	Friability	Bonded (non-friable)
		Labelled	Y	Exposure Risk	Low - Negligible or low risk
		Quantity

Maintain seals

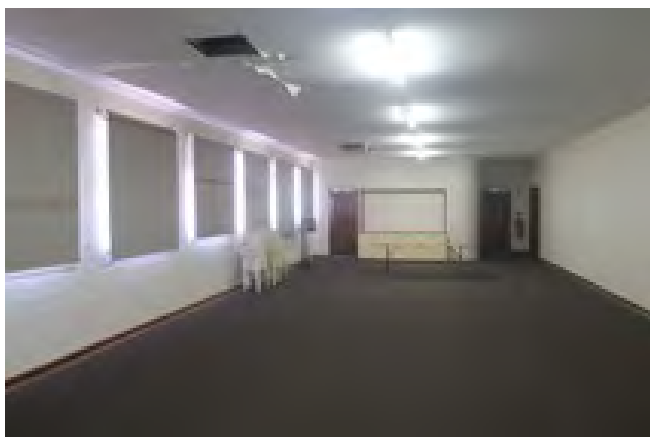
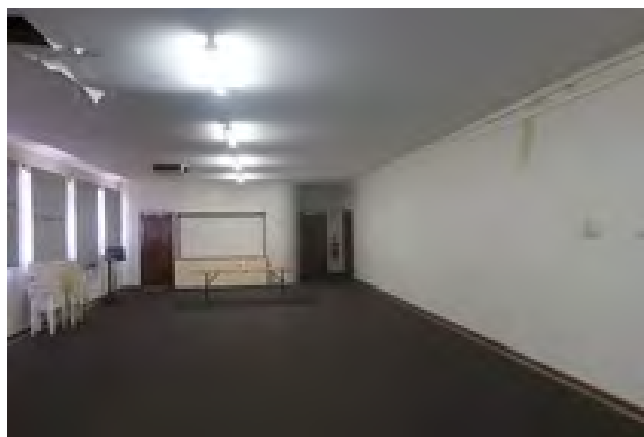
Area 3**LB1 Shire Hall: Ground Floor Supper room 6. The Electrical Cabinet (Debris) has Asbestos Containing Material (ACM) present.****RISK ASSESSMENT**

Type of Asbestos or Hazardous Material	Chrysotile	Condition	POOR	Likelihood of Damage	H (High) - almost certain
	Sample taken 62141-004	Activity	Low		
		Sealed	No	Friability	Exposed Fibres
		Labelled	Y	Exposure Risk	High - Short term exposure risk
		Quantity

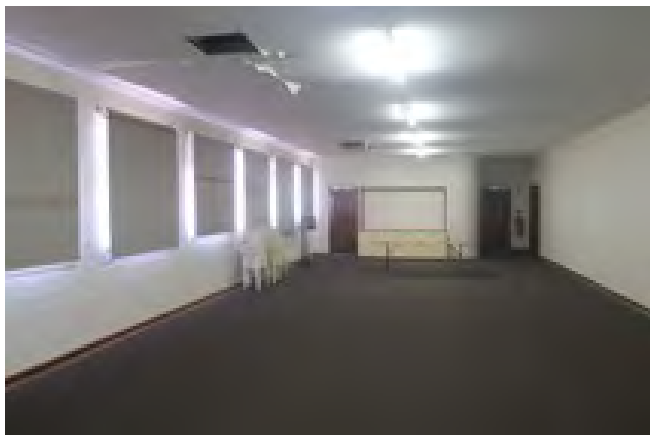
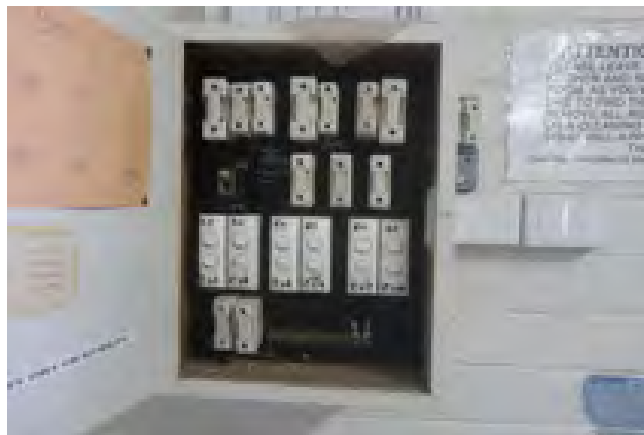
Area 25**LB1 Shire Hall: Ground Floor Supper room 6. The A: Electrical board; B: Ceramic Fuses (A: Zelemite; B: Cloth Inserts) has Asbestos Containing Material (ACM) present.****RISK ASSESSMENT**

Type of Asbestos or Hazardous Material	No sample taken - Visual ID	Condition	GOOD	Likelihood of Damage	L (Low) – possible
		Activity	Moderate		
		Sealed	Yes	Friability	Bonded (non-friable)
		Labelled	Y	Exposure Risk	Low - Negligible or low risk
		Quantity

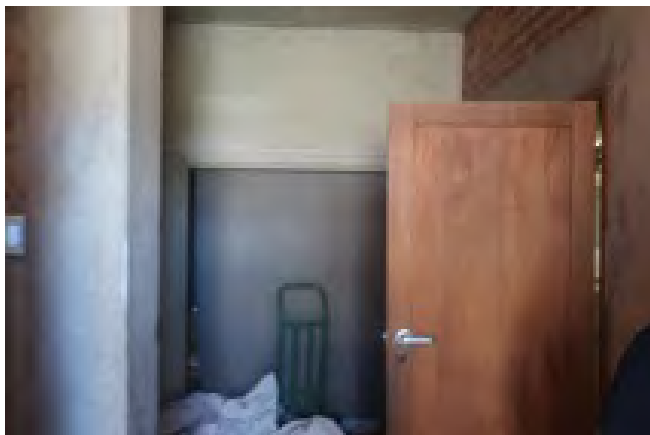
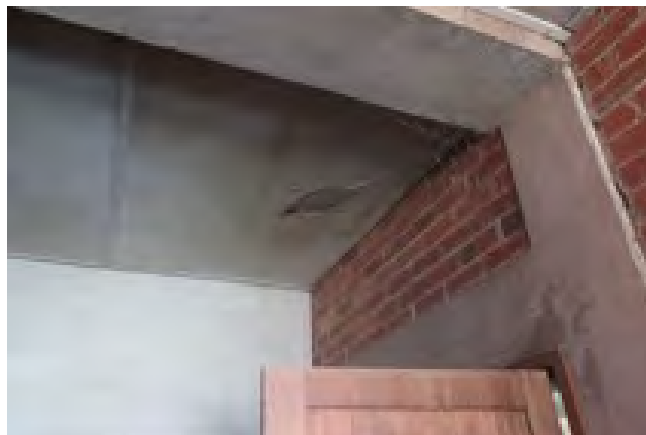
Area 10**LB1 Shire Hall: Ground Floor Rear entry 8. The Ceiling & dividing wall (F C Sheeting) has Asbestos Containing Material (ACM) present.****RISK ASSESSMENT**

Type of Asbestos or Hazardous Material	No sample taken - Visual ID	Condition	AVERAGE	Likelihood of Damage	L (Low) – possible
		Activity	Moderate		
		Sealed	No	Friability	Bonded (non-friable)
		Labelled	Y	Exposure Risk	Medium - Moderate risk
		Quantity

- 10 LB1 Shire Hall: Ground Floor Rear entry 8. The Ceiling & dividing wall (F C Sheeting) has Asbestos Containing Material (ACM) present.**
- Raw material sheeting - The area requires immediate remedial repairs. It is recommended the asbestos material be sealed with an approved membrane.

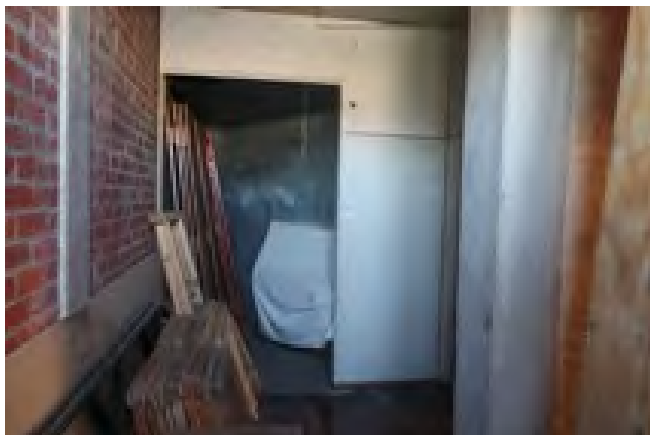
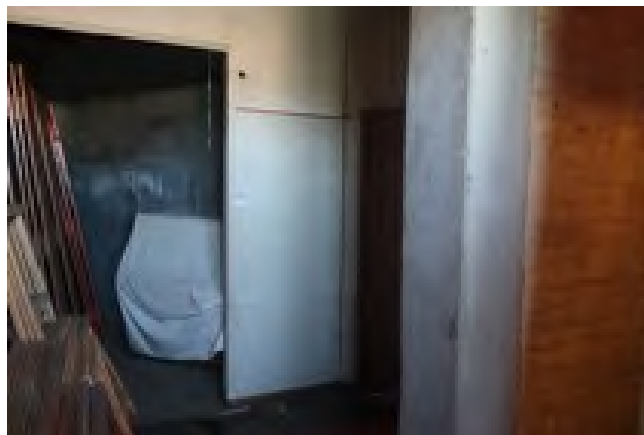
Area 9**LB1 Shire Hall: Ground Floor Rear entry 2 9. The Ceiling & dividing wall (F C Sheeting) has Asbestos Containing Material (ACM) present.****RISK ASSESSMENT**

Type of Asbestos or Hazardous Material	No sample taken - Visual ID	Condition	AVERAGE	Likelihood of Damage	L (Low) – possible
		Activity	Moderate		
		Sealed	No	Friability	Bonded (non-friable)
		Labelled	No	Exposure Risk	Medium - Moderate risk
		Quantity

- 9 LB1 Shire Hall: Ground Floor Rear entry 2 9. The Ceiling & dividing wall (F C Sheeting) has Asbestos Containing Material (ACM) present.**
- Raw material sheeting - The area requires immediate remedial repairs. It is recommended the asbestos material be sealed with an approved membrane.

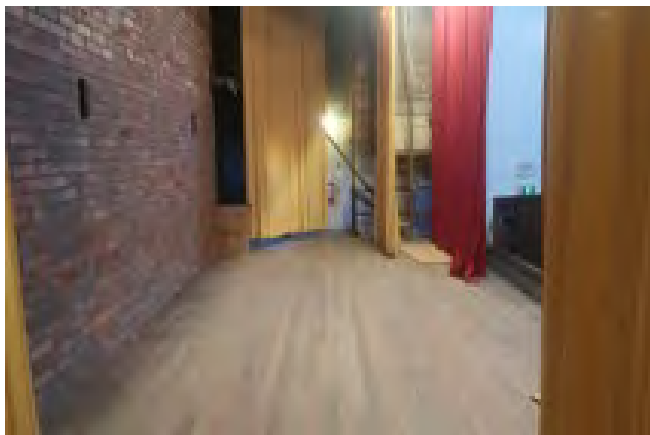
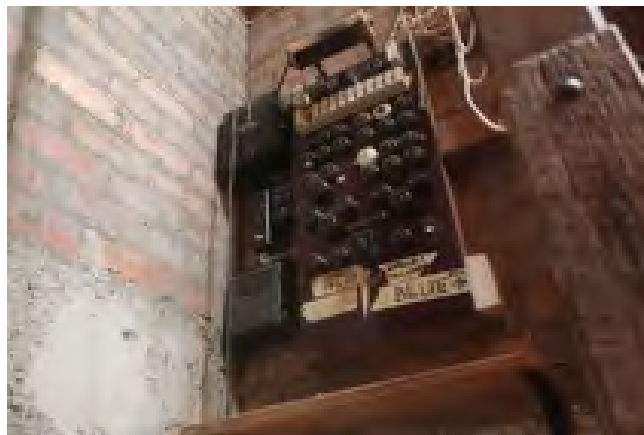
Area 23**LB1 Shire Hall: Ground Floor Stage 10.1. The Ceramic fuses (Cloth Inserts) has Asbestos Containing Material (ACM) present.****RISK ASSESSMENT**

Type of Asbestos or Hazardous Material	No sample taken - Visual ID	Condition	GOOD	Likelihood of Damage	L (Low) – possible
		Activity	Moderate		
		Sealed	Yes	Friability	Bonded (non-friable)
		Labelled	Y	Exposure Risk	Low - Negligible or low risk
		Quantity
