Asbestos Report

YARRIAMBIACK SHIRE COUNCIL

PROPERTY ADDRESS:
LB73 ILLUKA DEPOT
GARRARD STREET
HOPETOUN VIC 3396

INSPECTION DATE: 27 JANUARY 2021
REFERENCE NUMBER: 62070

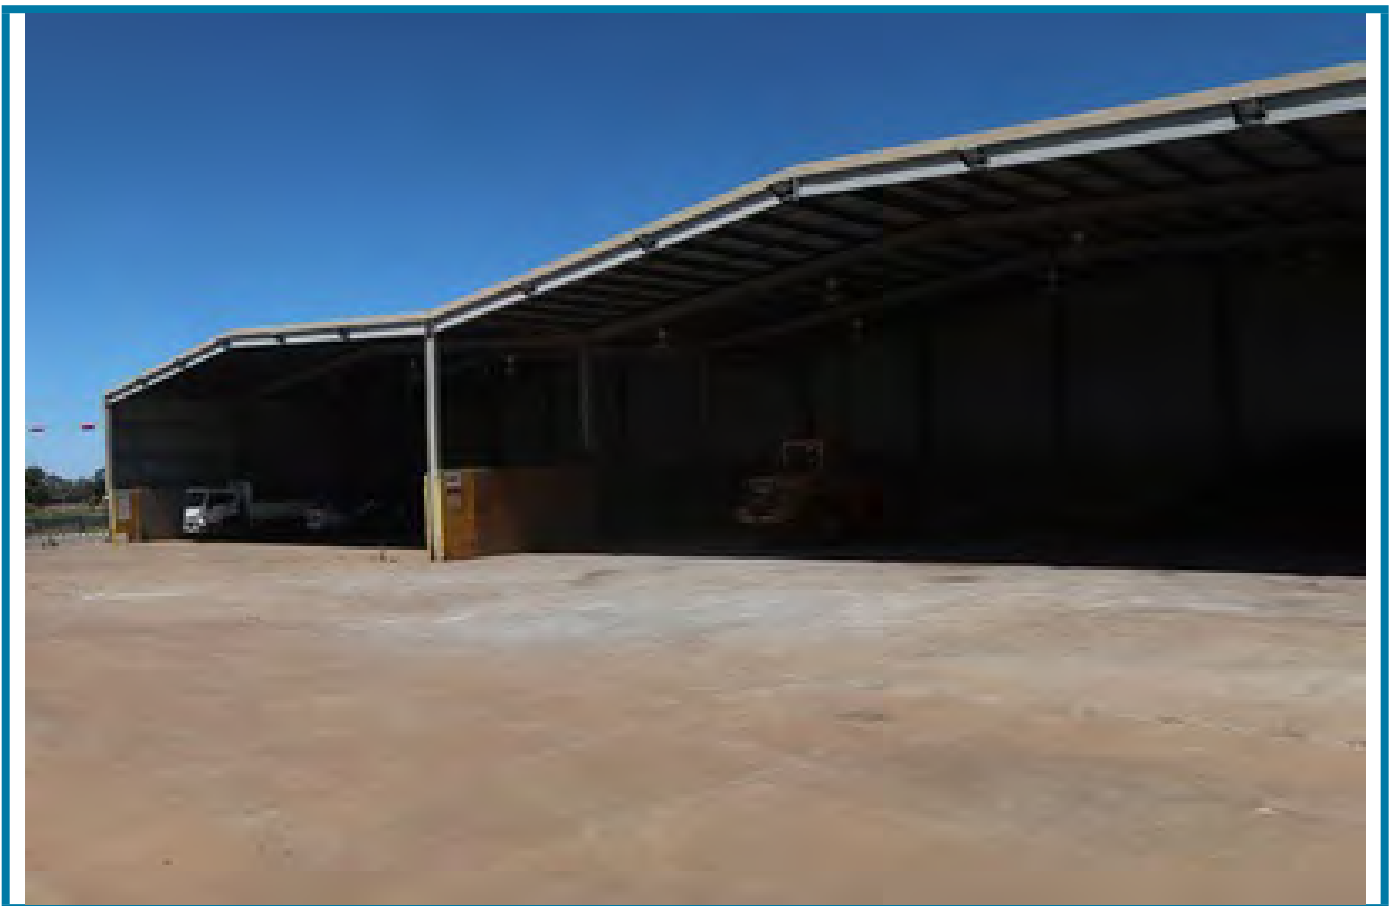
Location	Area	Component Materials	ACM Identified	Type Asbestos Assessment	ConditionPriority	Signage Required
Shed LB73 Illuka Depot - entire perimeter of building.		No Asbestos Materials	No	No sample taken - Visual ID

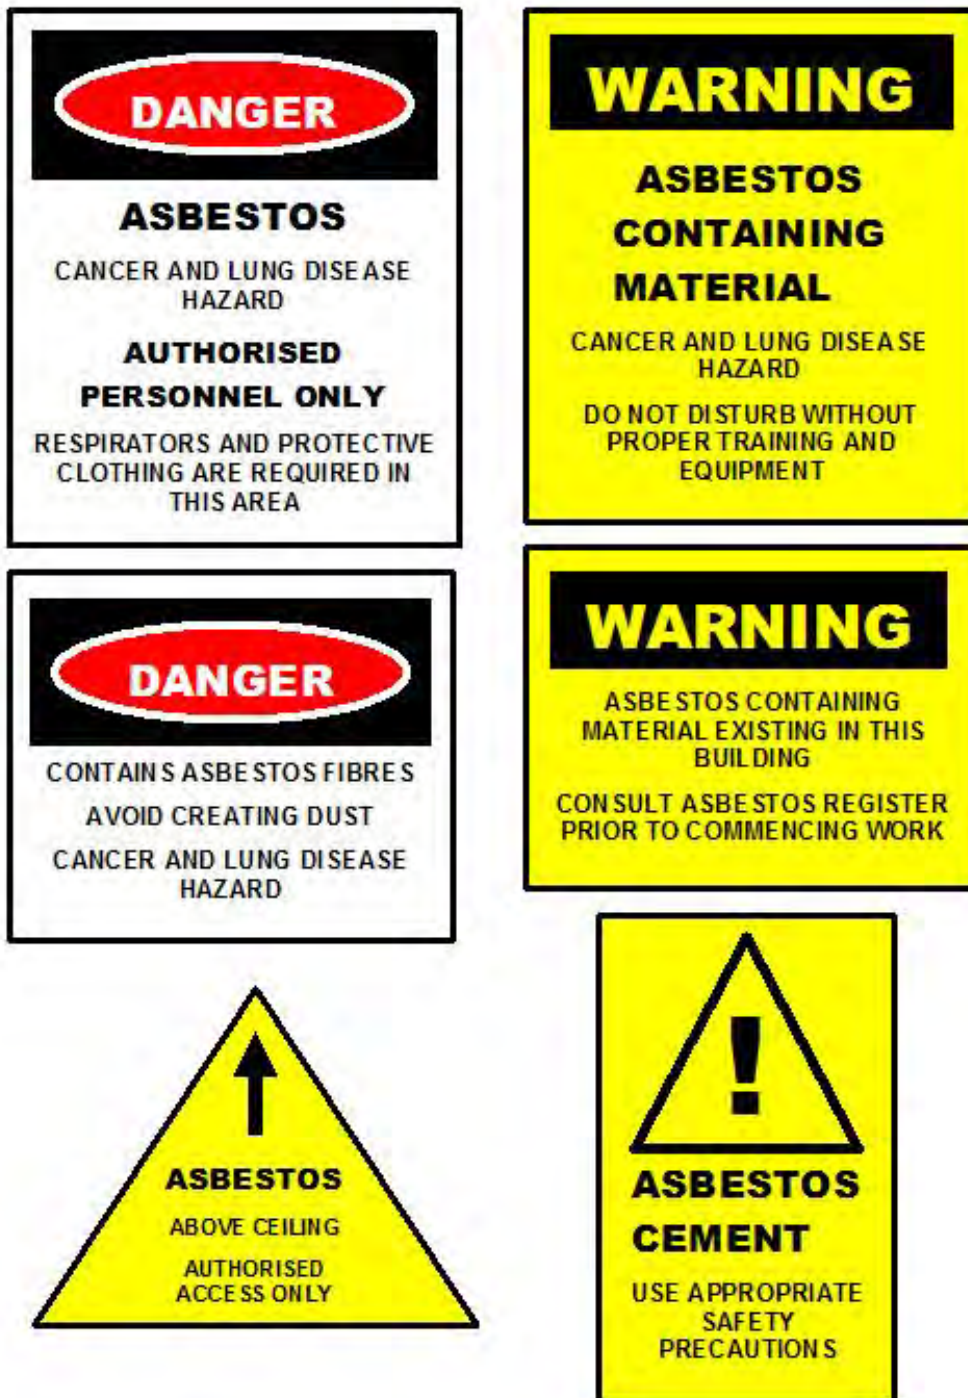
Figure 2 – Examples of warning signs and labels

Note: The examples of warning signs and labels in *Figure 2* provide only an indication of the words that may be used to alert persons to the presence of ACM and asbestos hazards. *The wording is not mandatory.* Other warning signs and labels may be used, provided they meet the requirements of AS 1319.
