Asbestos Report

YARRIAMBIACK SHIRE COUNCIL

PROPERTY ADDRESS:
LR46 CUST STORE
27A CROMIE STREET (IN MIDDLE OF ROAD)
RUPANYUP VIC 3388

INSPECTION DATE: 10 FEBRUARY 2021
REFERENCE NUMBER: 62107

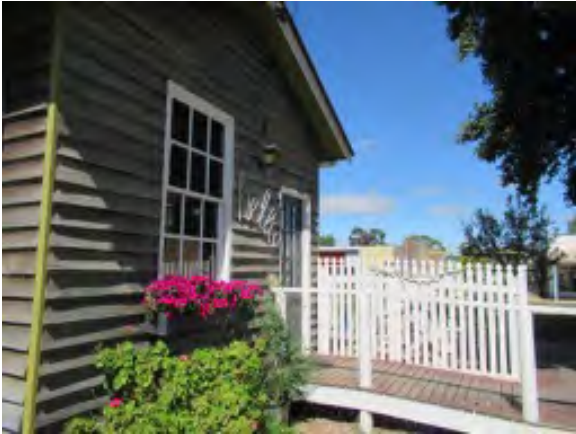
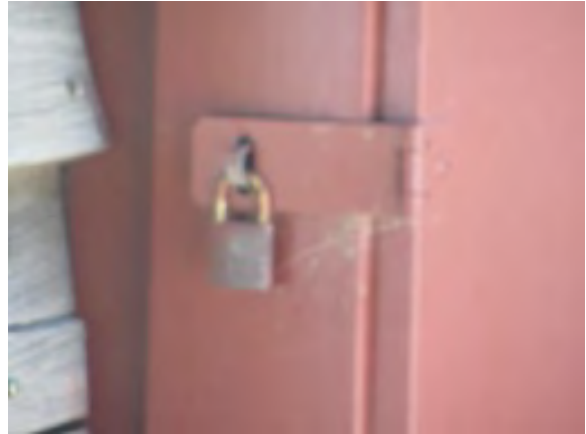
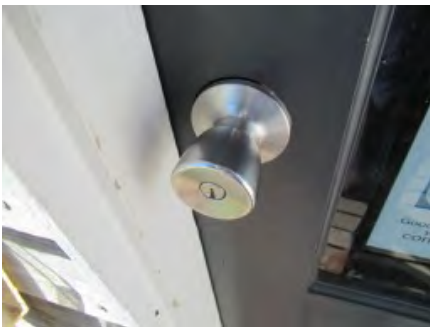
Area 1

LR46 Cust Store: Internal & Power Board. Until the area is inspected, it should be managed as if it Asbestos Containing Material (ACM) is present.

RISK ASSESSMENT					
Type of Asbestos or Hazardous Material	No sample taken - No Access	Condition		Likelihood of Damage	
		Activity			
		Sealed		Friability	
		Labelled	No	Exposure Risk	
		Quantity

RISK CONTROL					
Priority	HIGH	Label Required	Yes	Re- Audit Date	10 Feb 2022
Action					
Recommendation					
Legislative Requirements Victorian Regulation 2007	Unable to Gain Access. Assume asbestos in area and provide monitoring if work undertaken in these areas. If access is made available, contact Global Asbestos Audits for re-inspection

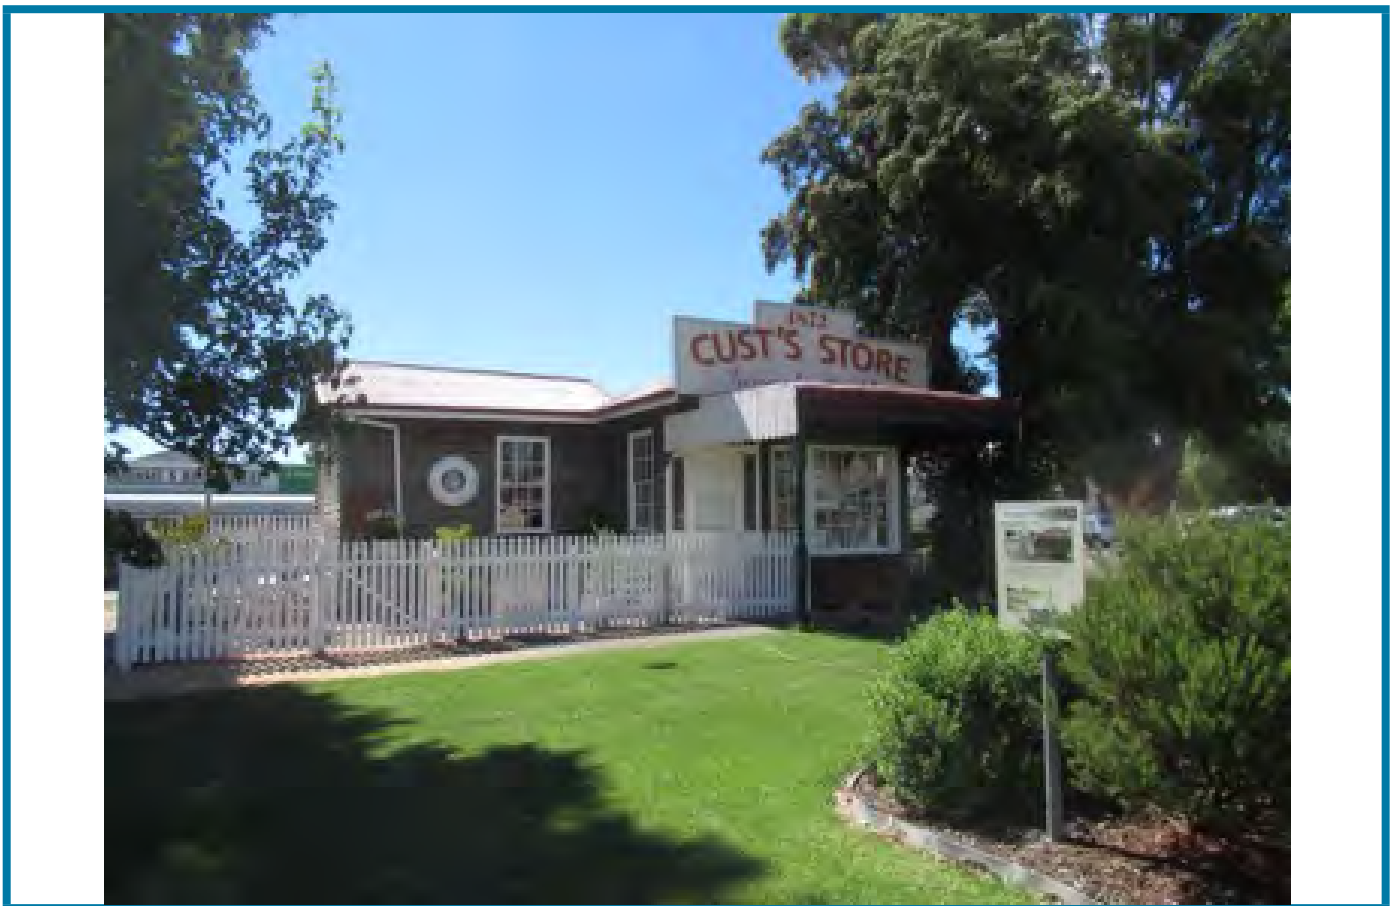
Asbestos Survey

Location	Area	Component Materials	ACM Identified	Type Asbestos Assessment	Condition	Priority	Signage Required
LR46 Cust Store - front of building.		No Asbestos Materials	No	No sample taken - Visual ID
