# Asbestos Report

YARRIAMBIACK SHIRE COUNCIL

PROPERTY ADDRESS:  
LR32 DEVELOPMENT AREA  
1 GLOUCESTER AVENUE  
WOOMELANG VIC 3485

INSPECTION DATE: 11 FEBRUARY 2021  
REFERENCE NUMBER: 62149

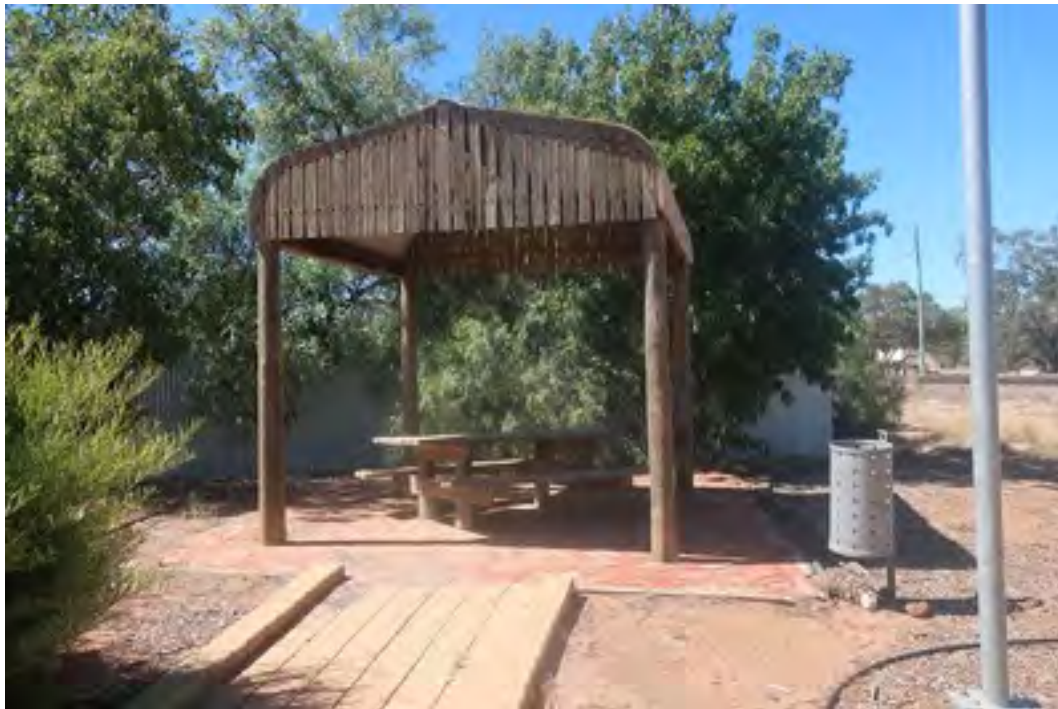
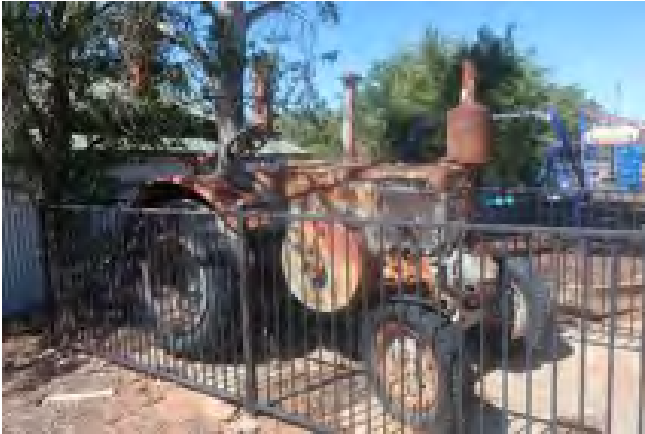
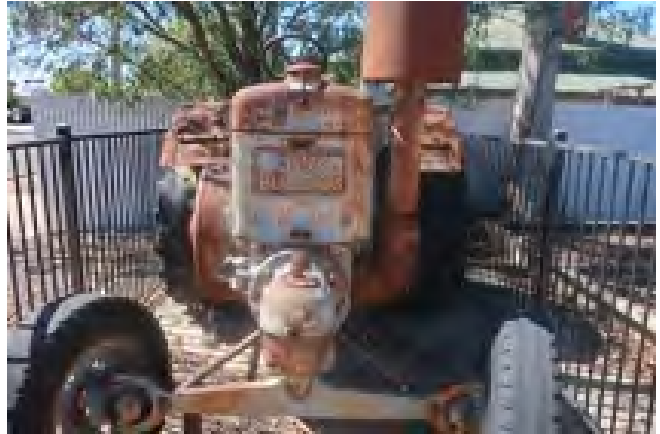
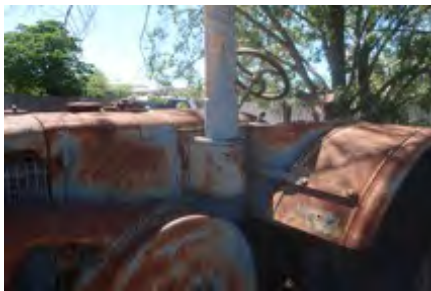
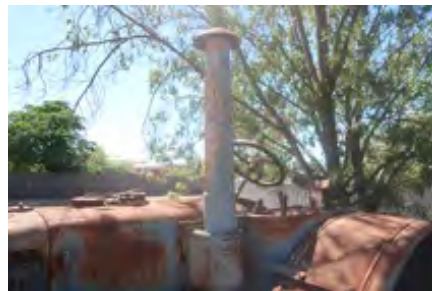
ASBESTOS REGISTER: LR32 Development area, 1 Gloucester Avenue, Woomelang VIC 3485

**Area 1****Grounds: Lanz Bulldog tractor. The exhaust Gasket (Compound material) has Asbestos Containing Material (ACM) present.****RISK ASSESSMENT**

Type of Asbestos or Hazardous Material	No sample taken - Visual ID	Condition	GOOD	Likelihood of Damage	L (Low) – possible
		Activity	Low		
		Sealed	Yes	Friability	Bonded (non-friable)
		Labelled	Y	Exposure Risk	Low - Negligible or low risk
		Quantity

Priority	MEDIUM	Label Required	Yes	Re- Audit Date	11 Feb 2022
Action	No remedial action required, unless disturbed				
Recommendation	Maintain paint or sealant to ACM surfaces. Particular attention should be given to side edges, ensure paint/sealant covers ALL exposed ACM surfaces.				
Legislative Requirements Victorian Regulation 2007	Warning labels should be affixed. Avoid mechanical damage and abrasion. Remove if refurbishment, structural alteration or demolition is to be carried out in this area. Re-inspect every 12 months or earlier if disturbed or removed in accordance with the Victorian Regulation 2007. <b>All remedial/removal repairs require a Clearance Inspection &amp; Certificate to be recorded by an approved and competent assessor.</b>

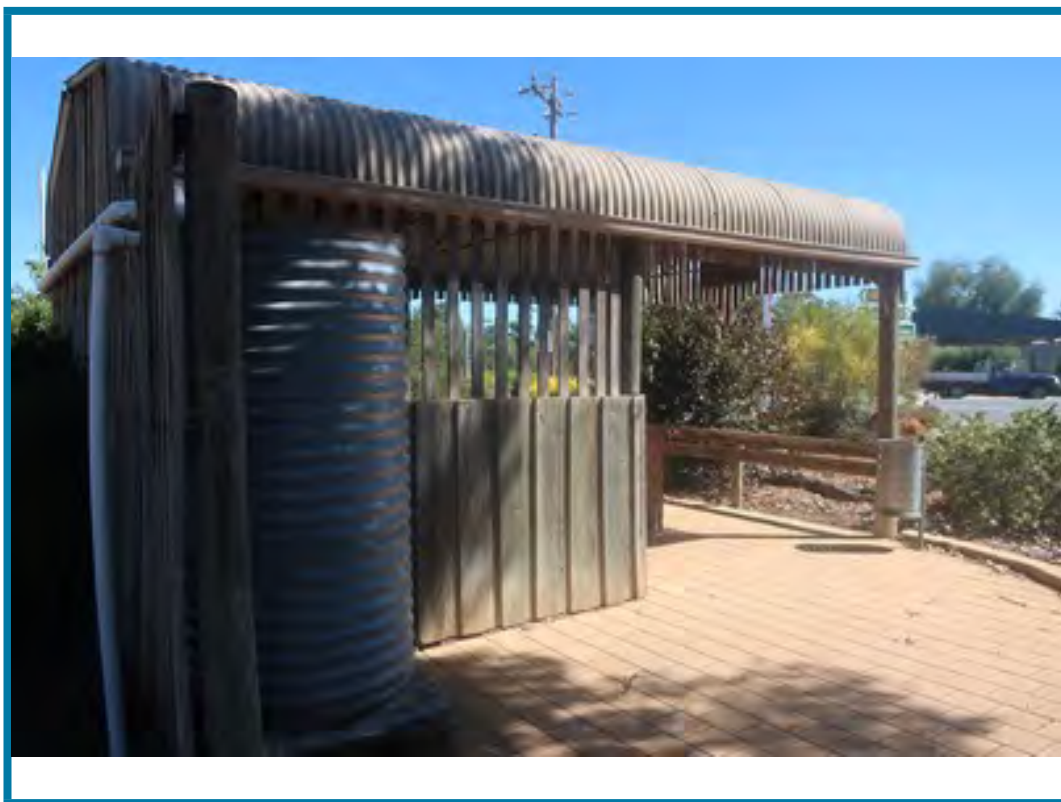
**ASBESTOS SURVEY: Lr32 Development Area, 1 Gloucester Avenue, Woomelang Vic 3485**

Location	Area	Component Materials	ACM Identified	Type Asbestos Assessment	ConditionPriority	Signage Required
Shelter - entire perimeter of building.		No Asbestos Materials	No	No sample taken - Visual ID
