Asbestos Report

YARRIAMBIACK SHIRE COUNCIL

PROPERTY ADDRESS:
LB82 AERODROME
78 HOPETOUN AERODROME ROAD
HOPETOUN VIC 3396

INSPECTION DATE: 27 JANUARY 2021
REFERENCE NUMBER: 62062

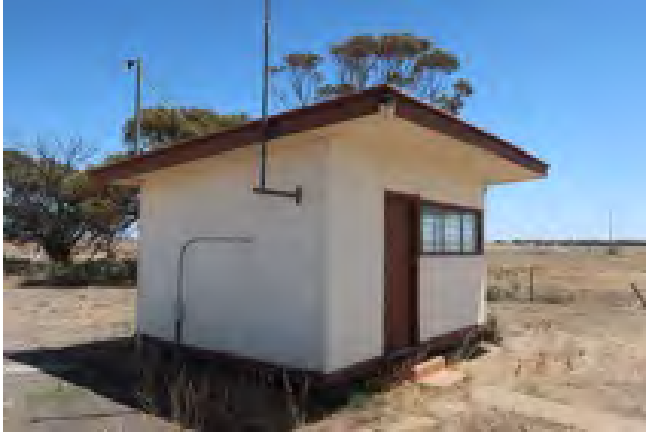
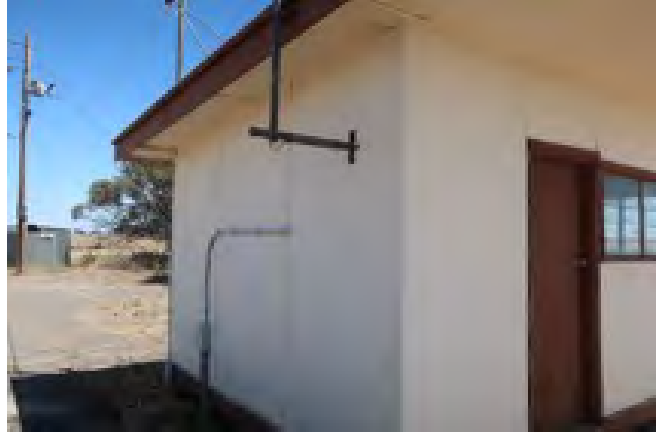
Area 5

LB82 Aerodrome: entire perimeter of building. The Walls (F C Sheeting) has Asbestos Containing Material (ACM) present.

RISK ASSESSMENT					
Type of Asbestos or Hazardous Material	No sample taken - Visual ID	Condition	GOOD	Likelihood of Damage	L (Low) – possible
		Activity	Moderate		
		Sealed	Yes	Friability	Bonded (non-friable)
		Labelled	Y	Exposure Risk	Low - Negligible or low risk
		Quantity

Priority	MEDIUM	Label Required	Yes	Re- Audit Date	27 Jan 2022
Action	No remedial action required, unless disturbed				
Recommendation	Maintain paint or sealant to ACM surfaces. Particular attention should be given to side edges, ensure paint/sealant covers ALL exposed ACM surfaces.				
Legislative Requirements Victorian Regulation 2007	Warning labels should be affixed. Avoid mechanical damage and abrasion. Remove if refurbishment, structural alteration or demolition is to be carried out in this area. Re-inspect every 12 months or earlier if disturbed or removed in accordance with the Victorian Regulation 2007. All remedial/removal repairs require a Clearance Inspection & Certificate to be recorded by an approved and competent assessor.

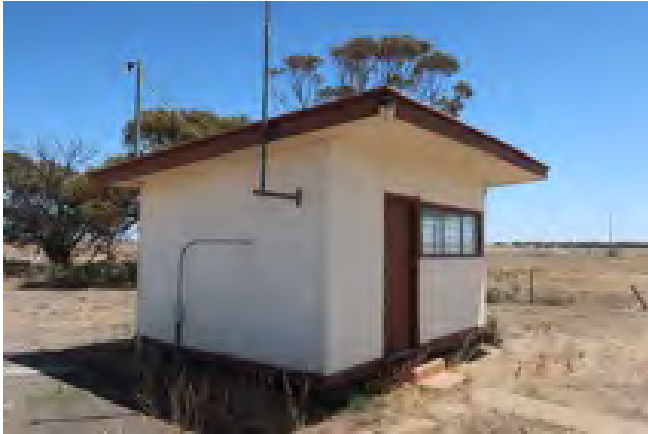
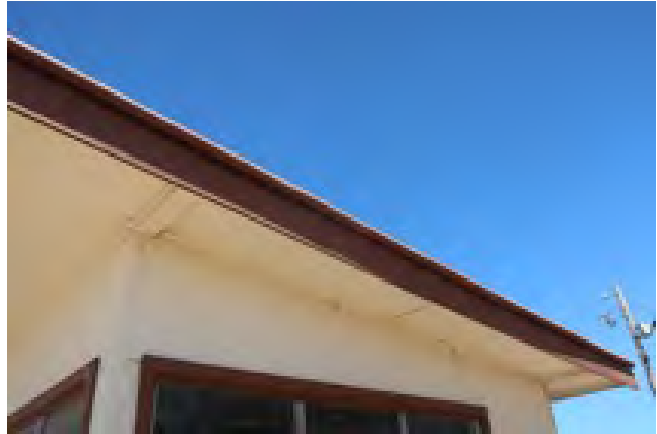
LB82 Aerodrome: entire perimeter of building. The Soffit (F C Sheeting) has Asbestos Containing Material (ACM) present.

RISK ASSESSMENT					
Type of Asbestos or Hazardous Material	No sample taken - Visual ID	Condition	GOOD	Likelihood of Damage	L (Low) – possible
		Activity	Moderate		
		Sealed	Yes	Friability	Bonded (non-friable)
		Labelled	Y	Exposure Risk	Low - Negligible or low risk
		Quantity

RISK CONTROL					
Priority	MEDIUM	Label Required	Yes	Re- Audit Date	27 Jan 2022
Action	No remedial action required, unless disturbed				
Recommendation	Maintain paint or sealant to ACM surfaces. Particular attention should be given to side edges, ensure paint/sealant covers ALL exposed ACM surfaces.				
Legislative Requirements Victorian Regulation 2007	Warning labels should be affixed. Avoid mechanical damage and abrasion. Remove if refurbishment, structural alteration or demolition is to be carried out in this area. Re-inspect every 12 months or earlier if disturbed or removed in accordance with the Victorian Regulation 2007. All remedial/removal repairs require a Clearance Inspection & Certificate to be recorded by an approved and competent assessor.

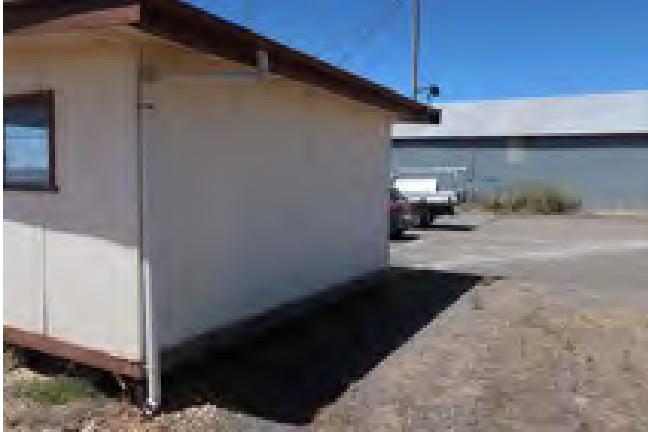
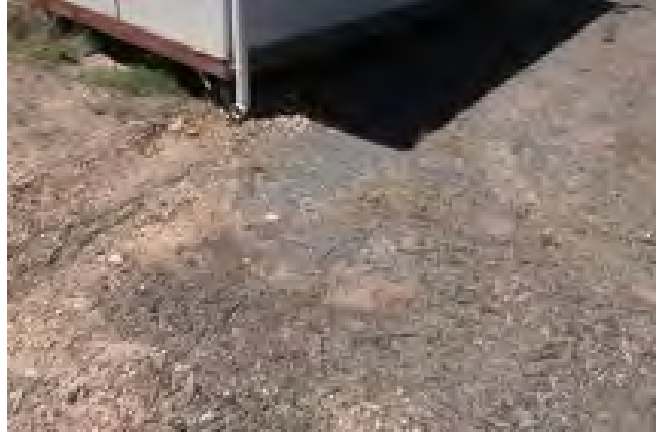
LB82 Aerodrome: rear of building. The Debris - Broken (Debris) has Asbestos Containing Material (ACM) present.

RISK ASSESSMENT					
Type of Asbestos or Hazardous Material	No sample taken - Visual ID	Condition	POOR	Likelihood of Damage	H (High) - almost certain
		Activity	Moderate		
		Sealed	No	Friability	Exposed Fibres
		Labelled	No	Exposure Risk	High - Short term exposure risk
		Quantity

RISK CONTROL					
Priority	IMMEDIATE	Label Required	Yes	Re- Audit Date	27 Jan 2022
Action	Restrict access and target for imminent removal				
Recommendation	Debris on Surface - The Debris requires immediate cleanup and disposal with specialised equipment and with licensed removalist to safely remove the asbestos debris.				
Legislative Requirements Victorian Regulation 2007	ACM debris visible. Recommend cleanup by licensed Asbestos Removalist. Warning labels should be affixed. Avoid mechanical damage and abrasion. Remove if refurbishment, structural alteration or demolition is to be carried out in this area. Re-inspect every 12 months or earlier if disturbed or removed in accordance with the Victorian Regulation 2007. All remedial/removal repairs require a Clearance Inspection & Certificate to be recorded by an approved and competent assessor.

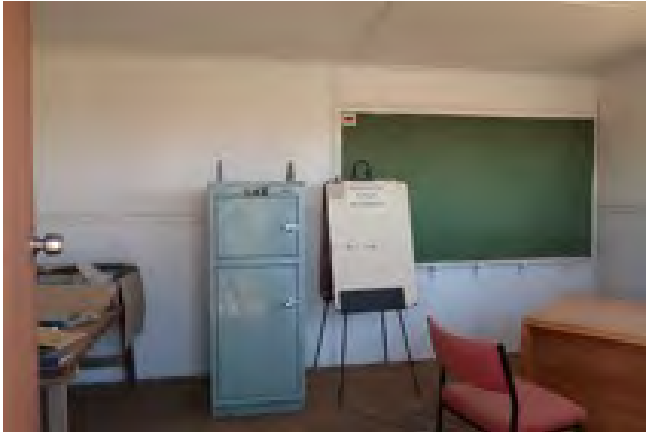
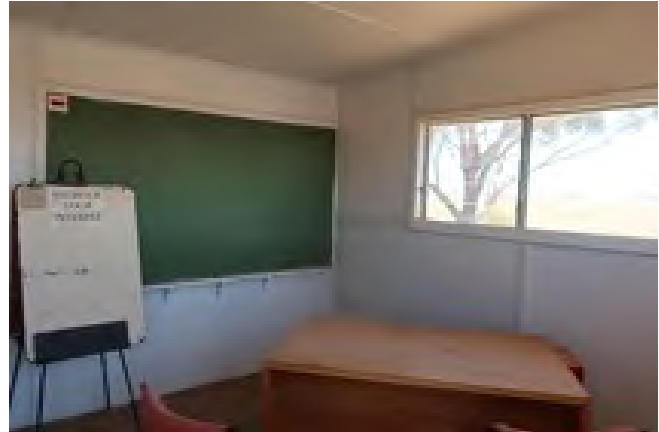
Area 3**LB82 Aerodrome: Office 1. The Walls and Ceiling (F C Sheeting) has Asbestos Containing Material (ACM) present.****RISK ASSESSMENT**

Type of Asbestos or Hazardous Material	No sample taken - Visual ID	Condition	AVERAGE	Likelihood of Damage	L (Low) – possible
		Activity	Moderate		
		Sealed	No	Friability	Bonded (non-friable)
		Labelled	Y	Exposure Risk	Medium - Moderate risk
		Quantity

Priority	HIGH	Label Required	Yes	Re- Audit Date	27 Jan 2022
Action	Remedial repairs required - seal raw material / edges				
Recommendation	Raw material sheeting - The area requires immediate remedial repairs. It is recommended the asbestos material be sealed with an approved membrane.				
Legislative Requirements Victorian Regulation 2007	<p>Damaged ACM visible in area. Requires IMMEDIATE ATTENTION. WARNING labels should be affixed. Avoid mechanical damage and abrasion. Remove if refurbishment, structural alteration or demolition is to be carried out in this area. Re-inspect every 12 months or earlier if disturbed or removed in accordance with the Victorian Regulation 2007.</p> <p>All remedial/removal repairs require a Clearance Inspection & Certificate to be recorded by an approved and competent assessor.</p>

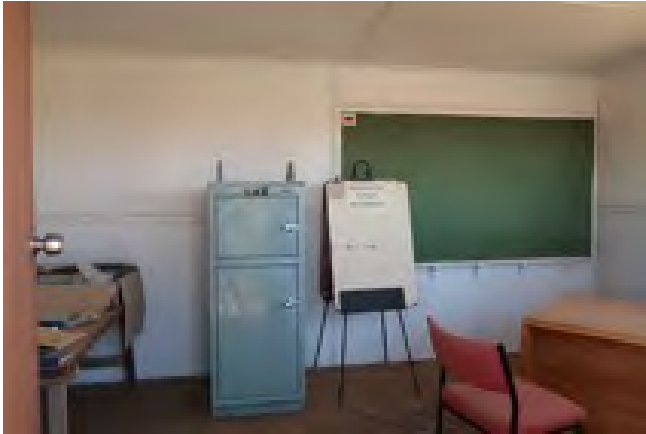
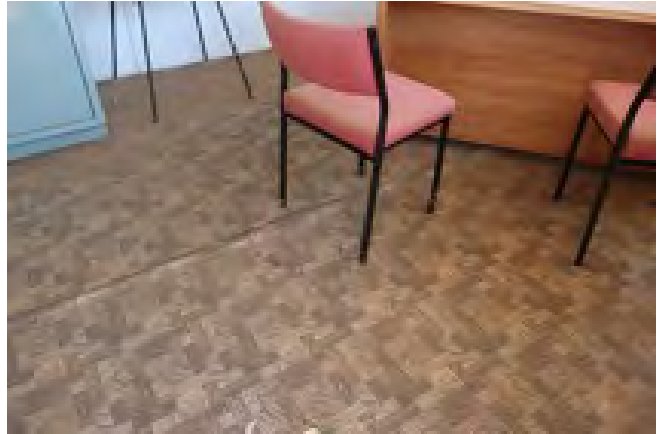
LB82 Aerodrome: Office 1. The Floor (Linoleum) has Asbestos Containing Material (ACM) present.

RISK ASSESSMENT					
Type of Asbestos or Hazardous Material	Chrysotile	Condition	POOR	Likelihood of Damage	L (Low) – possible
	Sample taken 62062-001	Activity	Moderate		
		Sealed	Yes	Friability	Friable
		Labelled	Y	Exposure Risk	High - Short term exposure risk
		Quantity

Damaged material

Damaged material - The damaged area requires immediate remedial repairs. It is recommended the asbestos sheeting be replaced.

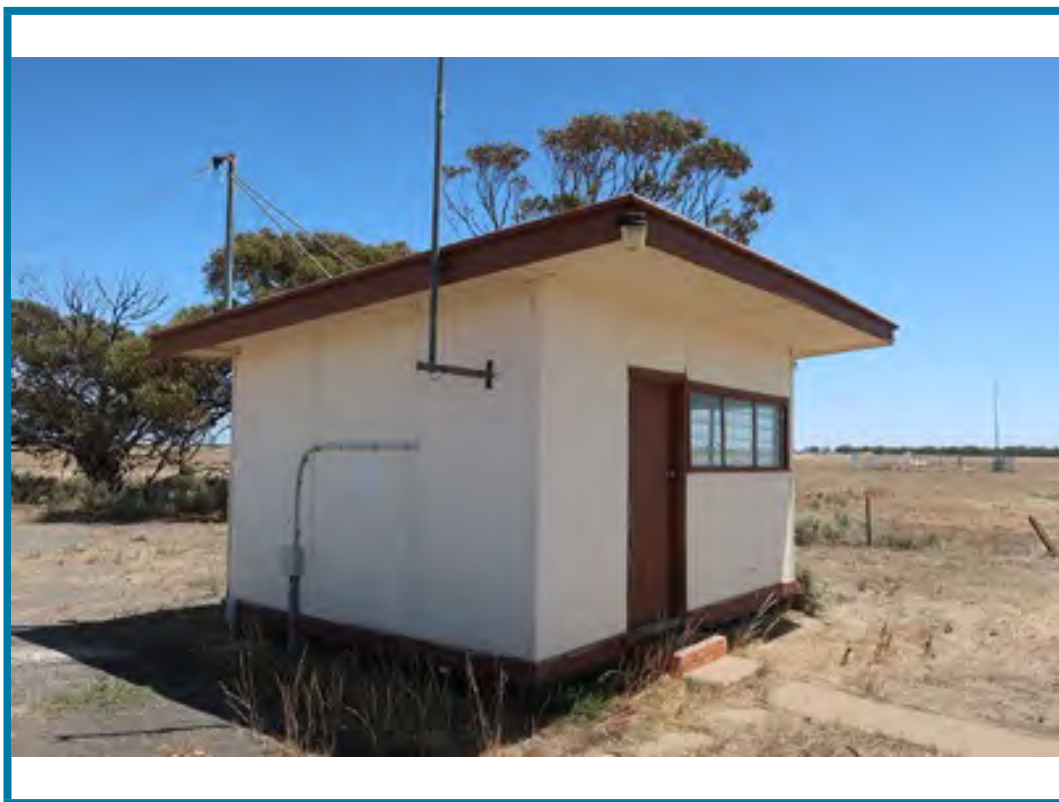
Location	Area	Component Materials	ACM Identified	Type Asbestos Assessment	Condition	Priority	Signage Required
LB82 Aerodrome - entire perimeter of building.	Walls	F C Sheeting	Yes	No sample taken - Visual ID	GOOD	MEDIUM	Yes
				Refer to the Abestos Register for more information.			
LB82 Aerodrome - entire perimeter of building.	Soffit	F C Sheeting	Yes	No sample taken - Visual ID	GOOD	MEDIUM	Yes
				Refer to the Abestos Register for more information.			
LB82 Aerodrome - rear of building.	Debris - Broken	Debris	Yes	No sample taken - Visual ID	POOR	IMMEDIATE	Yes
				Refer to the Abestos Register for more information.			
LB82 Aerodrome - Office 1.	Walls and Ceiling	F C Sheeting	Yes	No sample taken - Visual ID	AVERAGE	HIGH	Yes
				Refer to the Abestos Register for more information.			
LB82 Aerodrome - Office 1.	Electrical board	No Asbestos Materials	No	No sample taken - Visual ID
