# Asbestos Report

YARRIAMBIACK SHIRE COUNCIL

PROPERTY ADDRESS:  
LB58B BOWLING CLUB  
4 AUSTIN STREET AND 54 EVELYN STREET  
HOPETOUN VIC 3396

INSPECTION DATE: 27 JANUARY 2021  
REFERENCE NUMBER: 62063

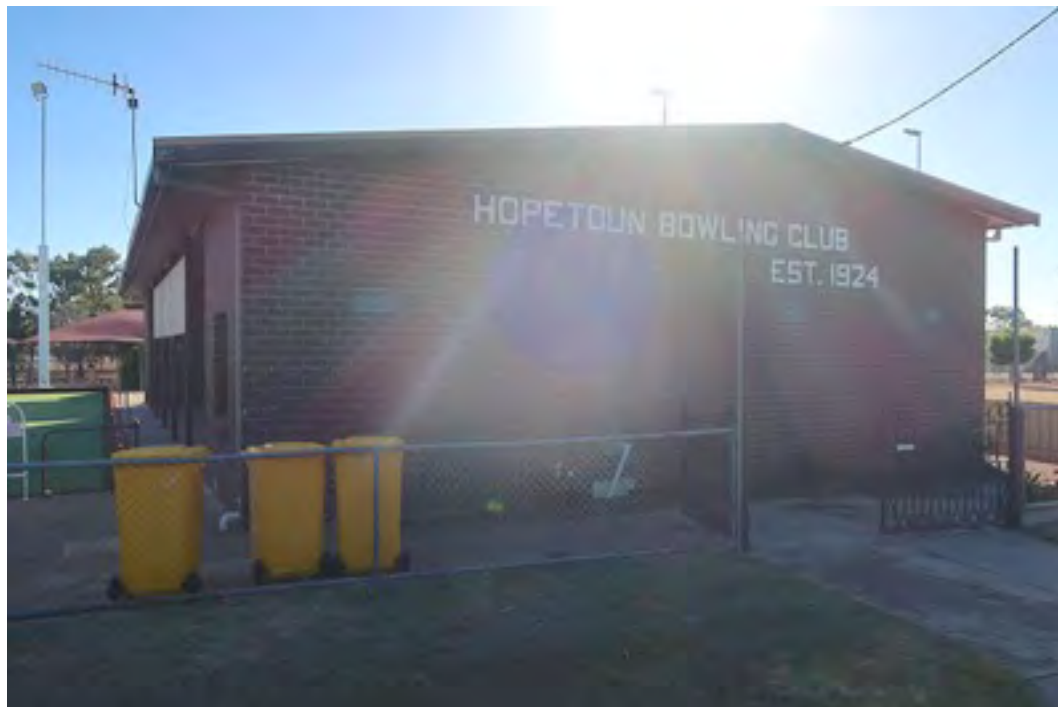
**Area 2**

RISK ASSESSMENT					
Type of Asbestos or Hazardous Material	No sample taken - Visual ID	Condition	AVERAGE	Likelihood of Damage	L (Low) – possible
		Activity	Moderate		
		Sealed	No	Friability	Bonded (non-friable)
		Labelled	Y	Exposure Risk	Medium - Moderate risk
		Quantity

RISK CONTROL					
Priority	HIGH	Label Required	Yes	Re- Audit Date	27 Jan 2022
Action	Remedial repairs required - seal raw material / edges				
Recommendation	Raw material sheeting - The area requires immediate remedial repairs. It is recommended the asbestos material be sealed with an approved membrane.				
Legislative Requirements Victorian Regulation 2007	Damaged ACM visible in area. Requires IMMEDIATE ATTENTION. WARNING labels should be affixed. Avoid mechanical damage and abrasion. Remove if refurbishment, structural alteration or demolition is to be carried out in this area. Re-inspect every 12 months or earlier if disturbed or removed in accordance with the Victorian OH&S Regulation 2017. All remedial/removal repairs require a Clearance Inspection & Certificate to be recorded by an approved and competent assessor.

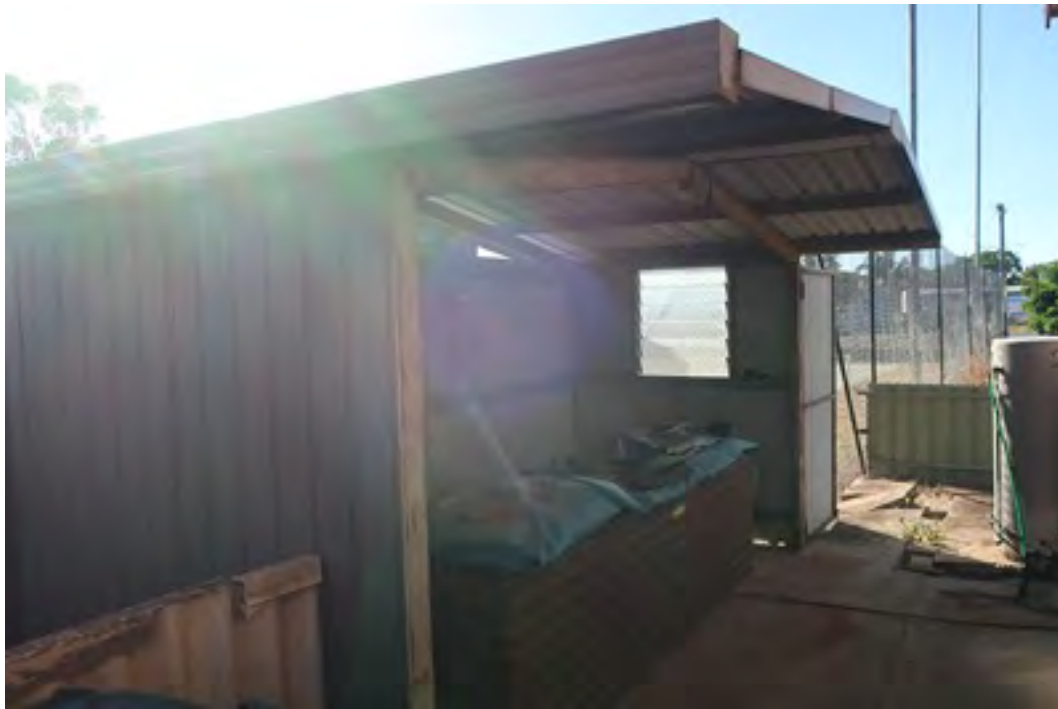
**Area 4**

RISK ASSESSMENT					
Type of Asbestos or Hazardous Material	No sample taken - Visual ID	Condition	AVERAGE	Likelihood of Damage	L (Low) – possible
		Activity	Moderate		
		Sealed	No	Friability	Bonded (non-friable)
		Labelled	Y	Exposure Risk	Medium - Moderate risk
		Quantity

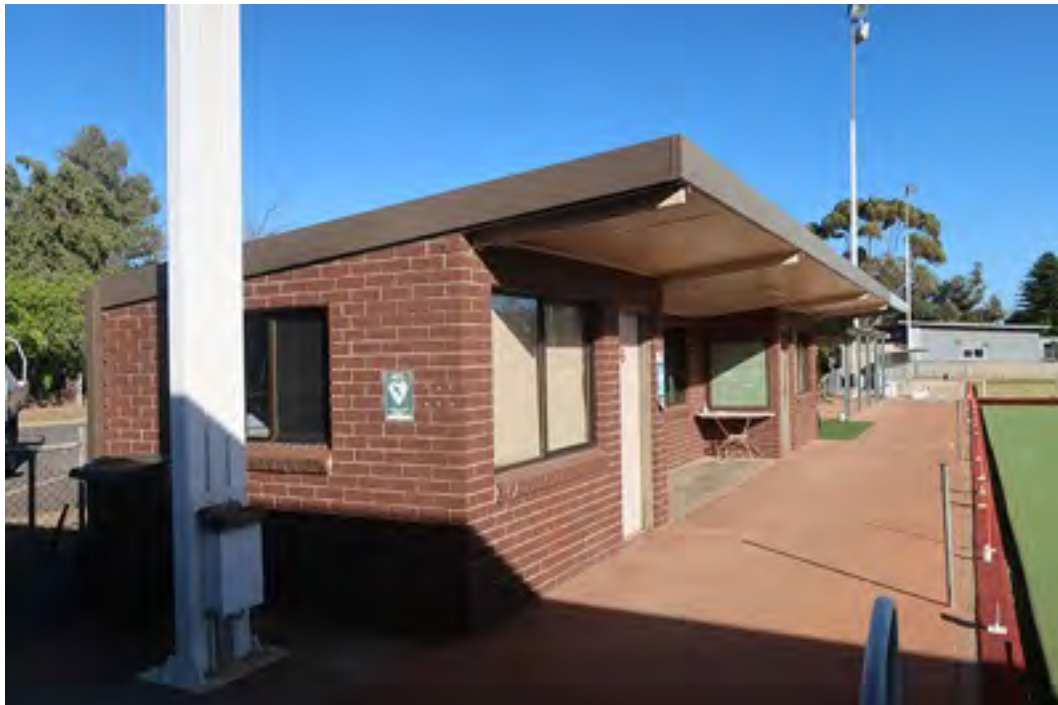
**Area 6**

RISK ASSESSMENT					
Type of Asbestos or Hazardous Material	No sample taken - Visual ID	Condition	GOOD	Likelihood of Damage	L (Low) – possible
		Activity	Moderate		
		Sealed	Yes	Friability	Bonded (non-friable)
		Labelled	Y	Exposure Risk	Low - Negligible or low risk
		Quantity

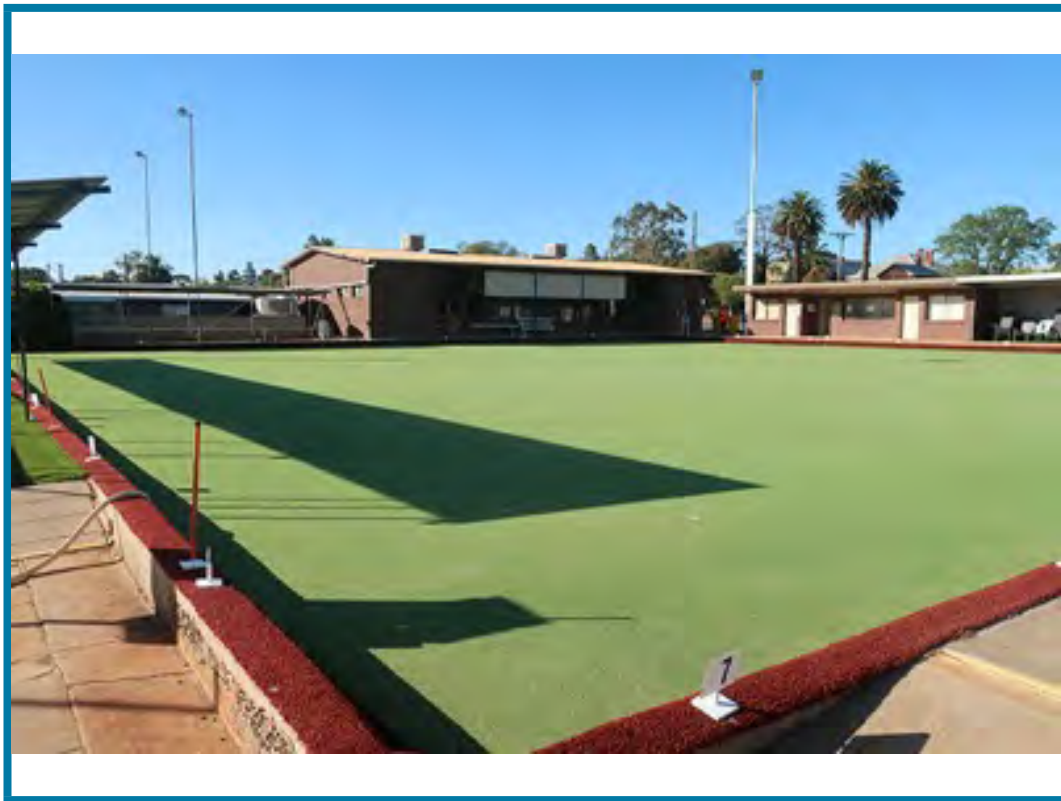
Location	Area	Component Materials	ACM Identified	Type Asbestos Assessment	Condition	Priority	Signage Required
Grounds - Various fencing.	Fence	Fibrous Cement Product	Yes	No sample taken - Visual ID

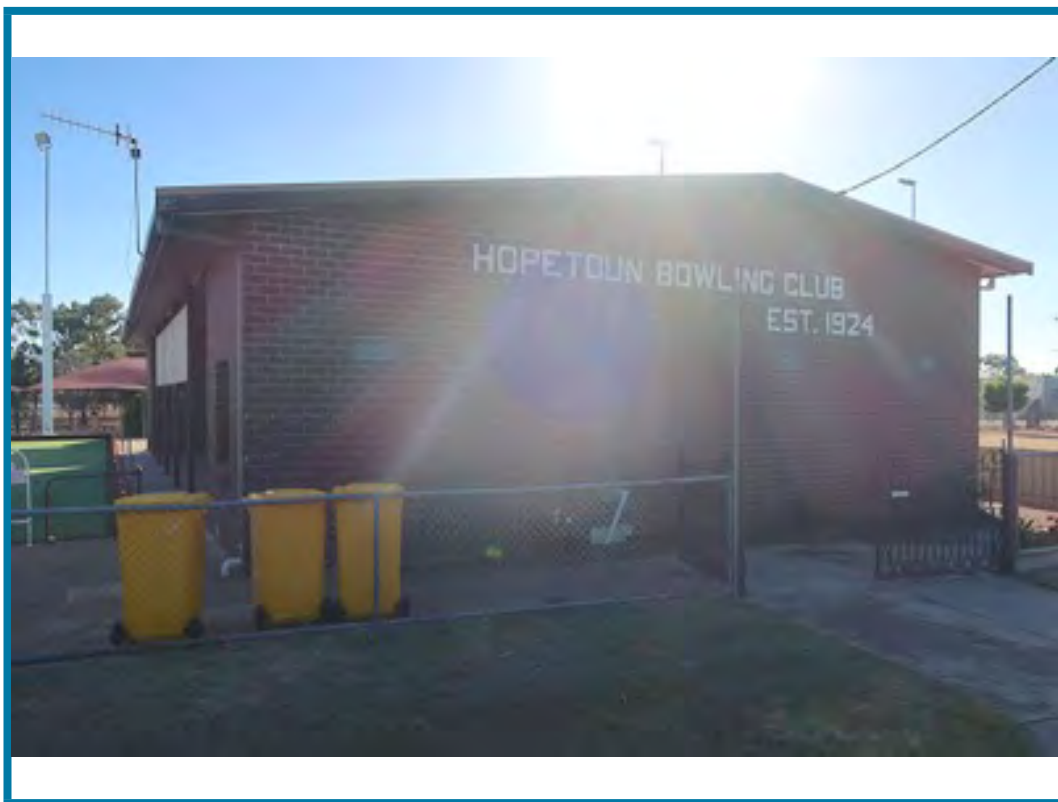
Location	Area	Component Materials	ACM Identified	Type Asbestos Assessment	Condition	Priority	Signage Required
Main building LB58B Bowling Club - front of building.	Debris - Broken	Debris	No	No Asbestos Detected			
				Sample taken	62063-001

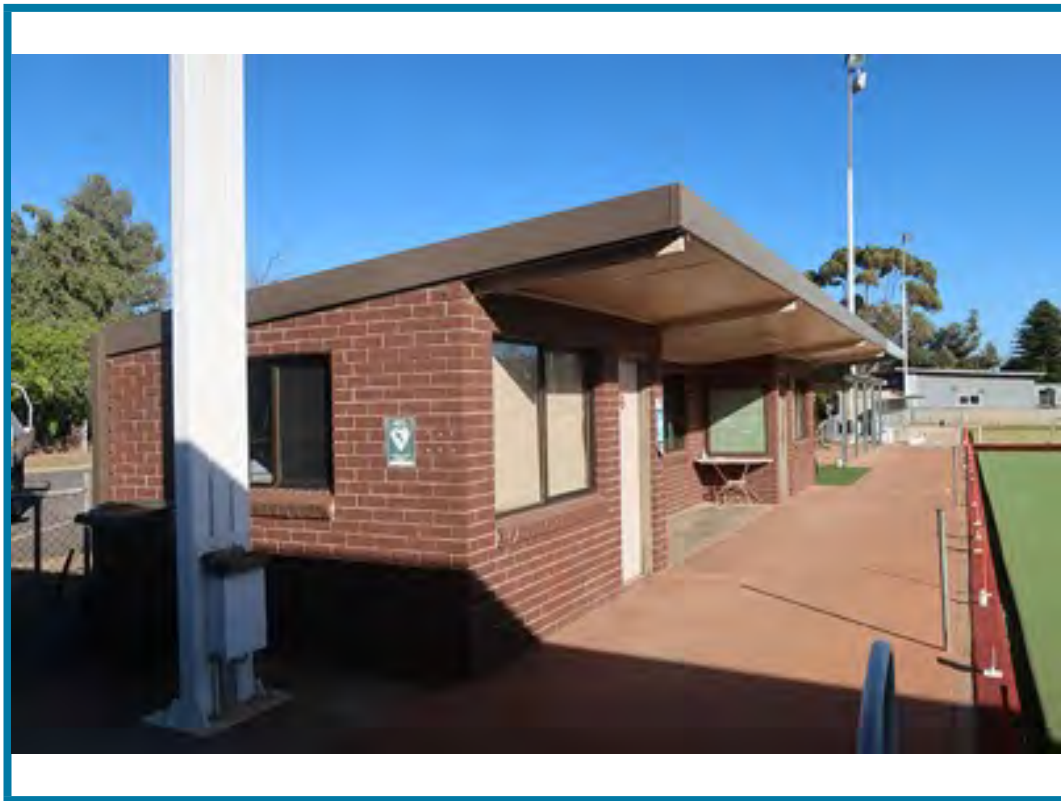
Location	Area	Component Materials	ACM Identified	Type Asbestos Assessment	Condition	Priority	Signage Required
Old club house - front of building.	Ceiling	F C Sheeting	Yes	No sample taken - Visual ID	GOOD	MEDIUM	Yes
				 		<p><b>Refer to the Asbestos Register for more information.</b></p>	
Old club house - Office 1.		No Asbestos Materials	No

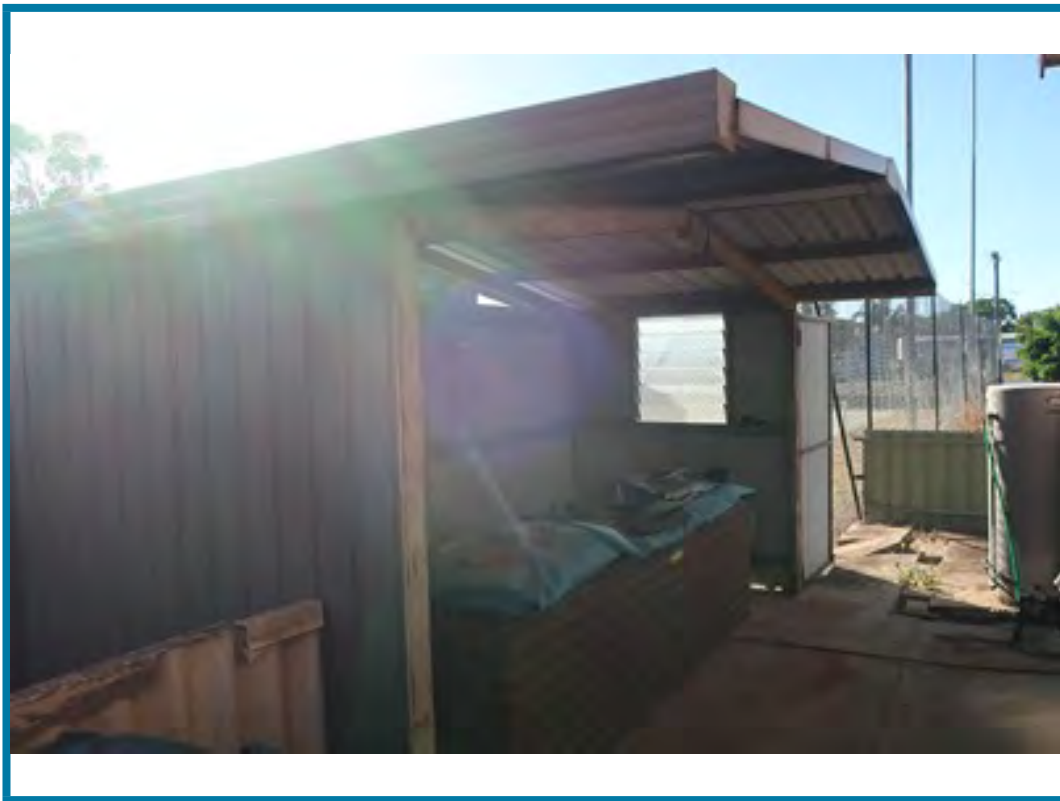
Location	Area	Component Materials	ACM Identified	Type Asbestos Assessment	ConditionPriority	Signage Required
Shed 1 - left side of building.	Fence	Fibrous Cement Product	Yes	No sample taken - Visual ID	AVERAGE HIGH	Yes
