Asbestos Report

YARRIAMBIACK SHIRE COUNCIL

PROPERTY ADDRESS:
LR33 CARAVAN PARK
6194 HENTY HIGHWAY
HOPETOUN VIC 3396

INSPECTION DATE: 27 JANUARY 2021
REFERENCE NUMBER: 62064

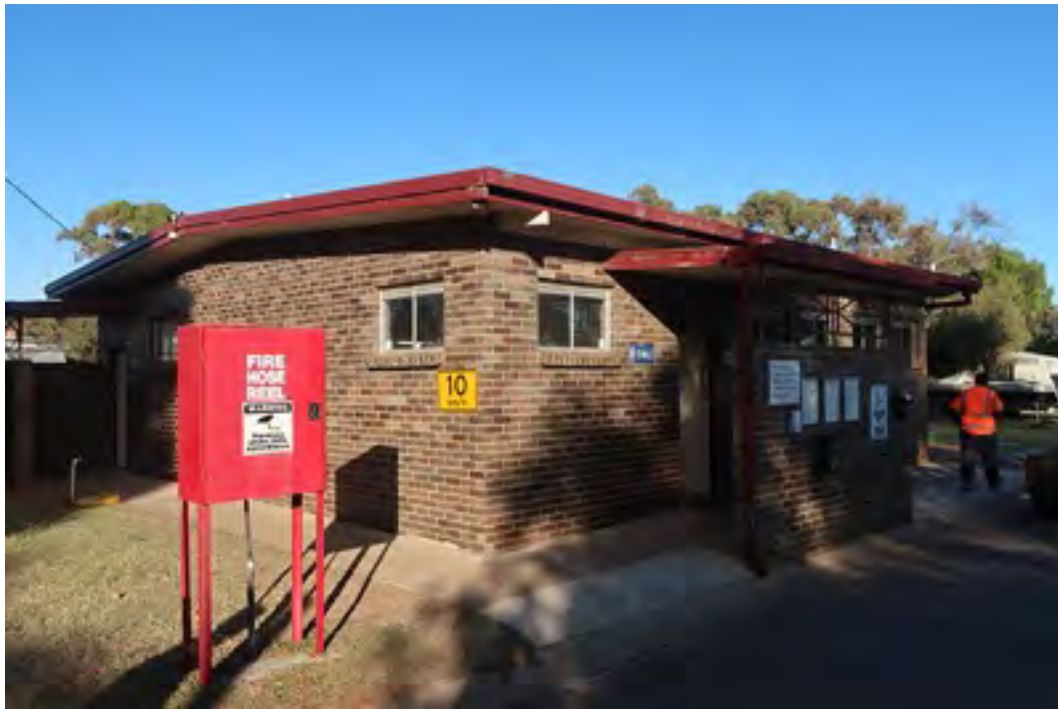
Area 2

Amenities Building LR33 Caravan Park: Service alley 1.1. The Debris - Broken (Debris) has Asbestos Containing Material (ACM) present.

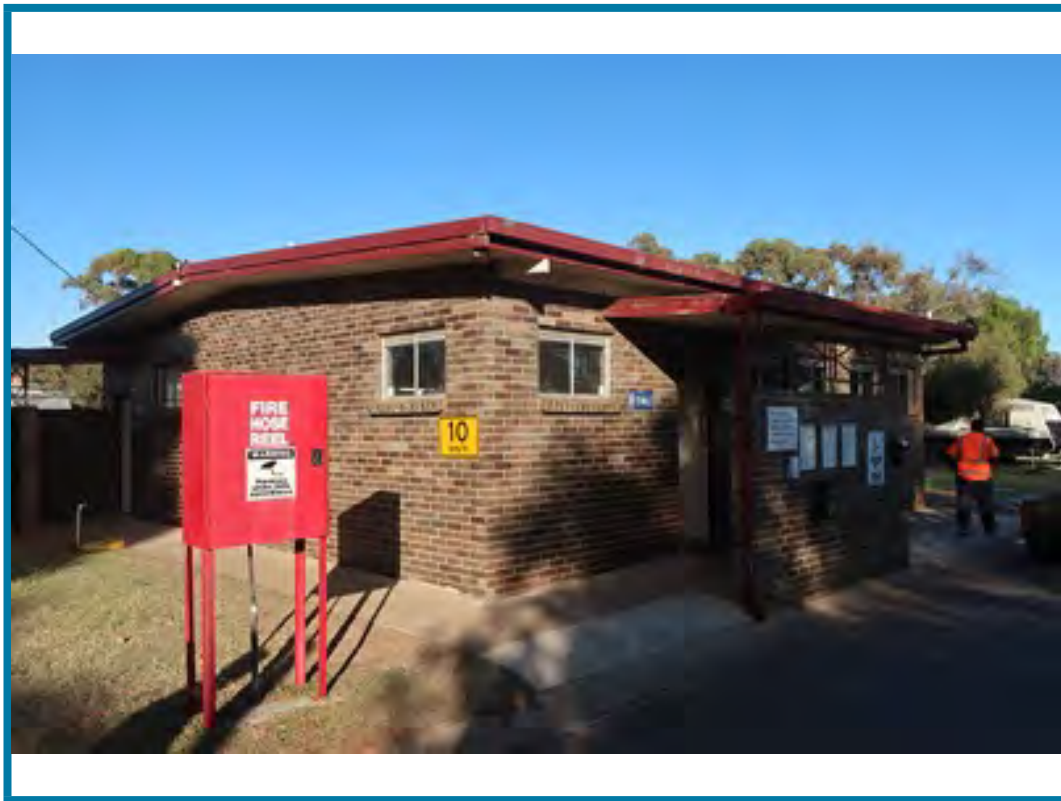
Location	Area	Component Materials	ACM Identified	Type Asbestos Assessment	Condition	Priority	Signage Required
Amenities Building LR33 Caravan Park - entire perimeter of building.	Soffits & Ceilings	F C Sheeting	Yes	Chrysotile	Same as Sample - 62064-002	GOOD MEDIUM	Yes
				Refer to the Abestos Register for more information.			
Amenities Building LR33 Caravan Park - Service room 1.		No Asbestos Materials	No	No sample taken - Visual ID

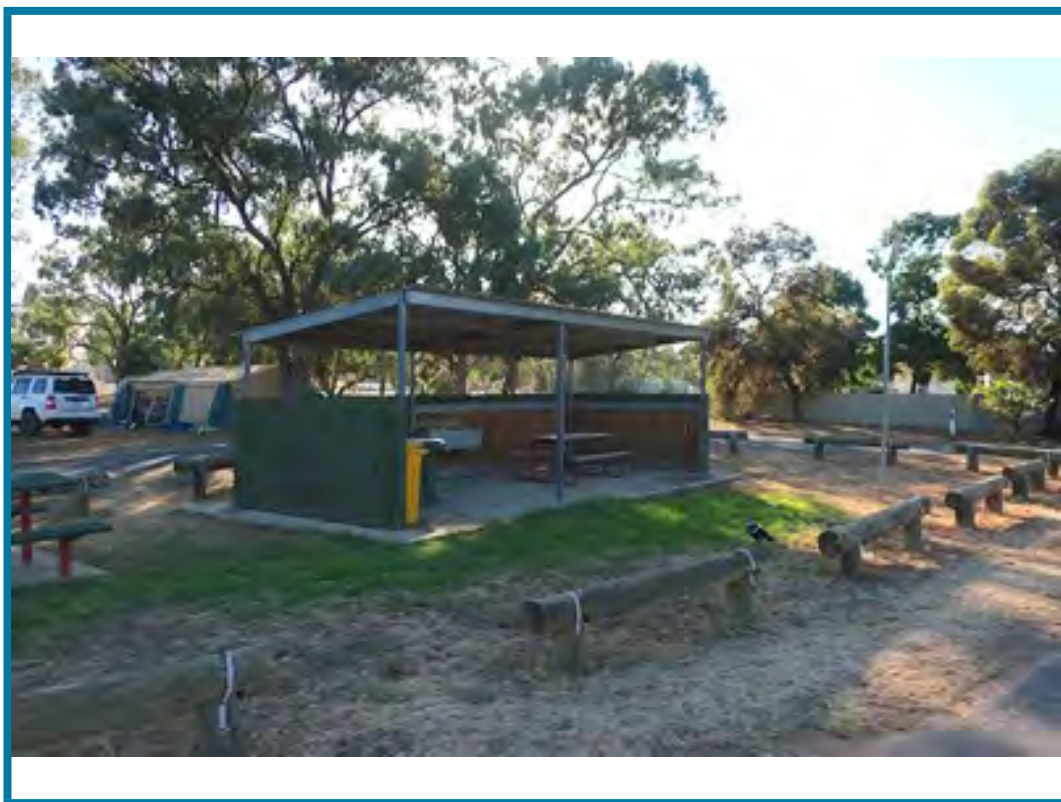
Location	Area	Component Materials	ACM Identified	Type Asbestos Assessment	Condition	Priority	Signage Required
Verandah - entire perimeter of building.		No Asbestos Materials	No	No sample taken - Visual ID
