Asbestos Report

YARRIAMBIACK SHIRE COUNCIL

PROPERTY ADDRESS:
LB86 CORRONG HOMESTEAD
EVELYN STREET
HOPETOUN VIC 3396

INSPECTION DATE: 27 JANUARY 2021
REFERENCE NUMBER: 62065

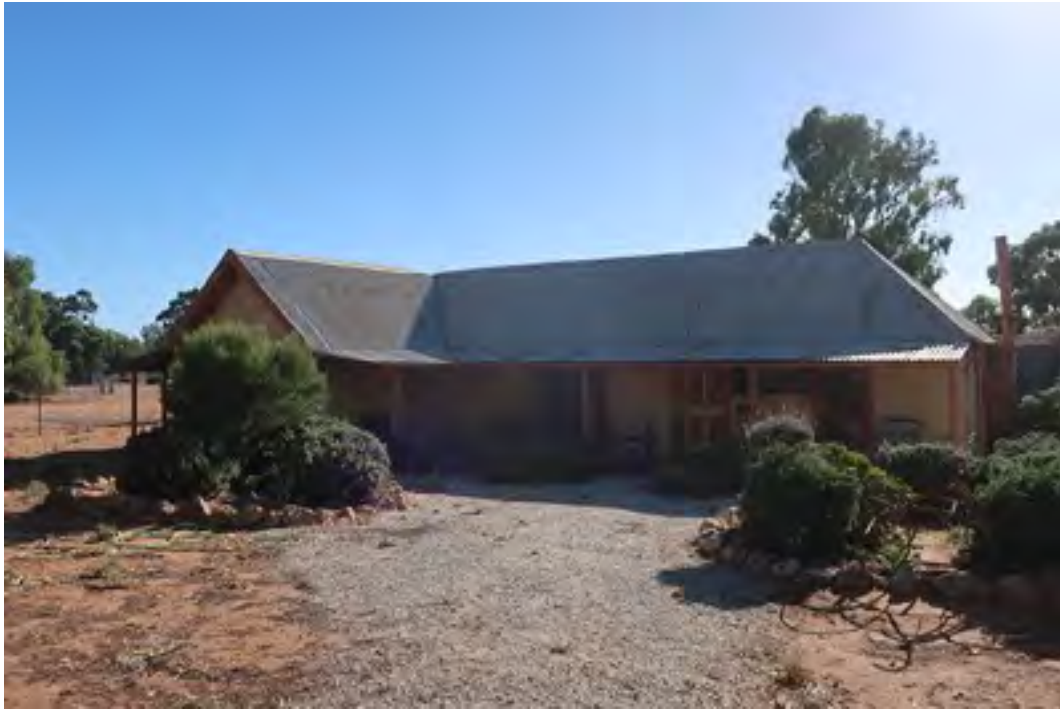
Area 1**LB86 Corrong Homestead: left side of building. The Debris - Broken (Debris) has Asbestos Containing Material (ACM) present.****RISK ASSESSMENT**

Type of Asbestos or Hazardous Material	Chrysotile Amosite Crocidolite Sample taken 62065-001	Condition	POOR	Likelihood of Damage	H (High) - almost certain
		Activity	Moderate		
		Sealed	No	Friability	Exposed Fibres
		Labelled	No	Exposure Risk	Medium - Moderate risk
		Quantity

Priority	IMMEDIATE	Label Required	Yes	Re- Audit Date	27 Jan 2022
Action	Restrict access and target for imminent removal				
Recommendation	Debris on Ground - The Debris requires immediate cleanup and disposal with specialized equipment and with licenced removalist to safely remove the asbestos debris.				
Legislative Requirements Victorian Regulation 2007	ACM debris visible. Recommend cleanup by licensed Asbestos Removalist. Warning labels should be affixed. Avoid mechanical damage and abrasion. Remove if refurbishment, structural alteration or demolition is to be carried out in this area. Re-inspect every 12 months or earlier if disturbed or removed in accordance with the Victorian OH&S Regulation 2017. All remedial/removal repairs require a Clearance Inspection & Certificate to be recorded by an approved and competent assessor.

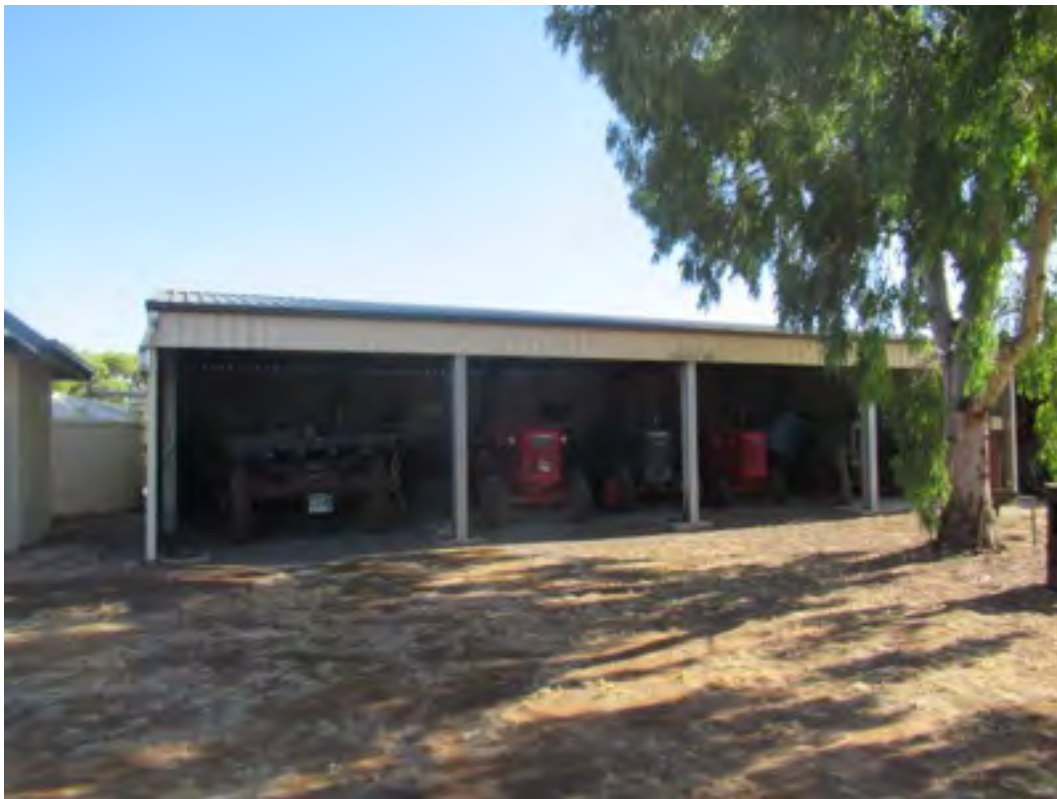
Area 3

Tractor shed: front of building. The Debris - Broken (Debris) has Asbestos Containing Material (ACM) present.

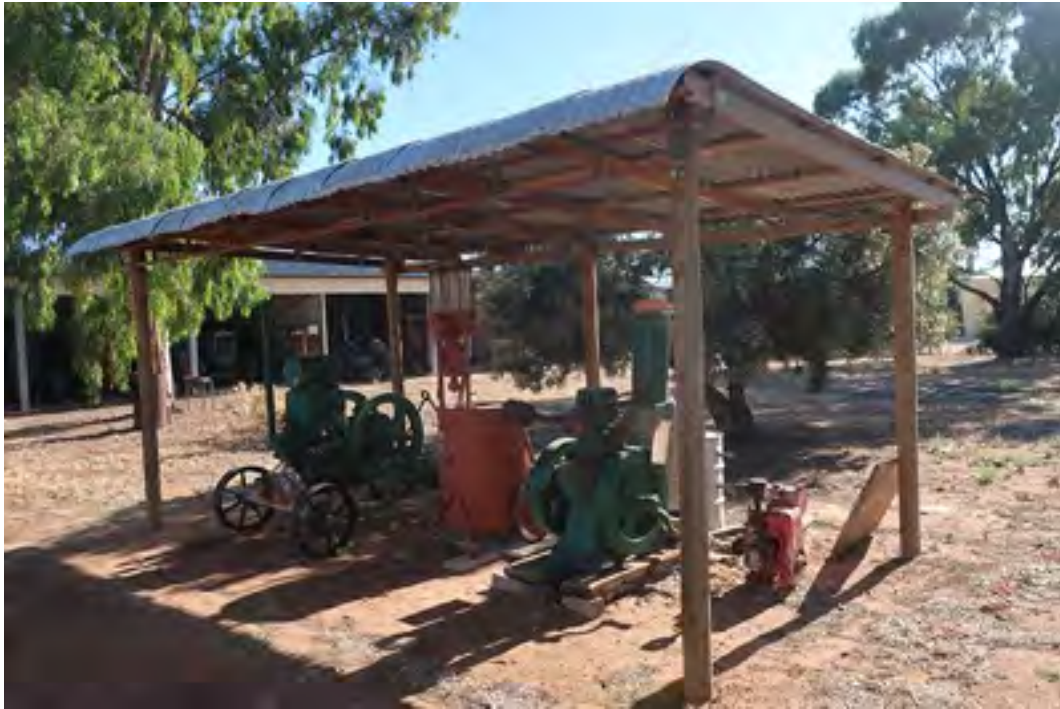
Area 5**Shelter: - Imperial engine 1. The Exhaust Gasket (Compound Material) has Asbestos Containing Material (ACM) present.****RISK ASSESSMENT**

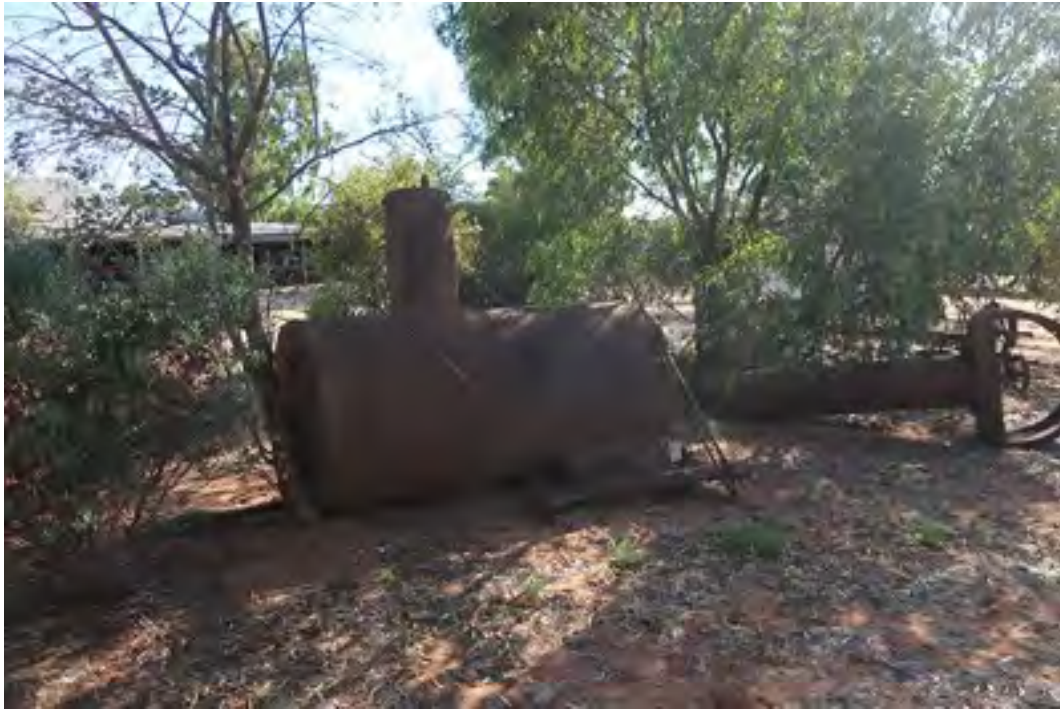
Area 4**Grounds: Fire stove. The Flue (Fibrous Cement Product) has Asbestos Containing Material (ACM) present.****RISK ASSESSMENT**

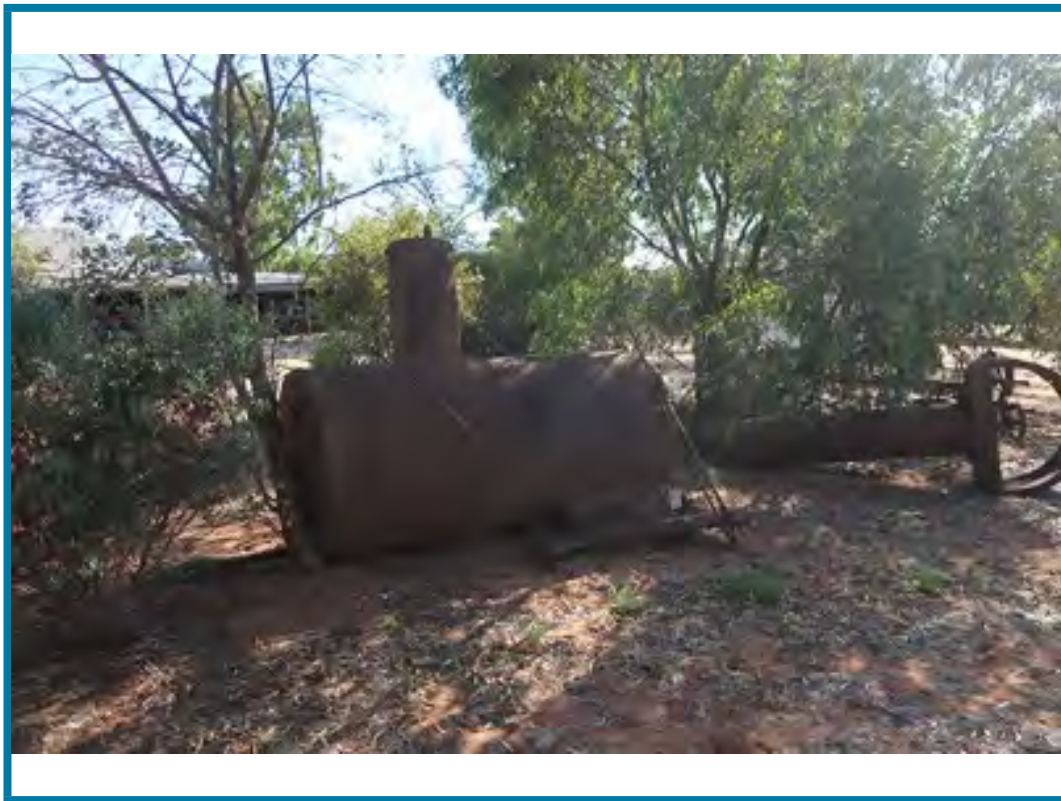
Location	Area	Component Materials	ACM Identified	Type Asbestos Assessment	ConditionPriority	Signage Required
Grounds - Boiler.	Lid - Gasket	Compound Material	No	No Asbestos Detected

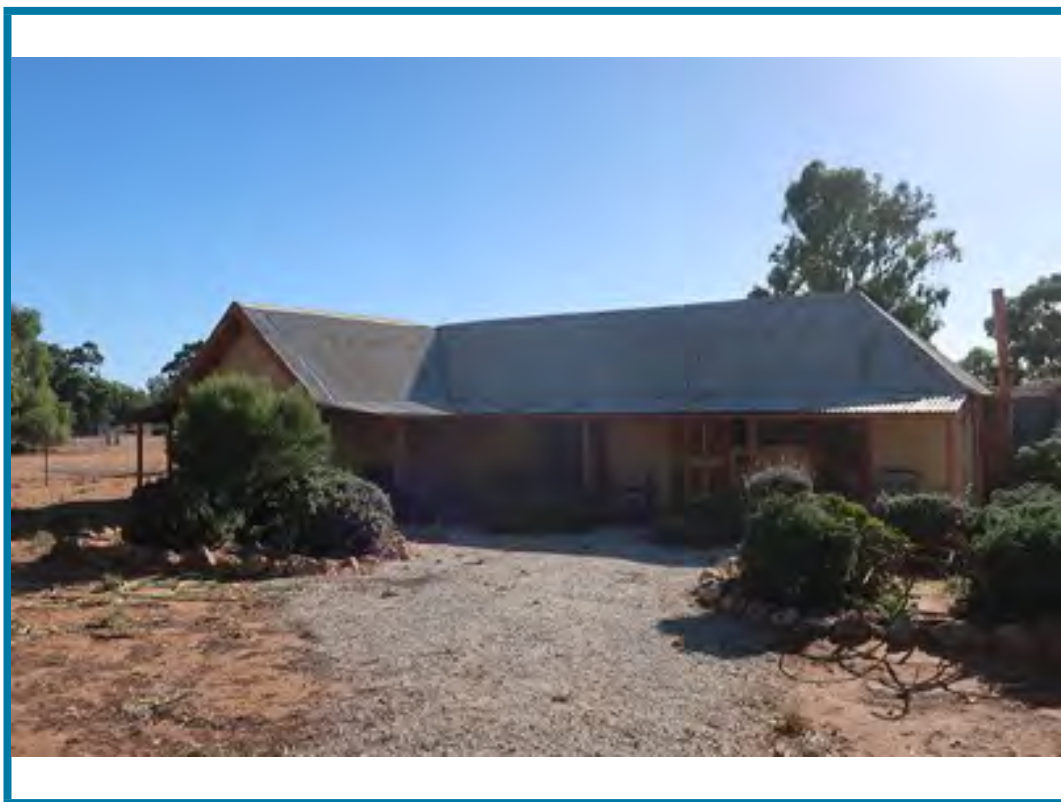
Location	Area	Component Materials	ACM Identified	Type Asbestos Assessment	Condition	Priority	Signage Required
LB86 Corrong Homestead - entire perimeter of building.		No Asbestos Materials	No	No sample taken - Visual ID

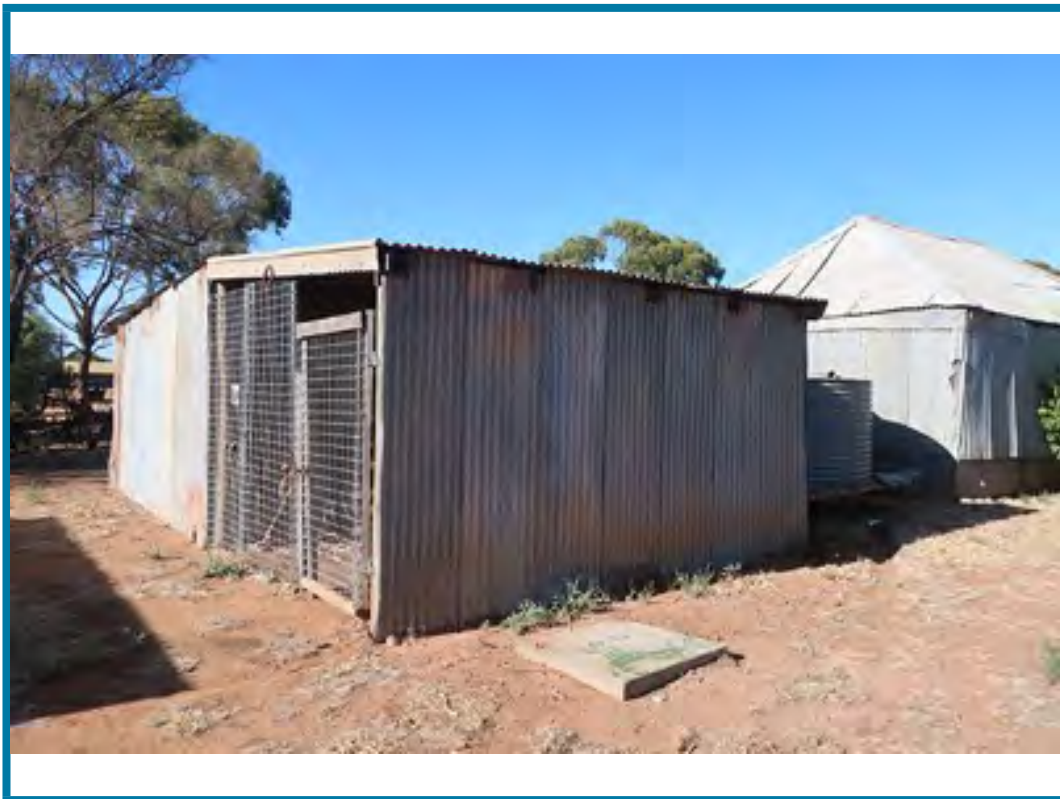
Location	Area	Component Materials	ACM Identified	Type Asbestos Assessment	ConditionPriority	Signage Required
Shed - entire perimeter of building.		No Asbestos Materials	No	No sample taken - Visual ID

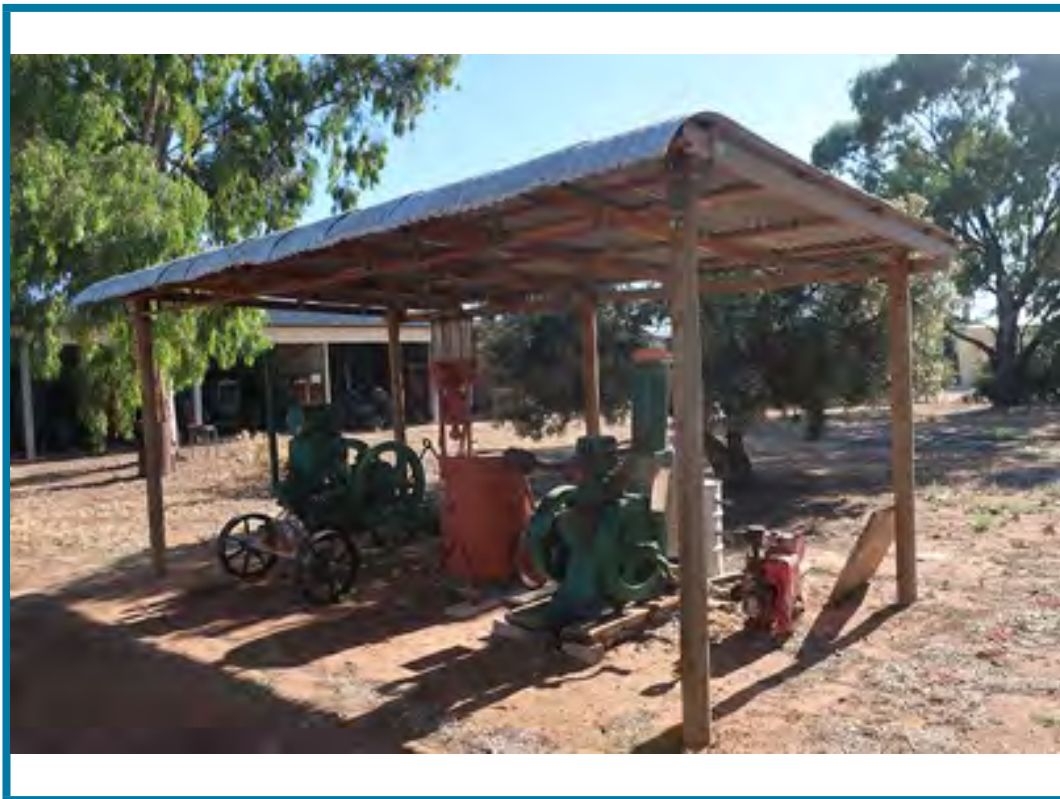
Location	Area	Component Materials	ACM Identified	Type Asbestos Assessment	Condition Priority	Signage Required
Shelter - Shelter - Imperial engine 1.	Exhaust Gasket	Compound Material	Yes	Chrysotile	Sample taken 62065-002 AVERAGE HIGH	Yes

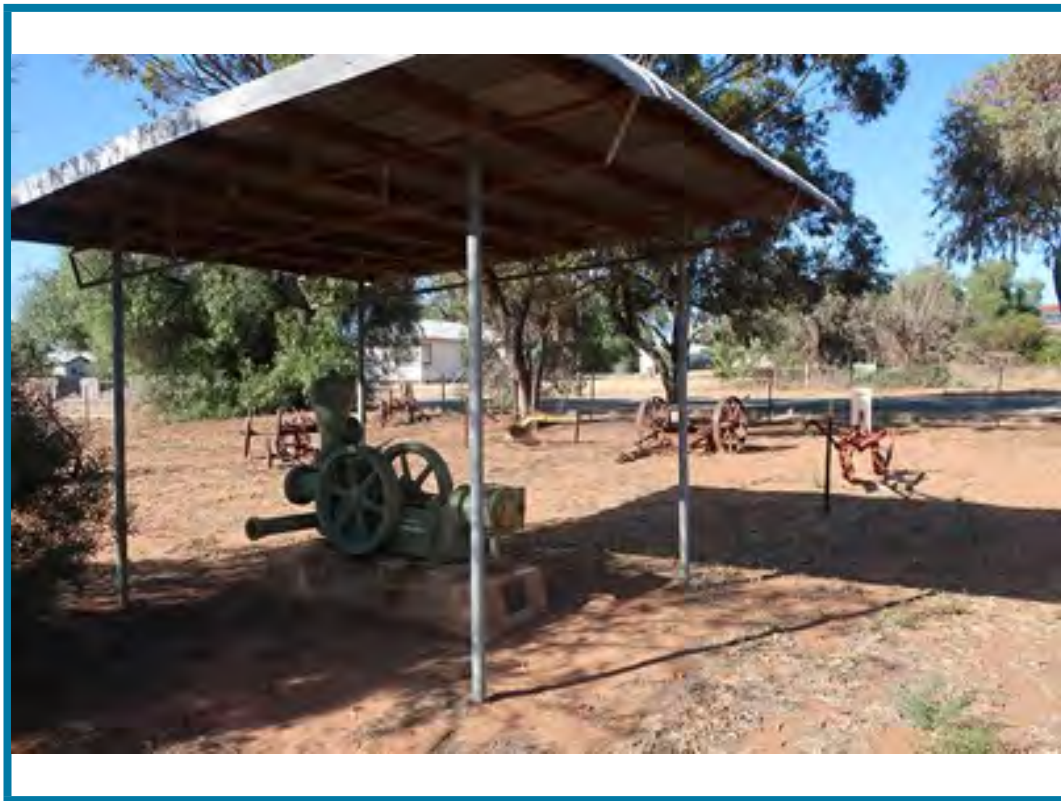
Location	Area	Component Materials	ACM Identified	Type Asbestos Assessment	ConditionPriority	Signage Required
Shelter 2 - Tangyes Birmingham - pump.	Gasket	Compound material	No	No Asbestos Detected		
				Sample taken	62065-006

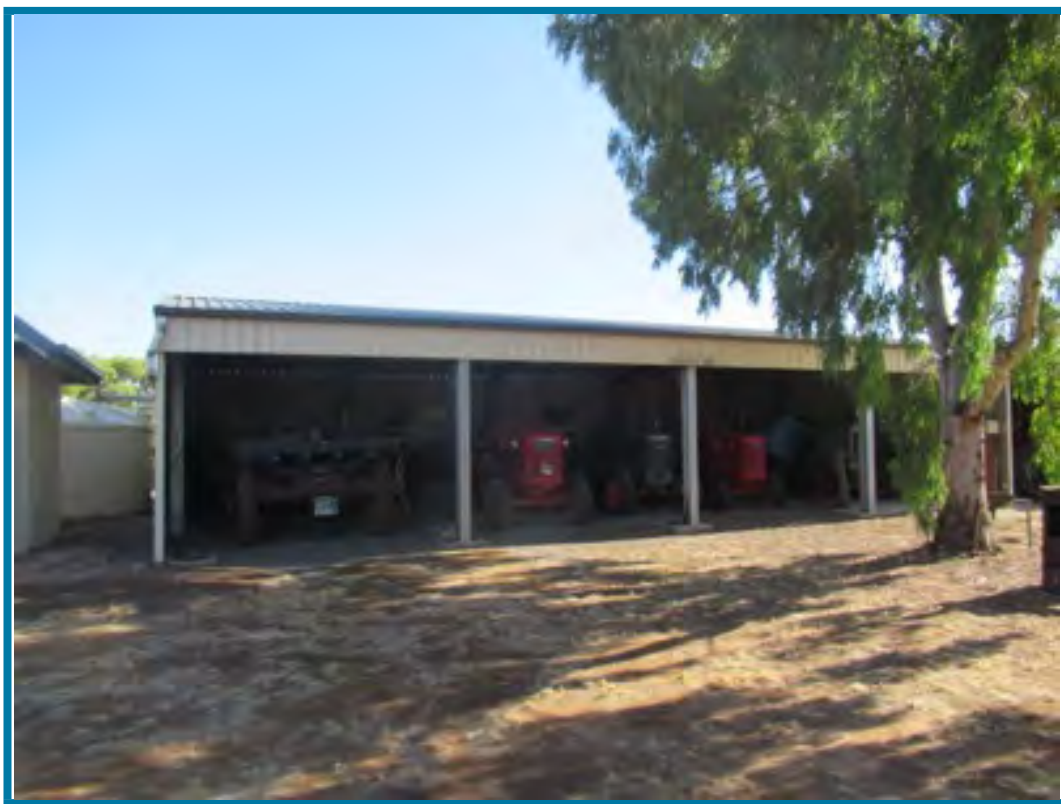
Location	Area	Component Materials	ACM Identified	Type Asbestos Assessment	Condition	Priority	Signage Required
Tractor shed - front of building.	Debris - Broken	Debris	Yes	No sample taken - Visual ID			
							POOR IMMEDIATE Yes
	 	 	 	Refer to the Abestos Register for more information.			
Tractor shed - Shed - McCormick International.	Gasket	Compound material	No	No Asbestos Detected			
				Sample taken 62065-004
