**Global
Asbestos
Audits**

Asbestos Report

YARRIAMBIACK SHIRE COUNCIL

PROPERTY ADDRESS:
LB72 DEPOT
92 CUMMING STREET
HOPETOUN VIC 3396

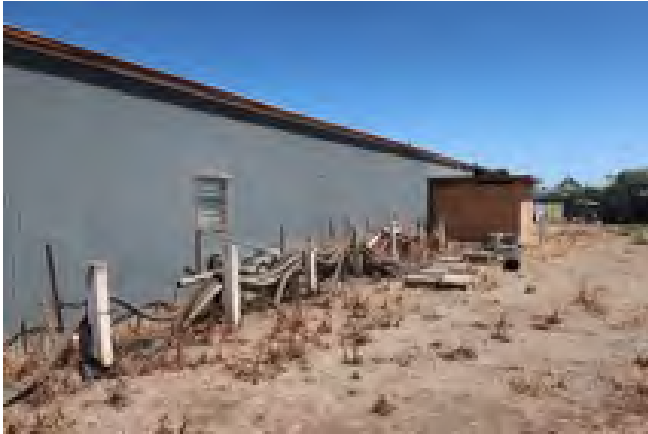
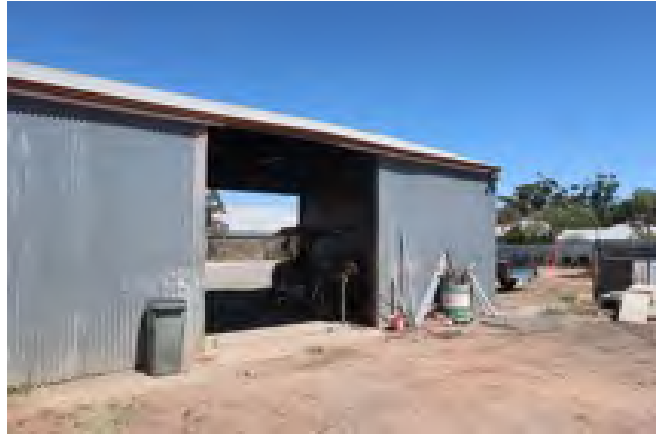
Area 1

LB72 Depot: rear of building. The Debris - Broken (Debris) has Asbestos Containing Material (ACM) present.

RISK ASSESSMENT					
Type of Asbestos or Hazardous Material	No sample taken - Visual ID	Condition	POOR	Likelihood of Damage	H (High) - almost certain
		Activity	Moderate		
		Sealed	No	Friability	Exposed Fibres
		Labelled	No	Exposure Risk	Medium - Moderate risk
		Quantity

RISK CONTROL					
Priority	IMMEDIATE	Label Required	Yes	Re- Audit Date	27 Jan 2022
Action	Restrict access and target for imminent removal				
Recommendation	Debris on Surface - The Debris requires immediate cleanup and disposal with specialised equipment and with licensed removalist to safely remove the asbestos debris.				
Legislative Requirements Victorian Regulation 2007	ACM debris visible. Recommend cleanup by licensed Asbestos Removalist. Warning labels should be affixed. Avoid mechanical damage and abrasion. Remove if refurbishment, structural alteration or demolition is to be carried out in this area. Re-inspect every 12 months or earlier if disturbed or removed in accordance with the Victorian OH&S Regulation 2017. All remedial/removal repairs require a Clearance Inspection & Certificate to be recorded by an approved and competent assessor.

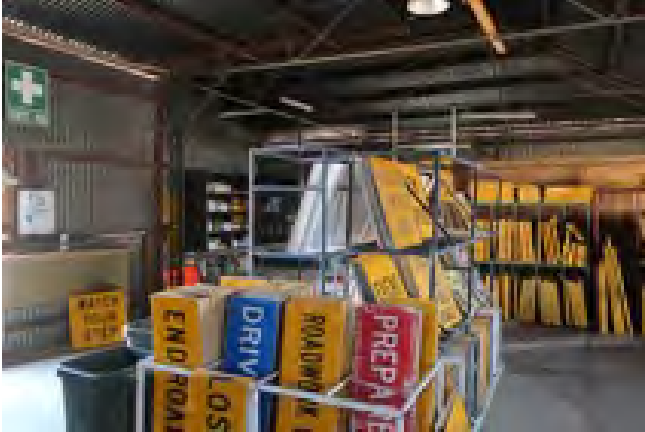
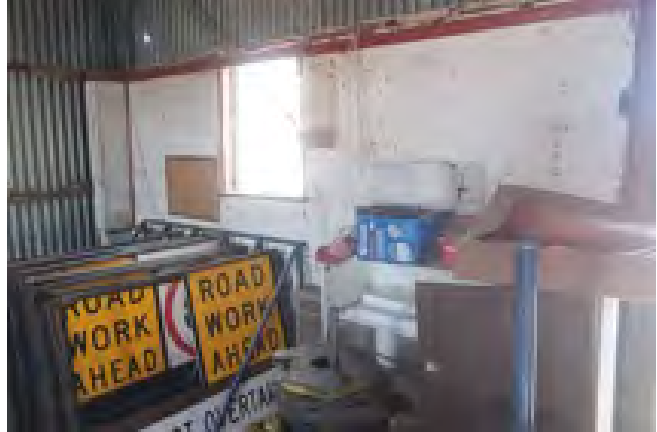
Area 3**LB72 Depot: Sign room 3. The Wall - Lower Panel (F C Sheeting) has Asbestos Containing Material (ACM) present.****RISK ASSESSMENT**

Type of Asbestos or Hazardous Material	Chrysotile	Condition	GOOD	Likelihood of Damage	L (Low) – possible
	Sample taken 62066-002	Activity	Moderate		
		Sealed	Yes	Friability	Bonded (non-friable)
		Labelled	Y	Exposure Risk	Low - Negligible or low risk
		Quantity

Priority	MEDIUM	Label Required	Yes	Re- Audit Date	27 Jan 2022
Action	No remedial action required, unless disturbed				
Recommendation	Maintain paint or sealant to ACM surfaces. Particular attention should be given to side edges, ensure paint/sealant covers ALL exposed ACM surfaces.				
Legislative Requirements Victorian Regulation 2007	Warning labels should be affixed. Avoid mechanical damage and abrasion. Remove if refurbishment, structural alteration or demolition is to be carried out in this area. Re-inspect every 12 months or earlier if disturbed or removed in accordance with the Victorian OH&S Regulation 2017. All remedial/removal repairs require a Clearance Inspection & Certificate to be recorded by an approved and competent assessor.

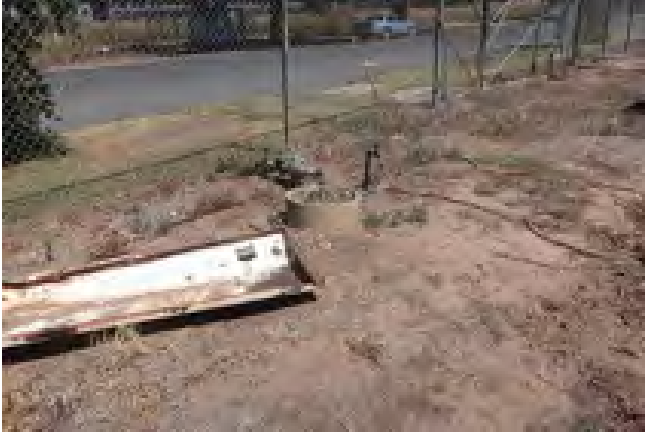
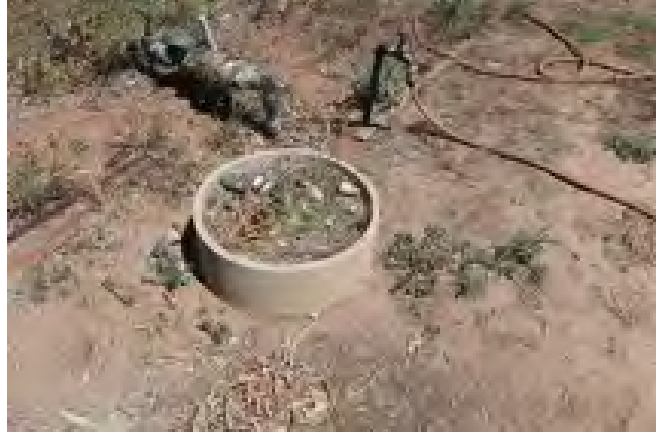
The pipes are being used as garden beds, the likelihood of damage and soil contamination is very high - recommend to remove.

Area 2**Yard: Yard. The Pipe(s) (Garden beds (unusable)) has Asbestos Containing Material (ACM) present.****RISK ASSESSMENT**

Type of Asbestos or Hazardous Material	Chrysotile	Condition	POOR	Likelihood of Damage	VH (Very High) – most likely
	Amosite	Activity	Low		
	Sample taken 62066-005	Sealed	No	Friability	Exposed Fibres
		Labelled	Y	Exposure Risk	Medium - Moderate risk
		Quantity

Priority	HIGH	Label Required	Yes	Re- Audit Date	27 Jan 2022
Action	Remove during normal maintenance or refurbishment				
Recommendation	The pipes are being used as garden beds, the likelihood of damage and soil contamination is very high - recommend to remove. Debris on Surface - The Debris requires immediate cleanup and disposal with specialised equipment and with licensed removalist to safely remove the asbestos debris.				
Legislative Requirements Victorian Regulation 2007	ACM debris visible. Recommend cleanup by licensed Asbestos Removalist. Warning labels should be affixed. Avoid mechanical damage and abrasion. Remove if refurbishment, structural alteration or demolition is to be carried out in this area. Re-inspect every 12 months or earlier if disturbed or removed in accordance with the Victorian OH&S Regulation 2017. All remedial/removal repairs require a Clearance Inspection & Certificate to be recorded by an approved and competent assessor.

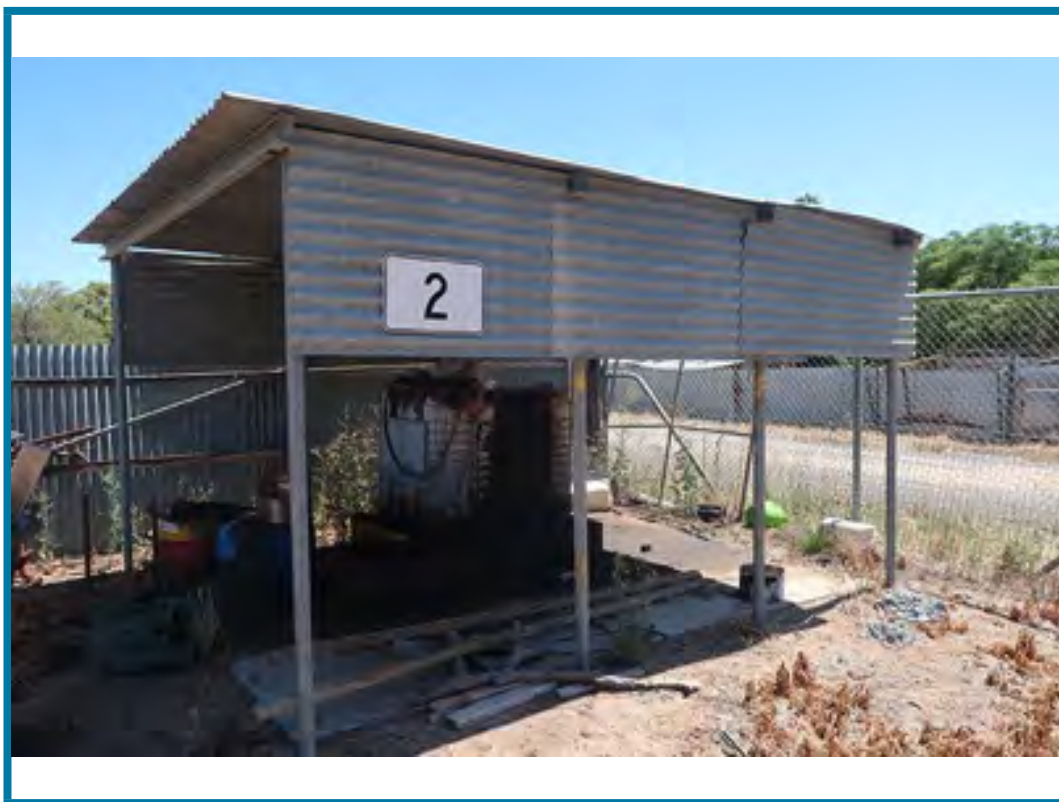
Location	Area	Component Materials	ACM Identified	Type Asbestos Assessment	Condition	Priority	Signage Required
2 - Oil Shed - Shed.		No Asbestos Materials	No	No sample taken - Visual ID

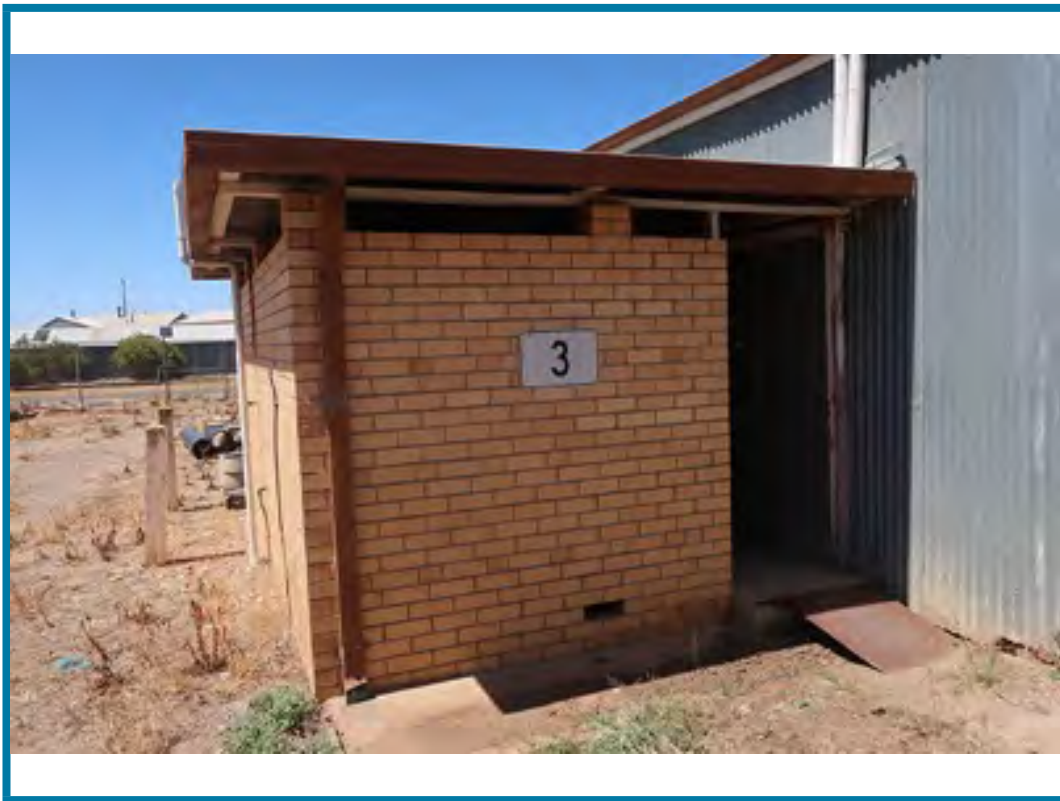
Location	Area	Component Materials	ACM Identified	Type Asbestos Assessment	ConditionPriority	Signage Required
3 - Toilet - Bathroom 1.		No Asbestos Materials	No	No sample taken - Visual ID

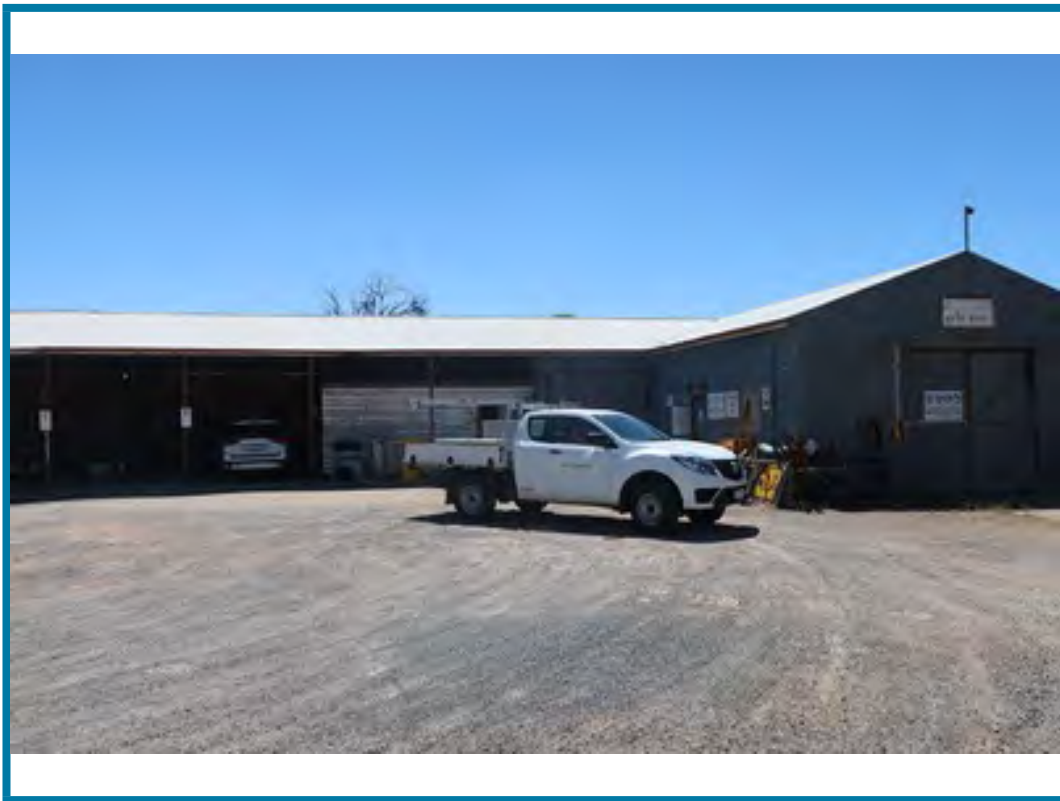
Location	Area	Component Materials	ACM Identified	Type Asbestos Assessment	ConditionPriority	Signage Required
LB72 Depot - front of building.	Electrical board	No Asbestos Materials	No	No sample taken - Visual ID

LB72 Depot - rear of building.	Debris - Broken	Debris	Yes	No sample taken - Visual ID		
--------------------------------	-----------------	--------	-----	-----------------------------	--	--

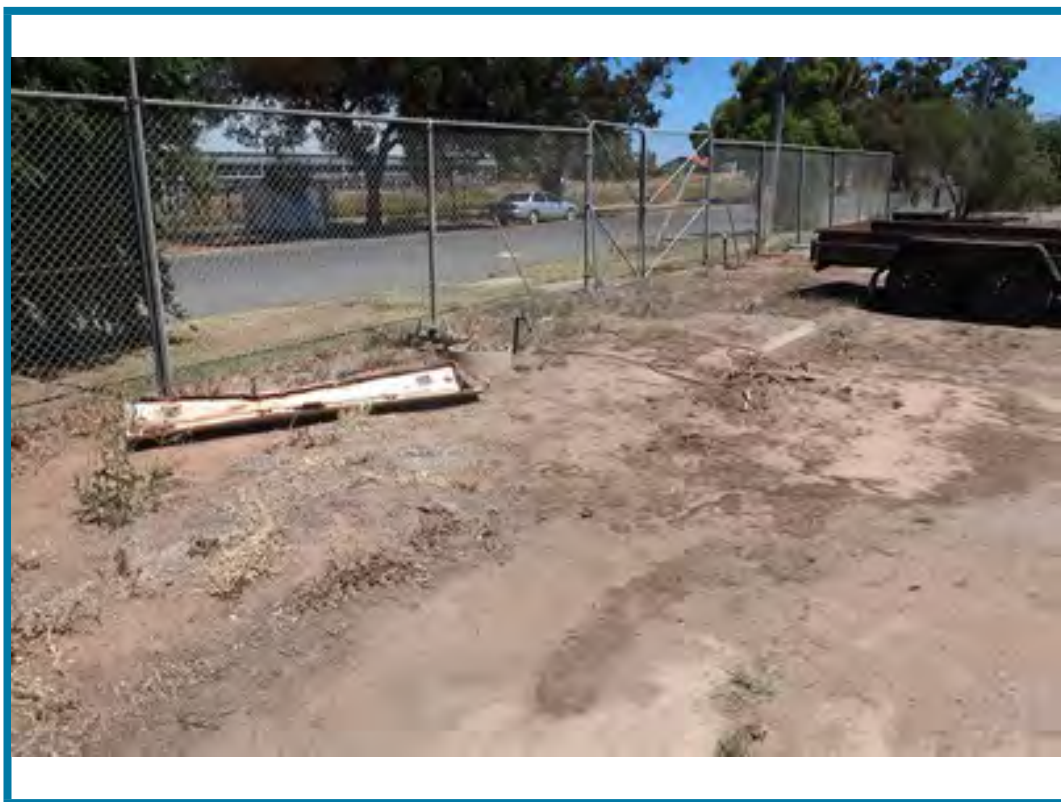
Location	Area	Component Materials	ACM Identified	Type Asbestos Assessment	ConditionPriority	Signage Required
Yard - Yard.	Pipe(s)	Garden beds (unusable)	Yes	Chrysotile Amosite
