# Asbestos Report

**YARRIAMBIACK SHIRE COUNCIL**

**PROPERTY ADDRESS:  
HOPETOUN CFA SHED  
62 LASCELLES STREET  
HOPETOUN VIC 3396**

**INSPECTION DATE: 27 JANUARY 2021  
REFERENCE NUMBER: 62069**

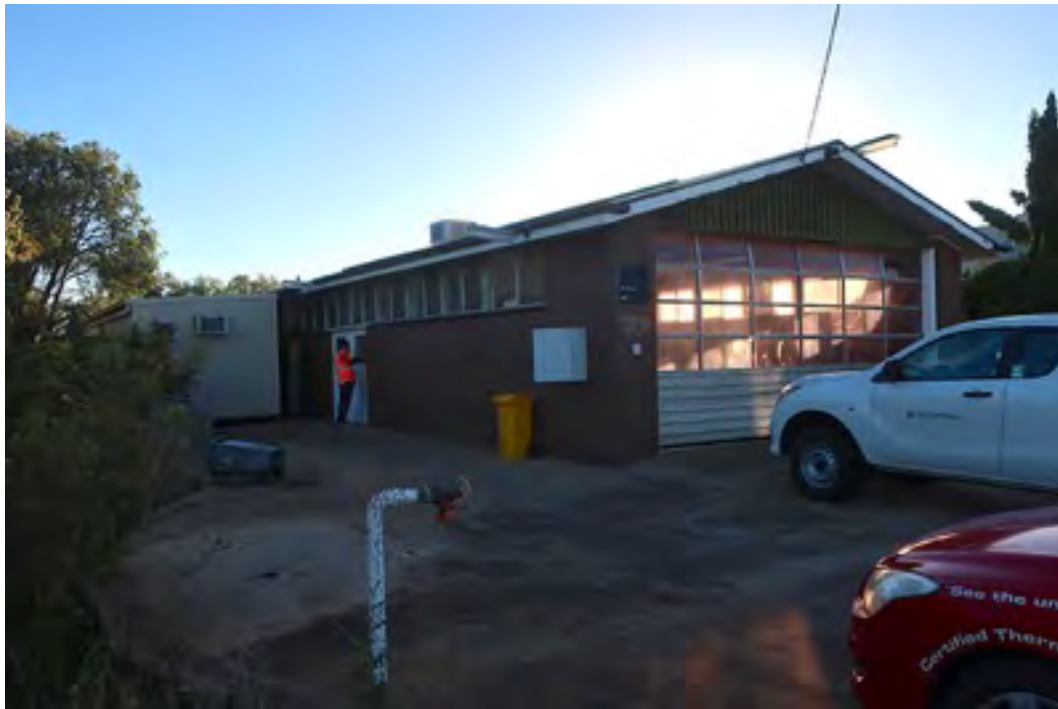
**Area 6**

RISK ASSESSMENT					
Type of Asbestos or Hazardous Material	Chrysotile	Condition	AVERAGE	Likelihood of Damage	L (Low) – possible
	Sample taken 62069-001	Activity	Moderate		
		Sealed	No	Friability	Bonded (non-friable)
		Labelled	Y	Exposure Risk	Medium - Moderate risk
		Quantity

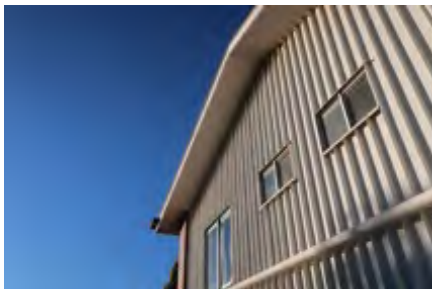
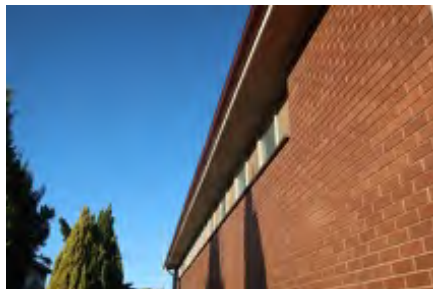
Raw Material

Raw material sheeting - The area requires immediate remedial repairs. It is recommended the asbestos material be sealed with an approved membrane.

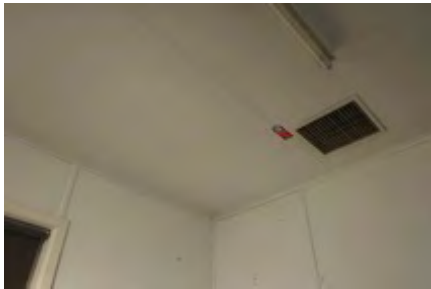
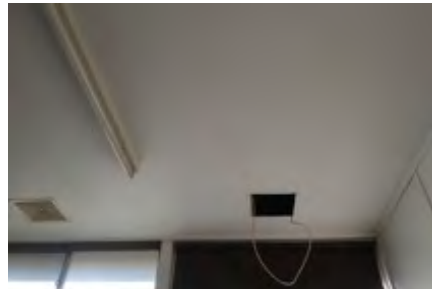
Maintain paint or sealant

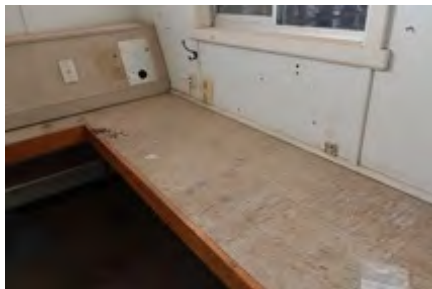
Maintain sealant

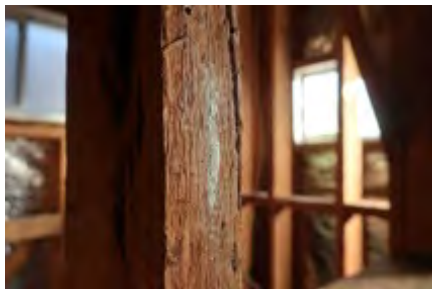
Removal Residue

Debris residue from incomplete or improper asbestos removal. Recommend to refer to removal Control Plan; Review & correct procedures.

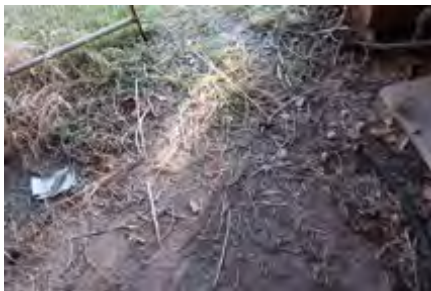
Debris on Surface

- 5 Hopetoun CFA Shed: Sub floor 1 - beneath bathroom. The Debris - Broken (Debris) has Asbestos Containing Material (ACM) present.**
- Debris on Surface - The Debris requires immediate cleanup and disposal with specialised equipment and with licensed removalist to safely remove the asbestos debris.

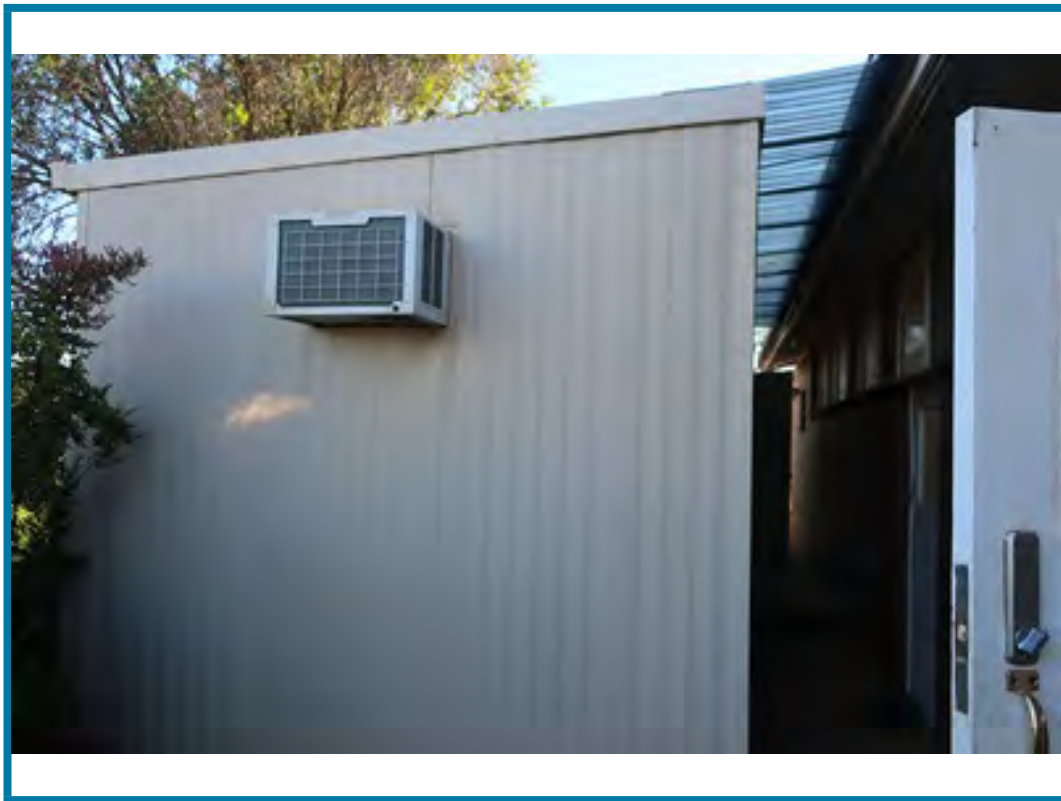
# Demountable office

Location	Area	Component Materials	ACM Identified	Type Asbestos Assessment	ConditionPriority	Signage Required
Demountable office - entire perimeter of building.		No Asbestos Materials	No	No sample taken - Visual ID

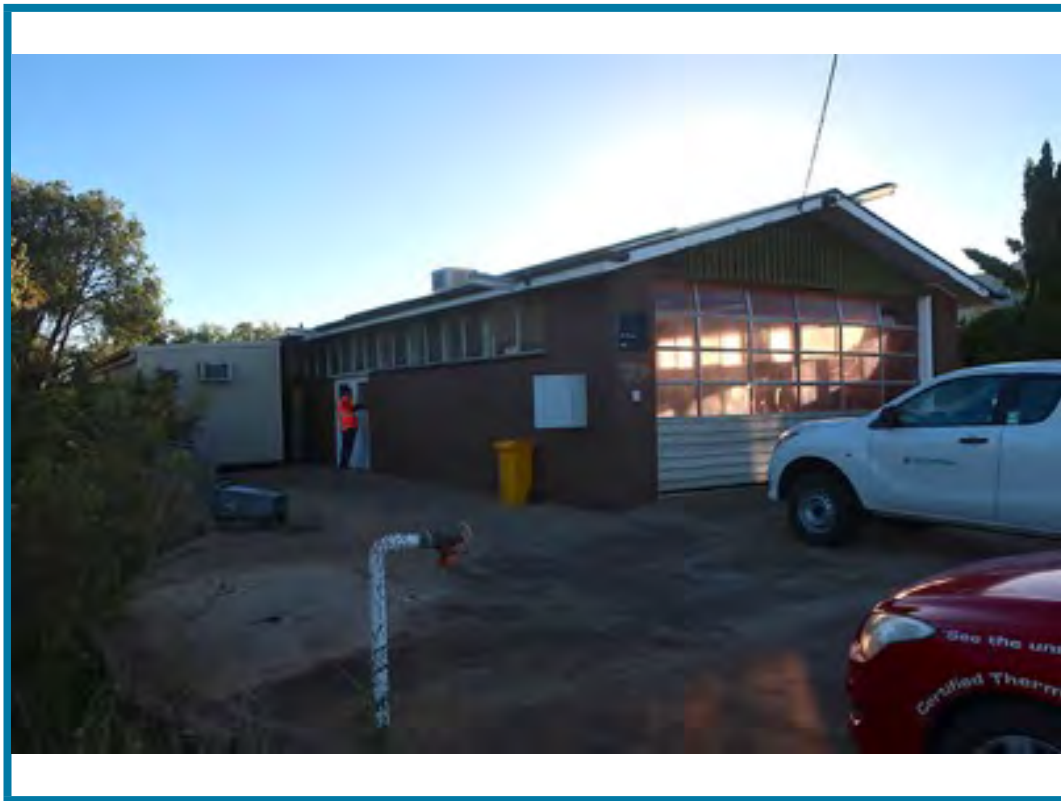
# Hopetoun CFA Shed

Location	Area	Component Materials	ACM Identified	Type Asbestos Assessment	ConditionPriority	Signage Required
Hopetoun CFA Shed - entire perimeter of building.	Soffit	F C Sheeting	Yes	Chrysotile Sample taken 62069-001	AVERAGE HIGH	Yes
		 		<p><b>Refer to the Asbestos Register for more information.</b></p>		
Hopetoun CFA Shed - left side of building.	Electrical board	No Asbestos Materials	No	No sample taken - Visual ID
