# Asbestos Report

YARRIAMBIACK SHIRE COUNCIL

PROPERTY ADDRESS:  
LB77 MEMORIAL HALL  
13 AUSTIN STREET  
HOPETOUN VIC 3396

INSPECTION DATE: 27 JANUARY 2021  
REFERENCE NUMBER: 62071

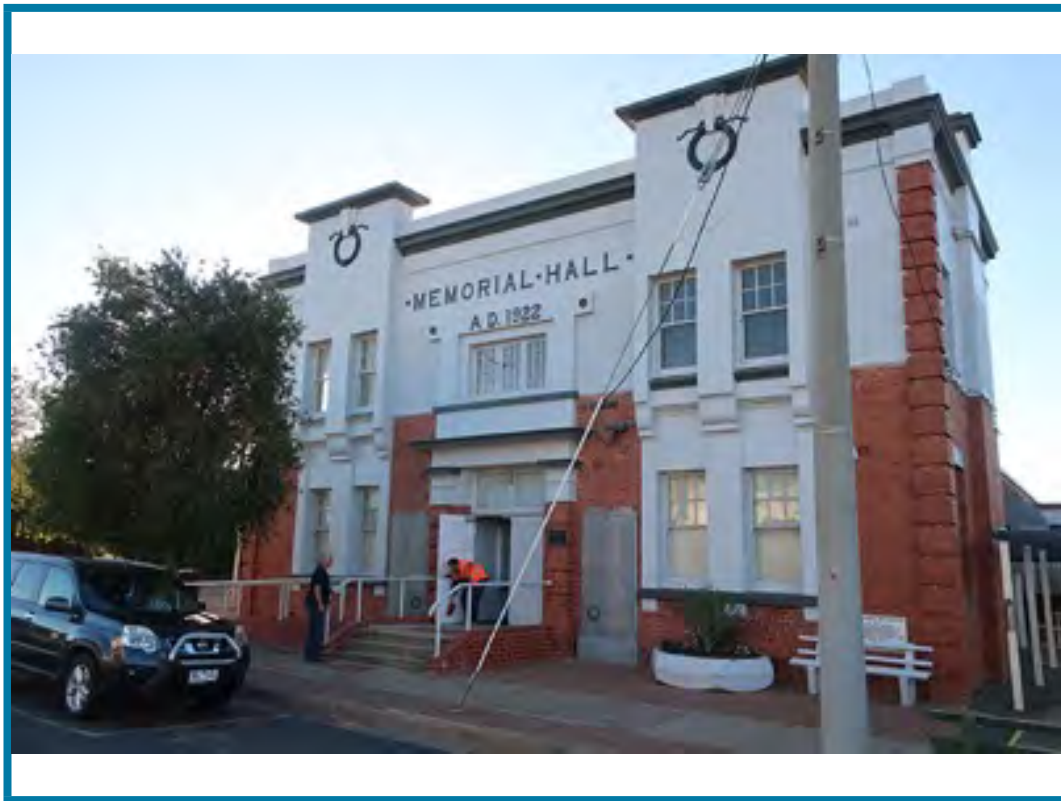
Location	Area	Component Materials	ACM Identified	Type Asbestos Assessment	ConditionPriority	Signage Required
LB77 Memorial Hall - entire perimeter of building.		No Asbestos Materials	No	No sample taken - Visual ID

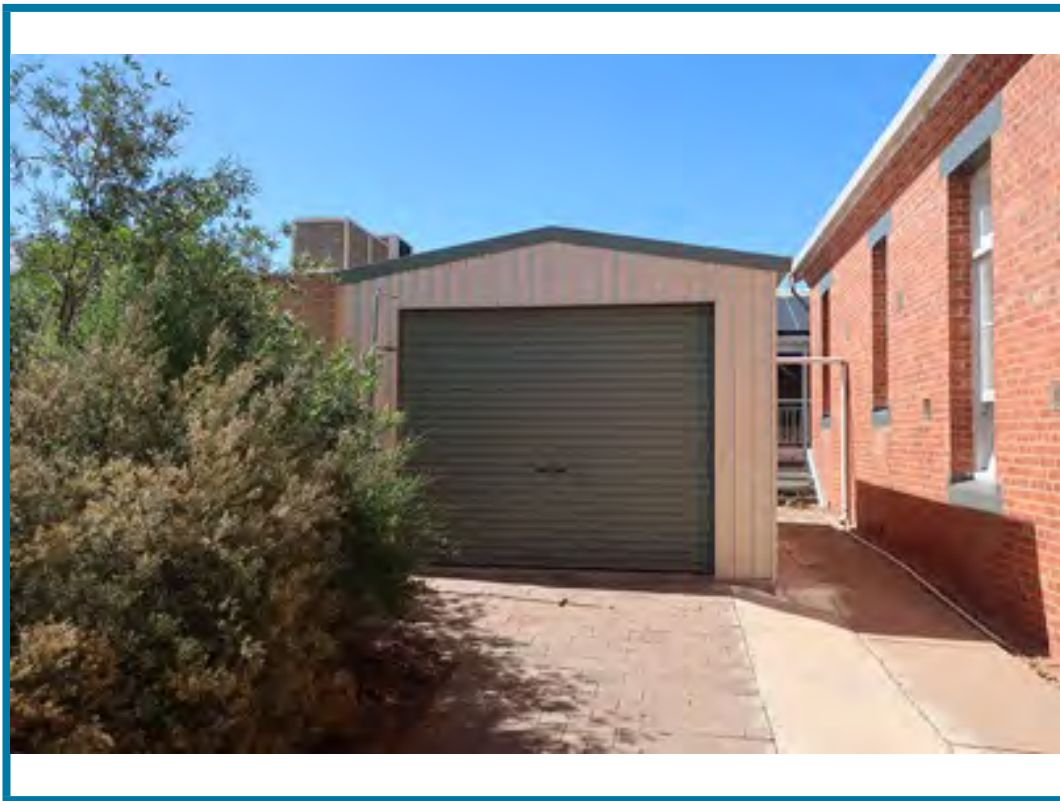
Location	Area	Component Materials	ACM Identified	Type Asbestos Assessment	ConditionPriority	Signage Required
Shed - entire perimeter of building.		No Asbestos Materials	No	No sample taken - Visual ID
