# Asbestos Report

YARRIAMBIACK SHIRE COUNCIL

PROPERTY ADDRESS:  
LB74A PRESCHOOL  
87-89 MANDEVILLE STREET  
HOPETOUN VIC 3396

INSPECTION DATE: 27 JANUARY 2021  
REFERENCE NUMBER: 62072

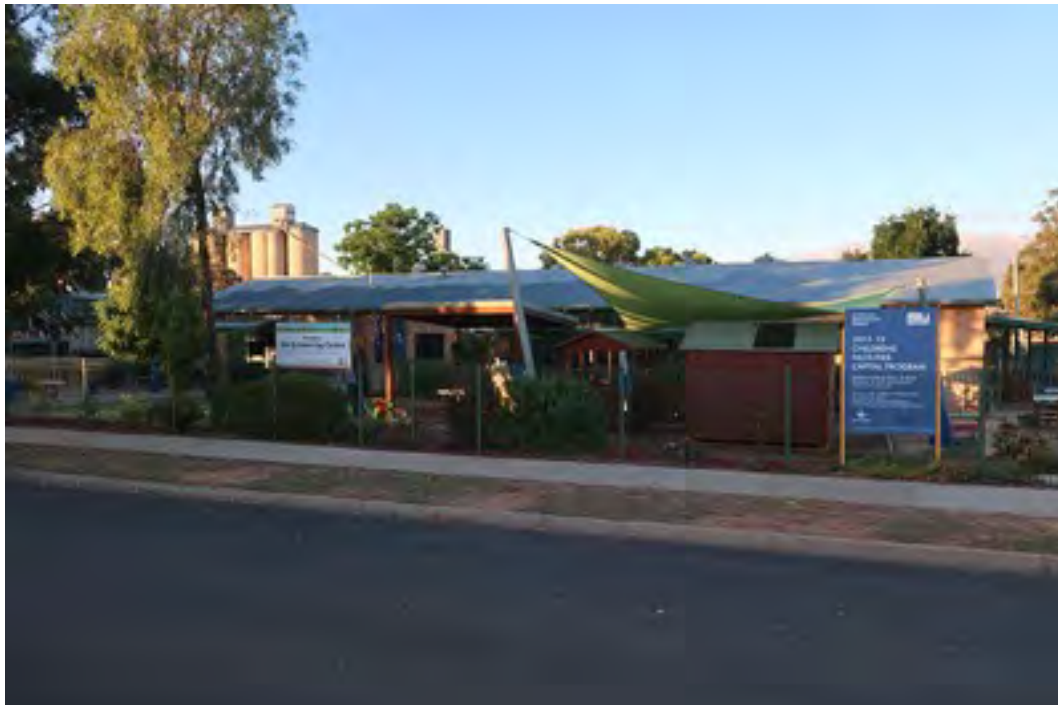
## LB74A Preschool, 87-89 Mandeville Street, Hopetoun VIC 3396

- 1 LB74A Preschool: Bathroom 11. The Walls - Upper wall above door (F C Sheeting) has Asbestos Containing Material (ACM) present.
- 2 LB74A Preschool: Storeroom 11.1. The Walls - above door (F C Sheeting) has Asbestos Containing Material (ACM) present.
