# Asbestos Report

YARRIAMBIACK SHIRE COUNCIL

PROPERTY ADDRESS:  
LB58D SCOUT HALL  
54 EVELYN STREET  
HOPETOUN VIC 3396

INSPECTION DATE: 27 JANUARY 2021  
REFERENCE NUMBER: 62075

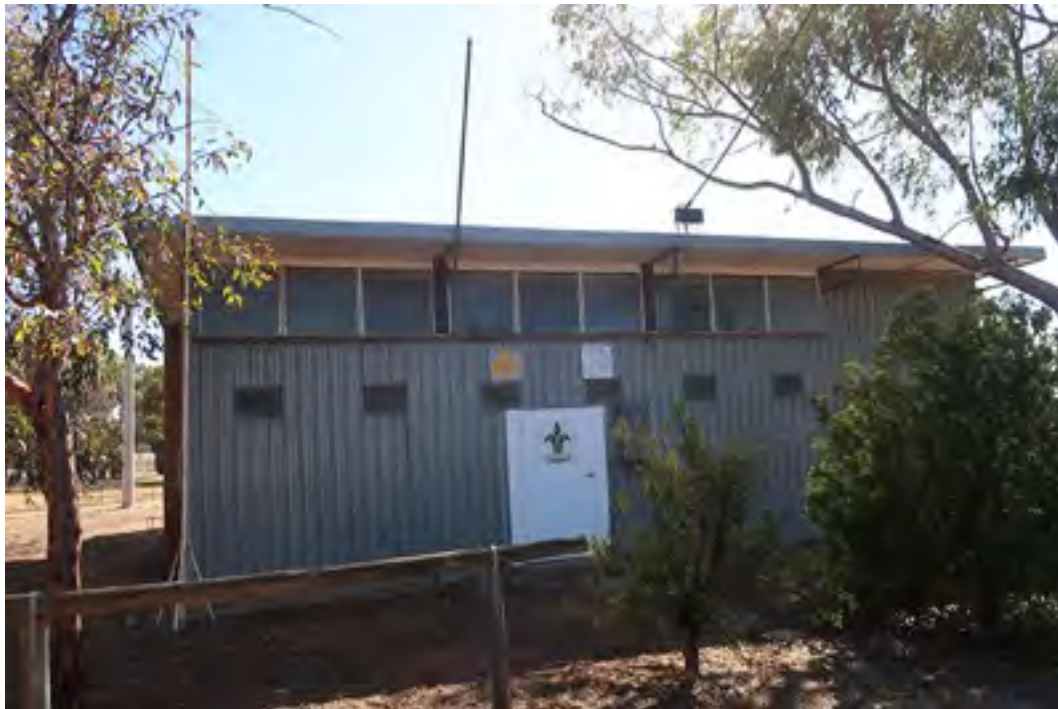
**Area 2**

2	LB58D Scout Hall: entire perimeter of building. The Soffit (F C Sheeting) has Asbestos Containing Material (ACM) present.	Orange
3	LB58D Scout Hall: right side of building. The Fence (F C Sheeting) has Asbestos Containing Material (ACM) present.	Orange
4	LB58D Scout Hall: Female bathroom 2. The Walls (F C Sheeting) has Asbestos Containing Material (ACM) present.	Yellow
5	LB58D Scout Hall: Male bathroom 3. The Walls (F C Sheeting) has Asbestos Containing Material (ACM) present.	Yellow
1	LB58D Scout Hall: 5. Until the area is inspected, it should be managed as if it Asbestos Containing Material (ACM) is present.	Orange

Raw material sheeting - The area requires immediate remedial repairs. It is recommended the asbestos material be sealed with an approved membrane.
