Asbestos Report

YARRIAMBIACK SHIRE COUNCIL

PROPERTY ADDRESS:
LB90 SENIOR CITIZENS
20 Dennys Street
HOPETOUN VIC 3396

Inspection Date: 27 January 2021
Reference Number: 62076

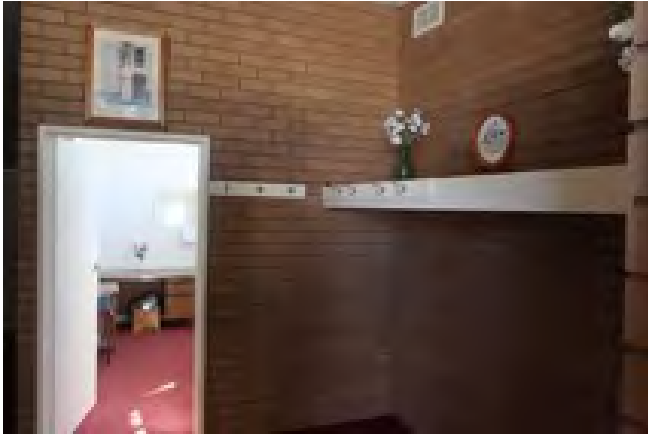
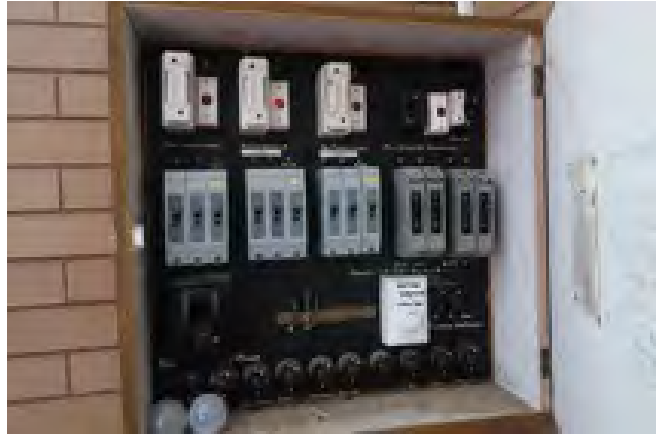
Area 3

LB90 Senior Citizens: Entry/ walkway 1. The Electrical Cabinet - lining (F C Sheeting) has Asbestos Containing Material (ACM) present.

RISK ASSESSMENT					
Type of Asbestos or Hazardous Material	No sample taken - Visual ID	Condition	AVERAGE	Likelihood of Damage	L (Low) – possible
		Activity	Moderate		
		Sealed	No	Friability	Bonded (non-friable)
		Labelled	Y	Exposure Risk	Medium - Moderate risk
		Quantity

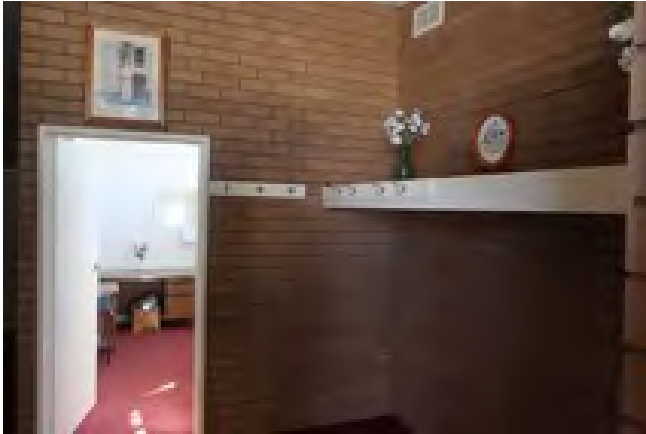
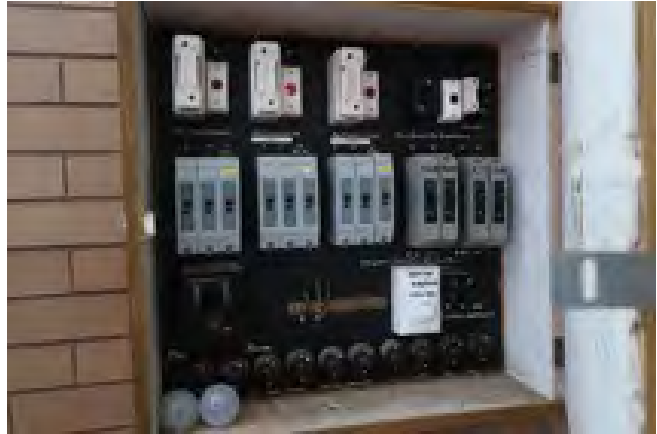
LB90 Senior Citizens: Entry/ walkway 1. The A: Electrical board; B: Ceramic Fuses (A: Zelemite; B: Cloth Inserts) has Asbestos Containing Material (ACM) present.

RISK ASSESSMENT					
Type of Asbestos or Hazardous Material	Chrysotile	Condition	AVERAGE	Likelihood of Damage	L (Low) – possible
	Sample taken 62076-002 (Zelemite)	Activity	Moderate	Friability	Exposed Fibres
		Sealed	Yes	Exposure Risk	Medium - Moderate risk
		Labelled	Y		
		Quantity

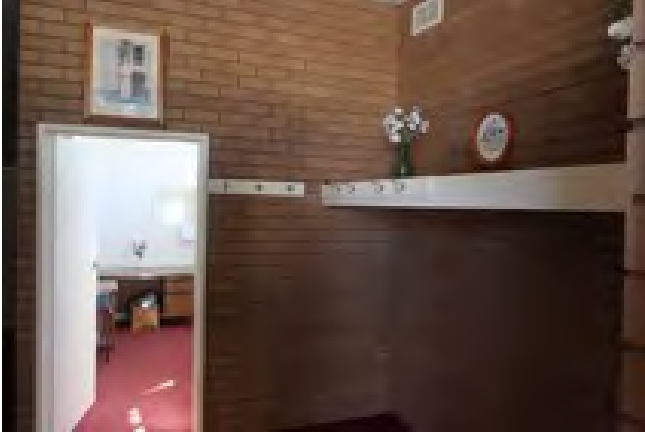
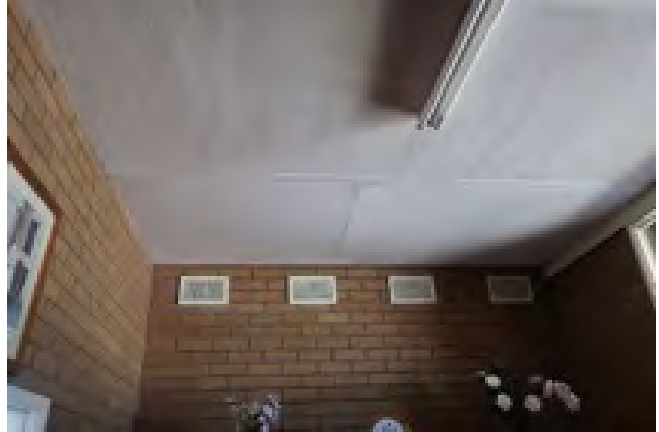
Area 4**LB90 Senior Citizens: Entry/ walkway 1. The Ceiling panels (F C Sheeting) has Asbestos Containing Material (ACM) present.****RISK ASSESSMENT**

Type of Asbestos or Hazardous Material	No sample taken - Visual ID	Condition	GOOD	Likelihood of Damage	L (Low) – possible
		Activity	Moderate		
		Sealed	Yes	Friability	Bonded (non-friable)
		Labelled	Y	Exposure Risk	Low - Negligible or low risk
		Quantity
