# Asbestos Report

YARRIAMBIACK SHIRE COUNCIL

PROPERTY ADDRESS:  
LB82 SHIRE DEPOT  
68 HOPETOUN AERODROME ROAD  
HOPETOUN VIC 3396

INSPECTION DATE: 27 JANUARY 2021  
REFERENCE NUMBER: 62077

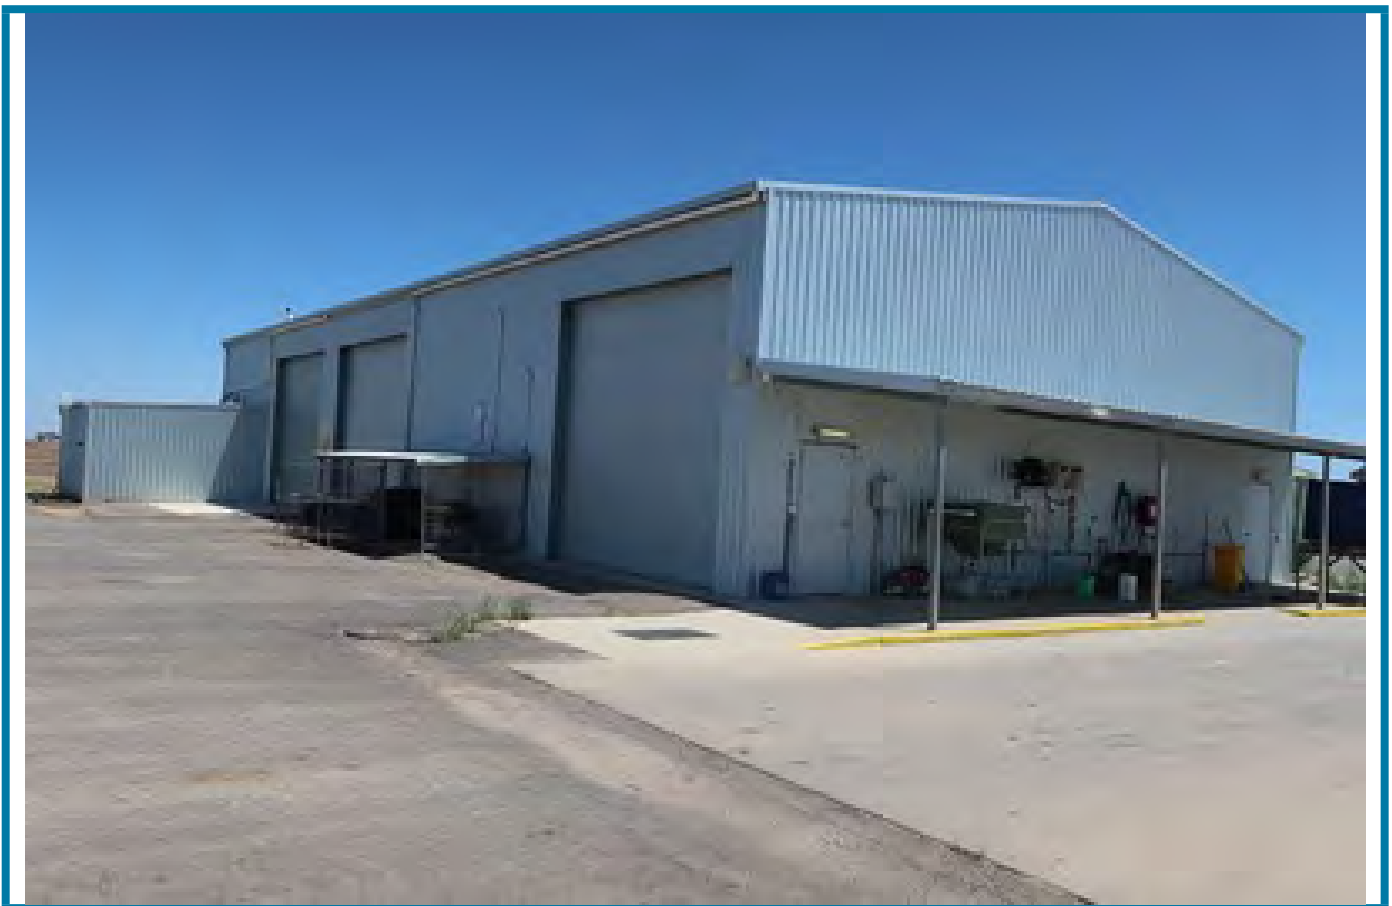
Location	Area	Component Materials	ACM Identified	Type Asbestos Assessment	ConditionPriority	Signage Required
1 - Workshop - entire perimeter of building.		No Asbestos Materials	No	No sample taken - Visual ID
