Asbestos Report

YARRIAMBIACK SHIRE COUNCIL

**PROPERTY ADDRESS:
LB58A SWIMMING POOL
4 AUSTIN STREET AND 54 EVELYN STREET
HOPETOUN VIC 3396**

**INSPECTION DATE: 27 JANUARY 2021
REFERENCE NUMBER: 62080**

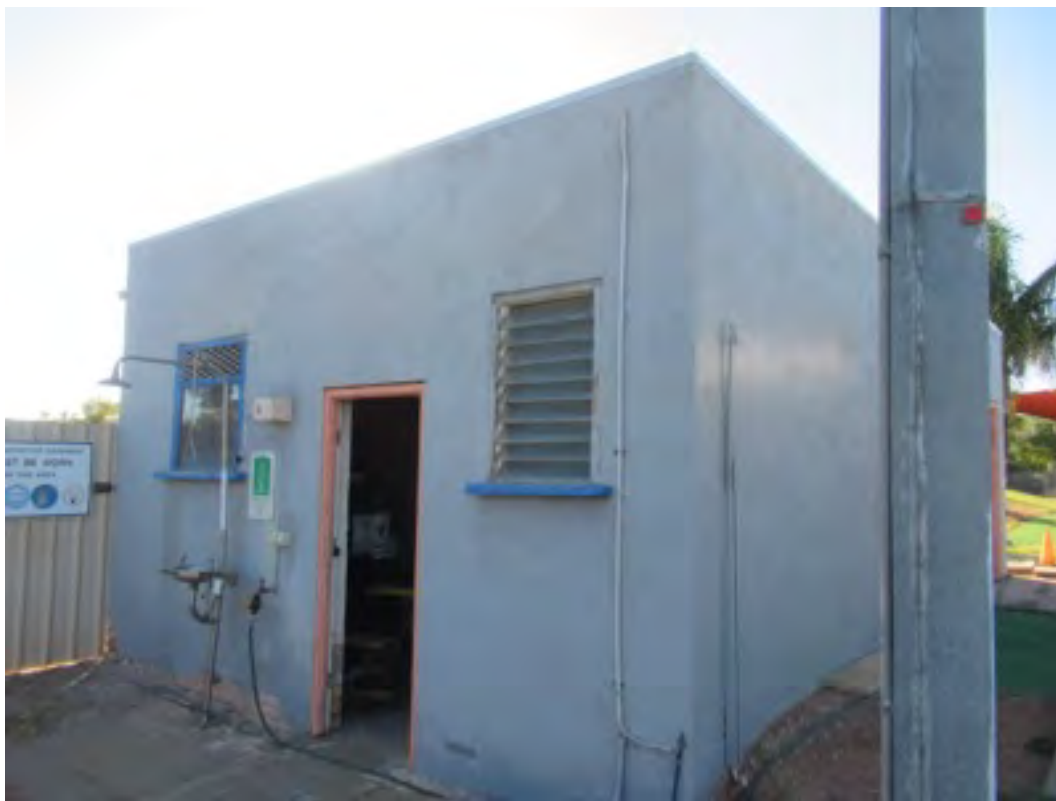
Pump house

Area 1

RISK ASSESSMENT					
Type of Asbestos or Hazardous Material	Chrysotile Amosite Crocidolite Sample taken 62080-004	Condition	AVERAGE	Likelihood of Damage	L (Low) – possible
		Activity	Low		
		Sealed	No	Friability	Bonded (non-friable)
		Labelled	Y	Exposure Risk	Medium - Moderate risk
		Quantity

Raw material sheeting - The area requires immediate remedial repairs. It is recommended the asbestos material be sealed with an approved membrane.

RISK CONTROL					
Priority	HIGH	Label Required	Yes	Re- Audit Date	27 Jan 2022
Action	Remedial repairs required - seal raw material / edges				
Recommendation	Raw material sheeting - The area requires immediate remedial repairs. It is recommended the asbestos material be sealed with an approved membrane.				
Legislative Requirements Victorian Regulation 2007	Damaged ACM visible in area. Requires IMMEDIATE ATTENTION. WARNING labels should be affixed. Avoid mechanical damage and abrasion. Remove if refurbishment, structural alteration or demolition is to be carried out in this area. Re-inspect every 12 months or earlier if disturbed or removed in accordance with the Victorian OH&S Regulation 2017. All remedial/removal repairs require a Clearance Inspection & Certificate to be recorded by an approved and competent assessor.

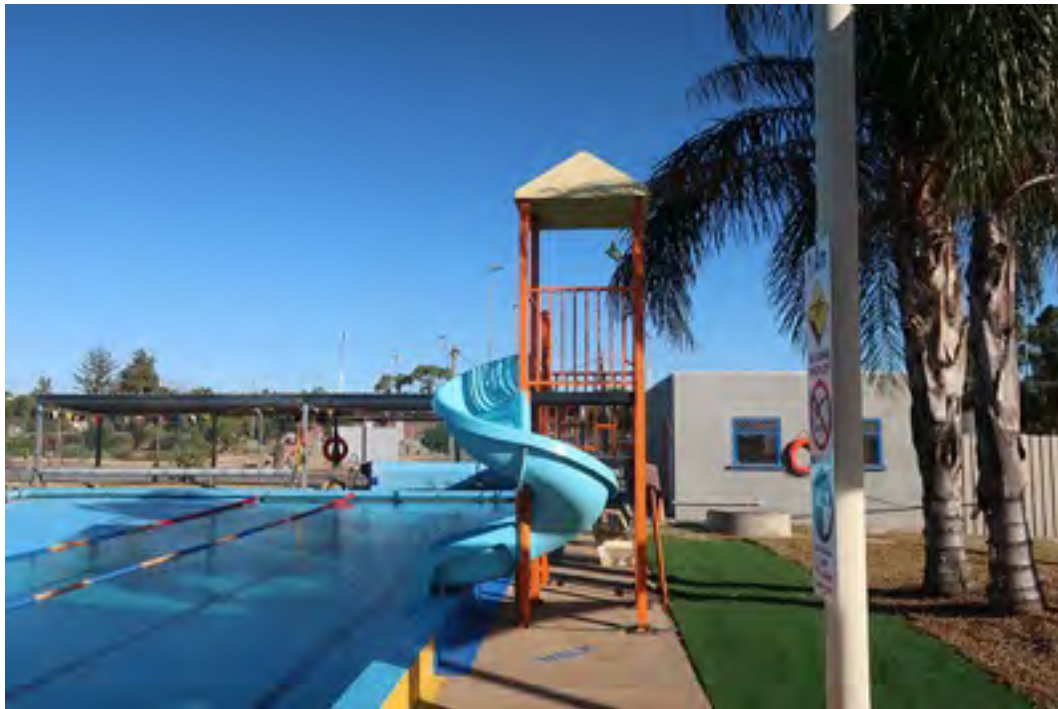
Swimming pool slide

Area 4**Swimming pool slide: Swimming pool slide. The Membrane lining (Marble sheen) has Asbestos Containing Material (ACM) present.****RISK ASSESSMENT**

Type of Asbestos or Hazardous Material	No sample taken - Visual ID	Condition	GOOD	Likelihood of Damage	L (Low) – possible
		Activity	Moderate		
		Sealed	Yes	Friability	Bonded (non-friable)
		Labelled	No	Exposure Risk	Low - Negligible or low risk
		Quantity

Priority	MEDIUM	Label Required	No	Re- Audit Date	27 Jan 2022
Action	No remedial action required, unless disturbed				
Recommendation	Maintain paint or sealant to ACM surfaces. Particular attention should be given to side edges, ensure paint/sealant covers ALL exposed ACM surfaces. Test membrane - Marble sheen				
Legislative Requirements Victorian Regulation 2007	Warning labels should be affixed. Avoid mechanical damage and abrasion. Remove if refurbishment, structural alteration or demolition is to be carried out in this area. Re-inspect every 12 months or earlier if disturbed or removed in accordance with the Victorian OH&S Regulation 2017. All remedial/removal repairs require a Clearance Inspection & Certificate to be recorded by an approved and competent assessor.

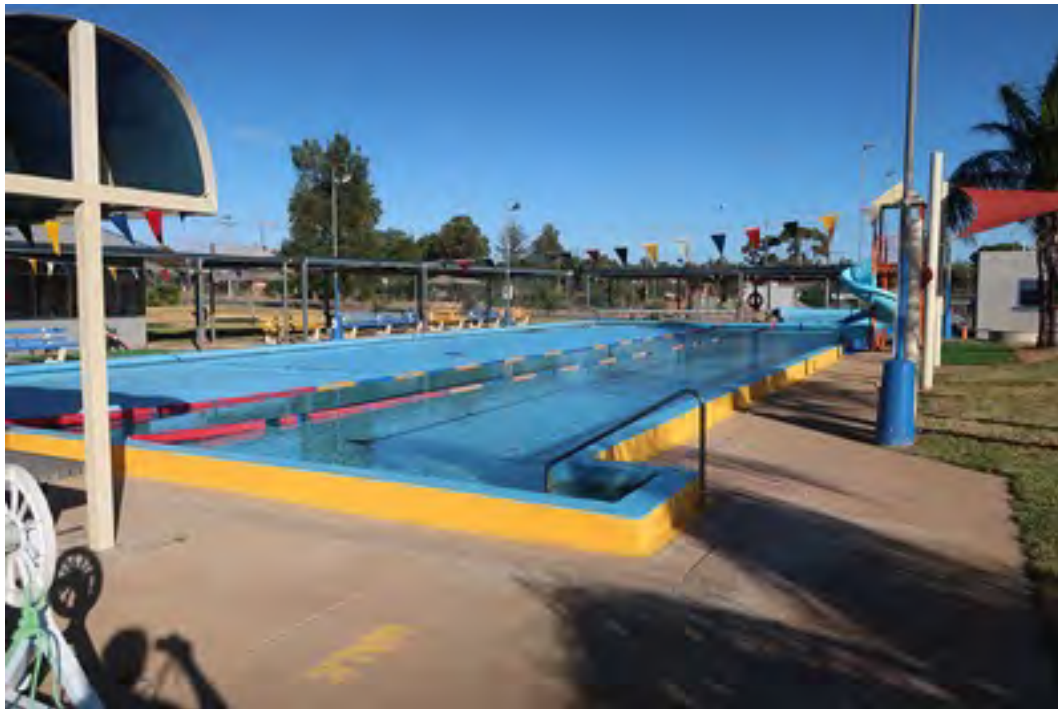
General

Area 2

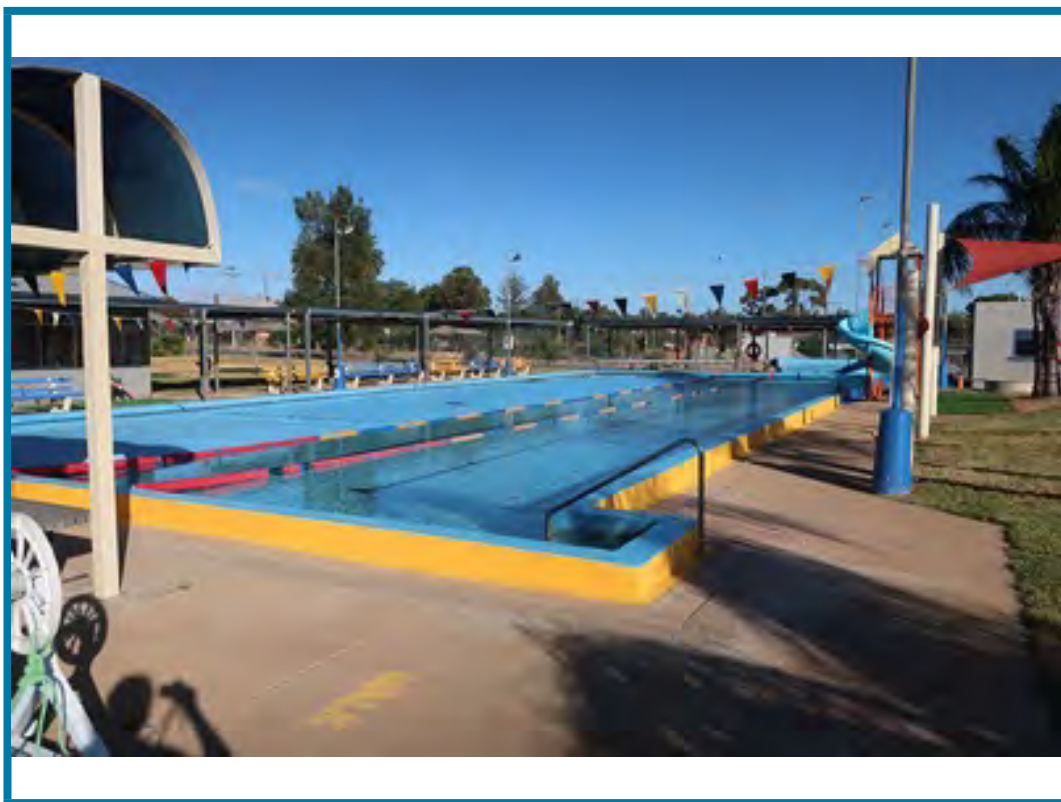
Location	Area	Component Materials	ACM Identified	Type Asbestos Assessment	Condition	Priority	Signage Required
General - Underground.	Pipe(s)	F C Sheeting	Yes	Chrysotile Amosite Crocidolite	GOOD	MEDIUM	Yes

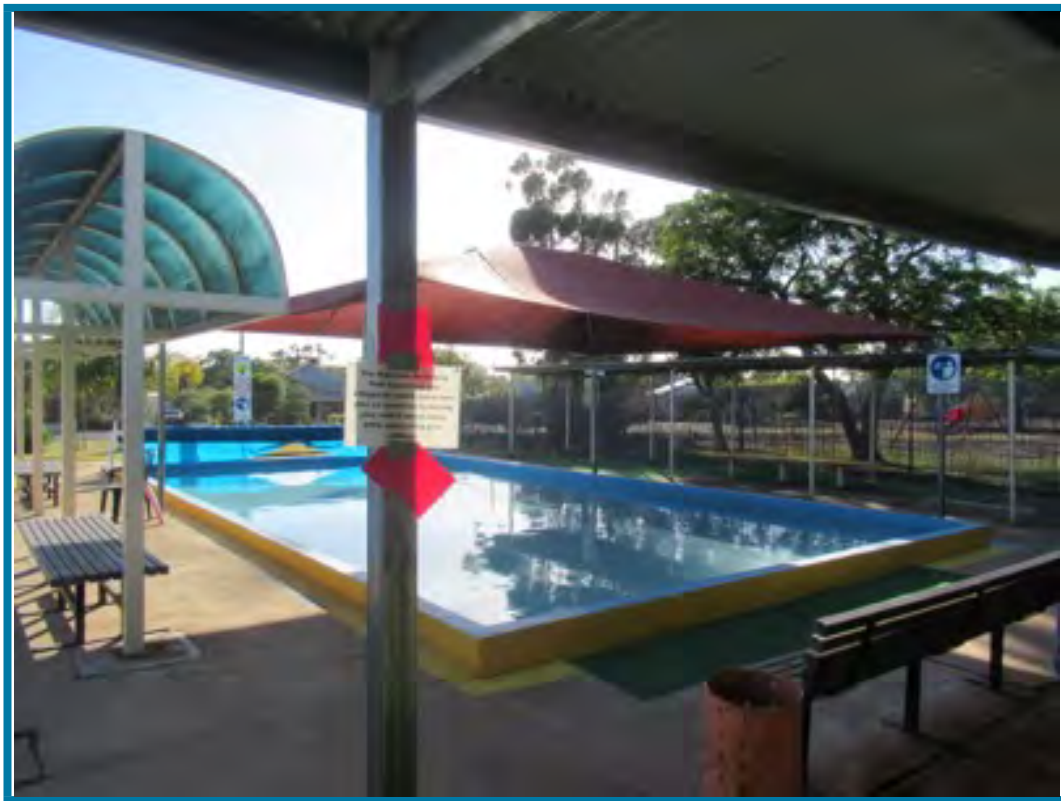
Location	Area	Component Materials	ACM Identified	Type Asbestos Assessment	Condition	Priority	Signage Required
Kids Swimming pool - Kids swimming pool.		No Asbestos Materials	No	No sample taken - Visual ID

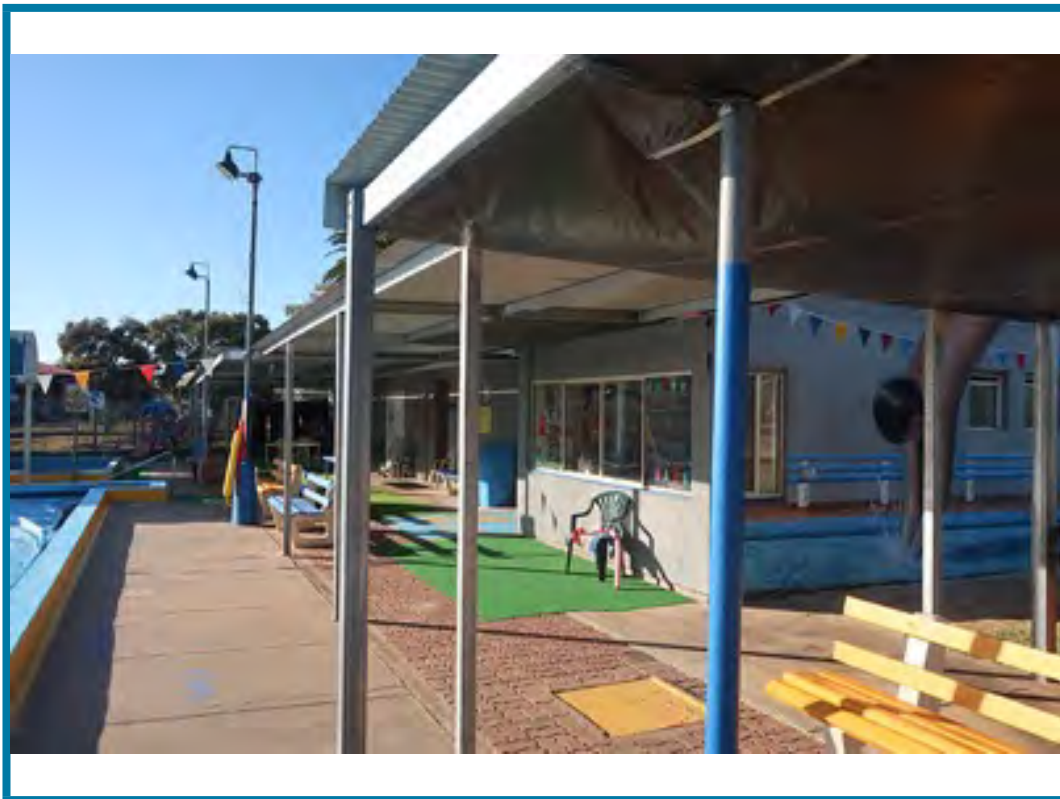
Location	Area	Component Materials	ACM Identified	Type Asbestos Assessment	ConditionPriority	Signage Required
Kiosk & Changerooms LB58A Swimming Pool - rear of building - Kiosk.	Infill panel/s above windows	F C Sheeting	No	No Asbestos Detected	Same as Sample - 62080-001

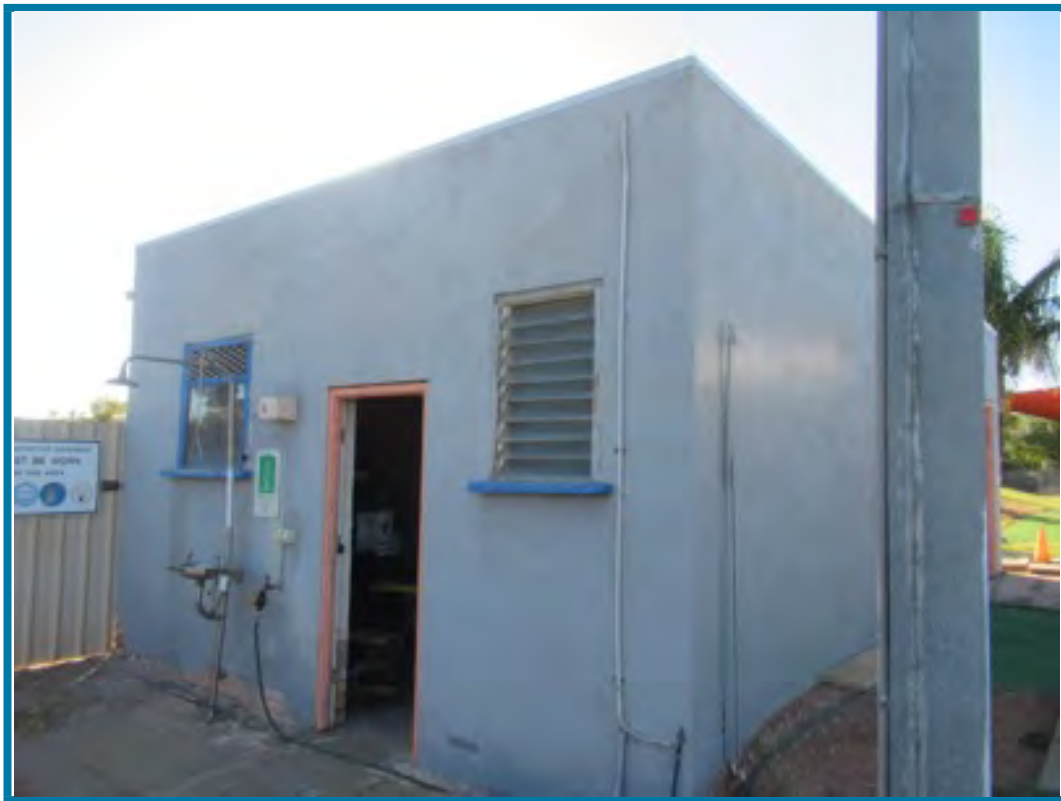
Location	Area	Component Materials	ACM Identified	Type Asbestos Assessment	ConditionPriority	Signage Required
Pump house - entire perimeter of building.		No Asbestos Materials	No	No sample taken - Visual ID

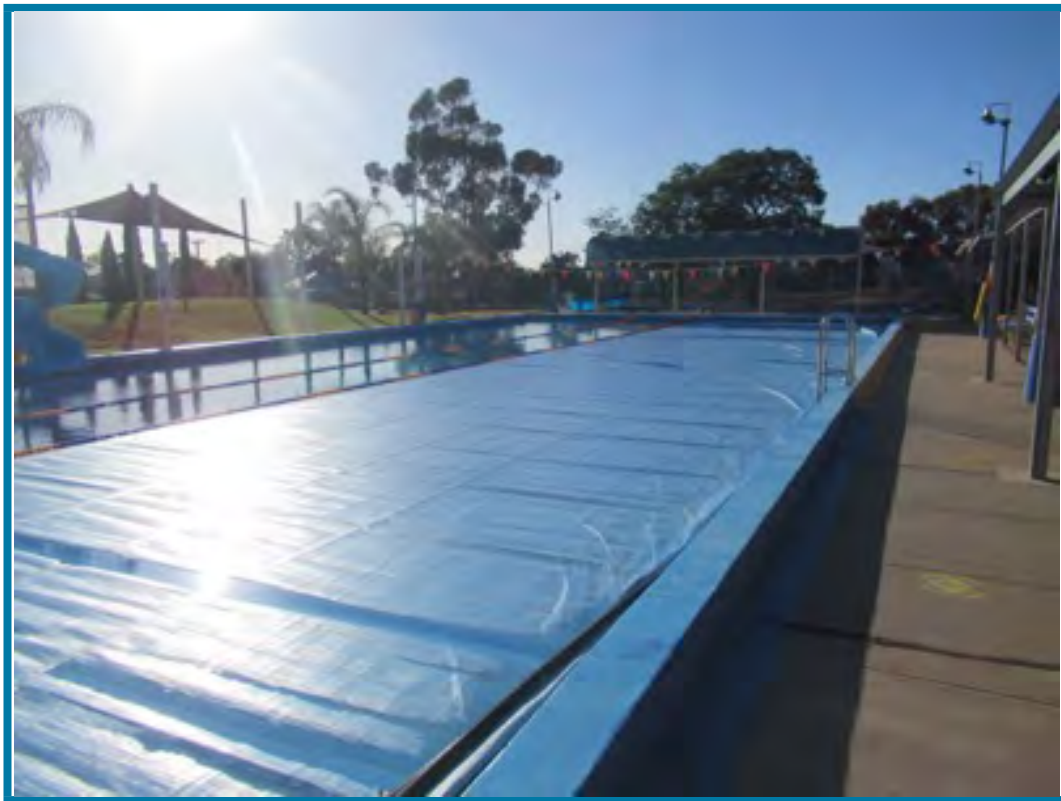
Location	Area	Component Materials	ACM Identified	Type Asbestos Assessment	ConditionPriority	Signage Required
Swimming pool - Swimming pool.		No Asbestos Materials	No	No sample taken - Visual ID

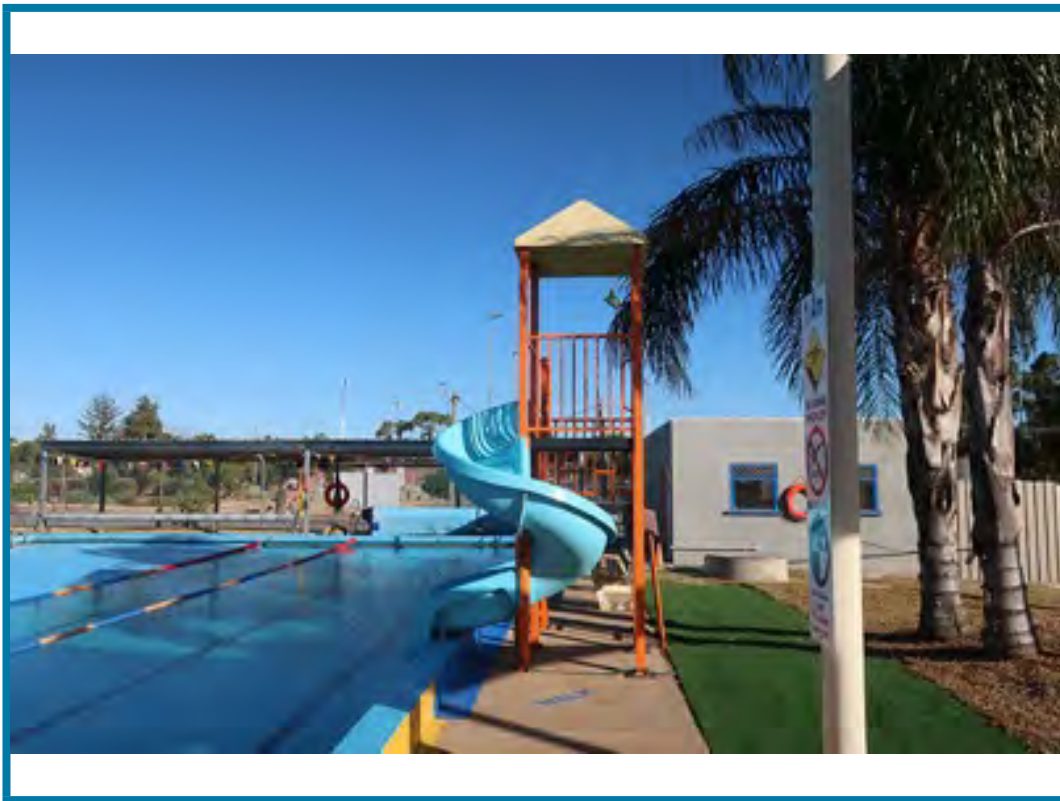
Location	Area	Component Materials	ACM Identified	Type Asbestos Assessment	Condition	Priority	Signage Required
Swimming pool slide - Swimming pool slide.	Membrane lining	Marble sheen	Yes	No sample taken - Visual ID
