Asbestos Report

YARRIAMBIACK SHIRE COUNCIL

PROPERTY ADDRESS:
LB58C TENNIS COURT CLUBROOMS
4 AUSTIN STREET
HOPETOUN VIC 3396

INSPECTION DATE: 27 JANUARY 2021
REFERENCE NUMBER: 62082

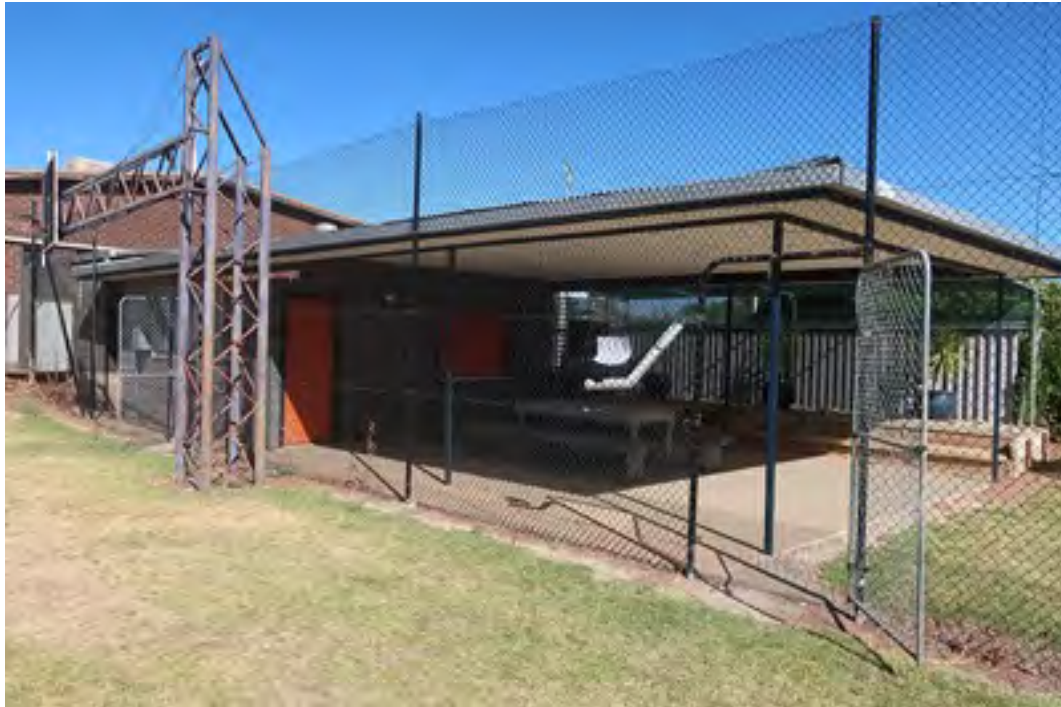
Area 4

- 1 **Clubrooms LB58C Tennis Court Clubrooms: right side of building. The Debris - Broken (Debris) has Asbestos Containing Material (ACM) present.**

Raw material sheeting - The area requires immediate remedial repairs. It is recommended the asbestos material be sealed with an approved membrane.
