Asbestos Report

YARRIAMBIACK SHIRE COUNCIL

PROPERTY ADDRESS:
LB69 TIP HOPETOUN
8 TIP ROAD
HOPETOUN VIC 3396

INSPECTION DATE: 27 JANUARY 2021
REFERENCE NUMBER: 62083

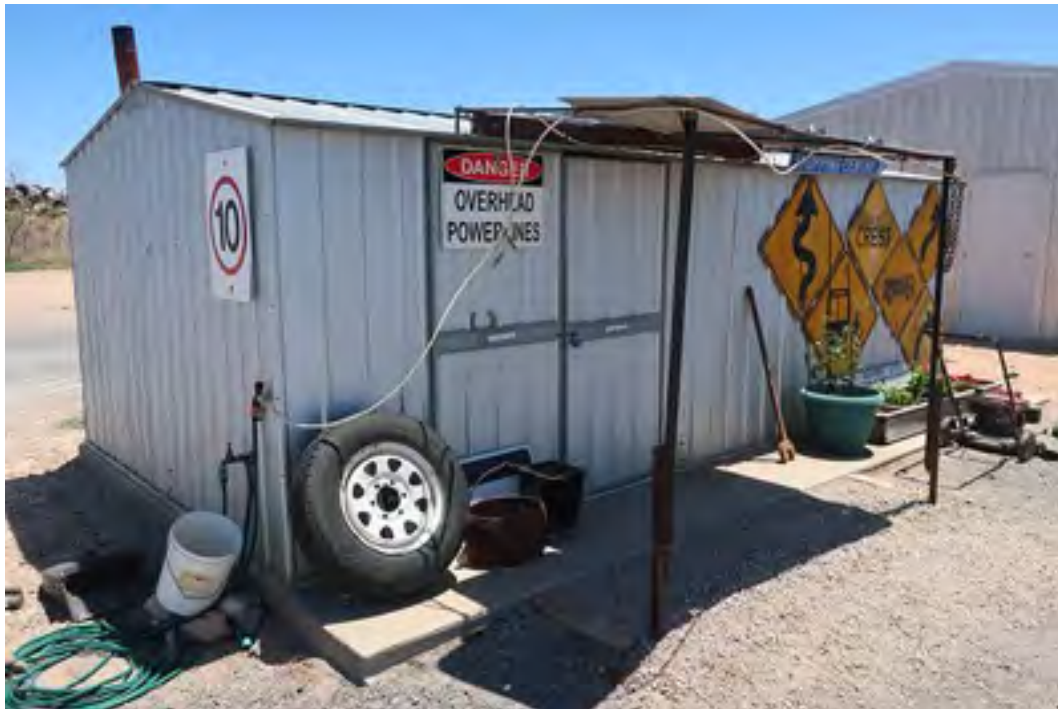
Shed 1

Area 5**Shed 1 LB69 Tip: . Until the area is inspected, it should be managed as if it Asbestos Containing Material (ACM) is present.****RISK ASSESSMENT**

Type of Asbestos or Hazardous Material	No sample taken - No Access	Condition		Likelihood of Damage	
		Activity			
		Sealed		Friability	
		Labelled	No	Exposure Risk	
		Quantity

Priority	HIGH	Label Required	Yes	Re- Audit Date	27 Jan 2022
Action					
Recommendation					
Legislative Requirements Victorian Regulation 2007	Unable to Gain Access. Assume asbestos in area and provide monitoring if work undertaken in these areas. If access is made available, contact Global Asbestos Audits for re-inspection

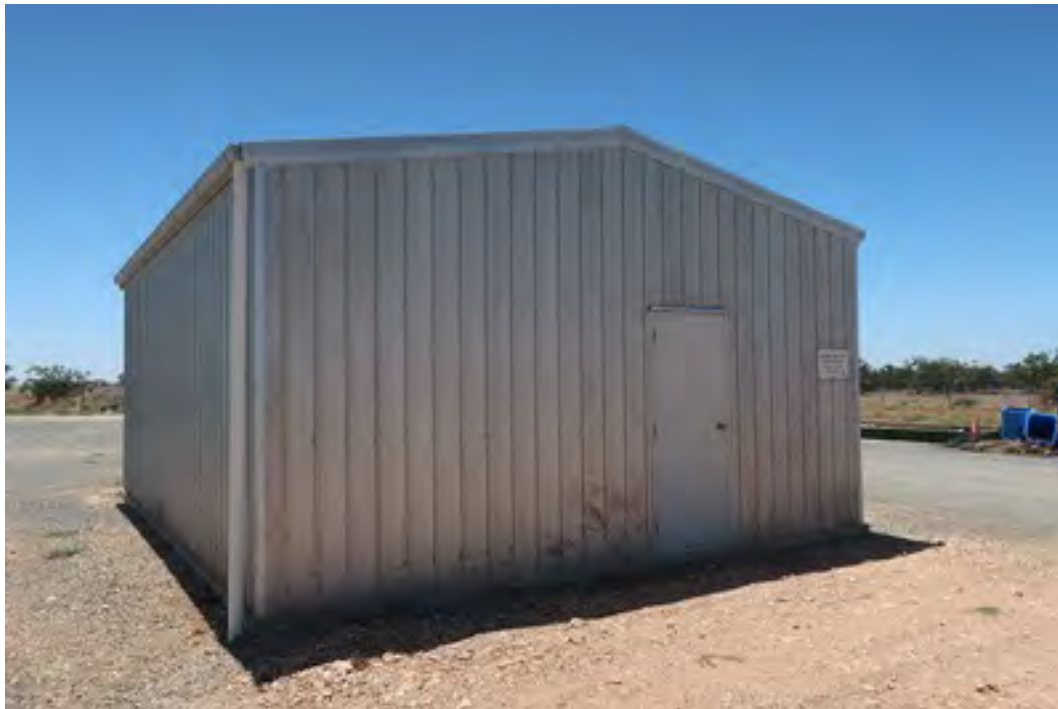
Second chance - Shed 2

- 4 Second chance - Shed 2: left side of building. The Debris - Broken (Debris) has Asbestos Containing Material (ACM) present.

Area 4

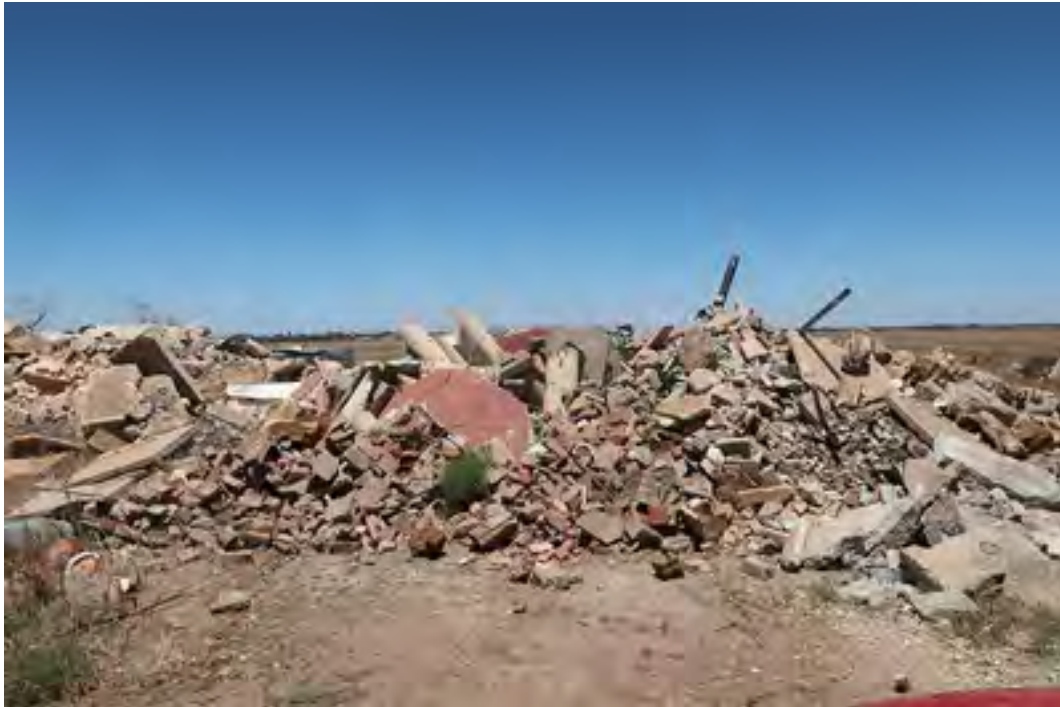
Rubish Tip

- 2 Rubish Tip: Tip pile. The Debris - Broken (Debris) has Asbestos Containing Material (ACM) present.
- 3 Rubish Tip: Tip pile. The Debris - Broken (Debris) has Asbestos Containing Material (ACM) present.

Area 2

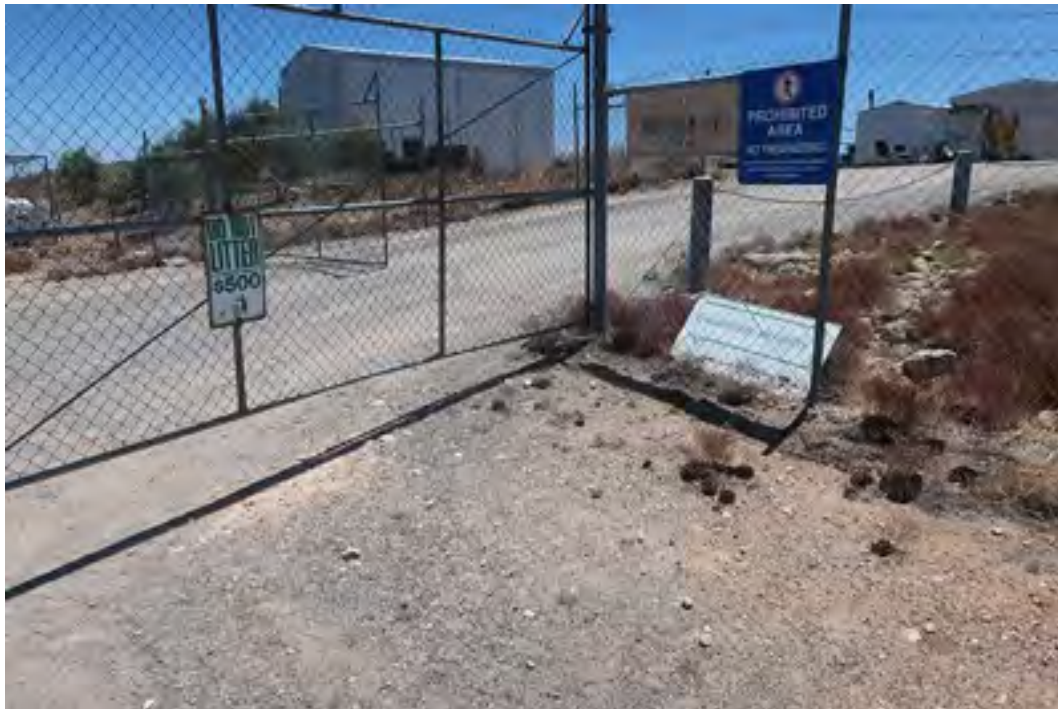
Grounds

- 1 Grounds: Front entrance. The Debris - Broken (Debris) has Asbestos Containing Material (ACM) present.

Area 1

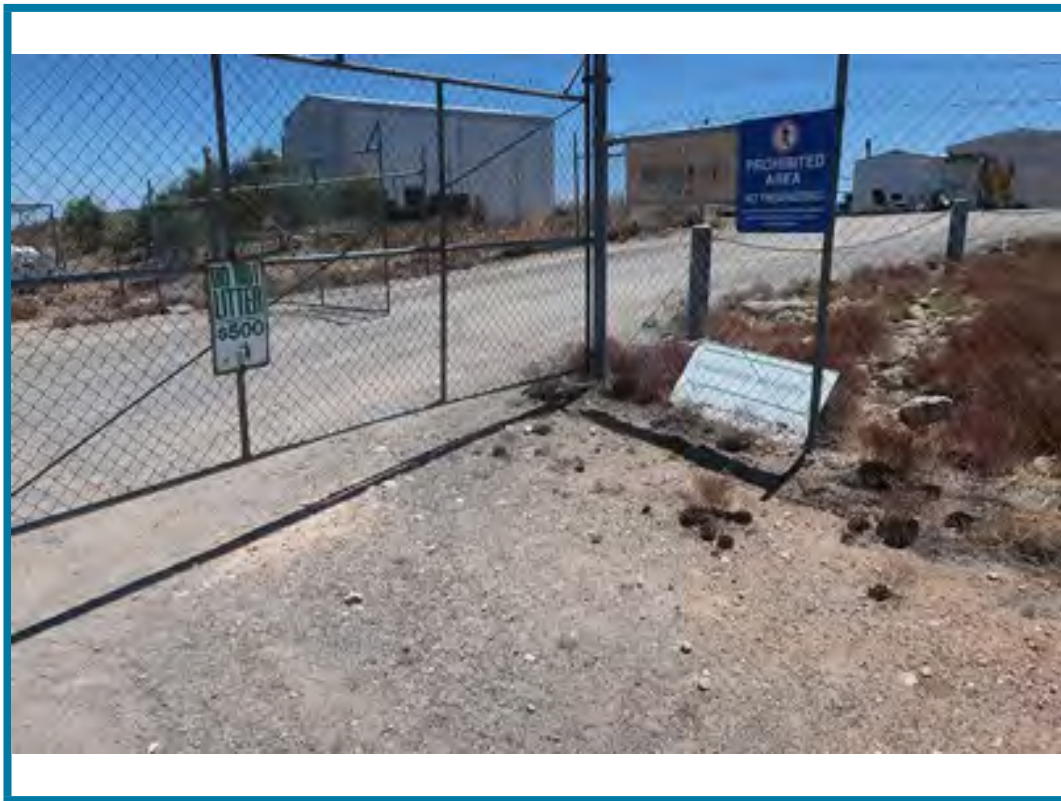
Location	Area	Component Materials	ACM Identified	Type Asbestos Assessment	ConditionPriority	Signage Required
Grounds - Front entrance.	Debris - Broken	Debris	Yes	No sample taken - Visual ID

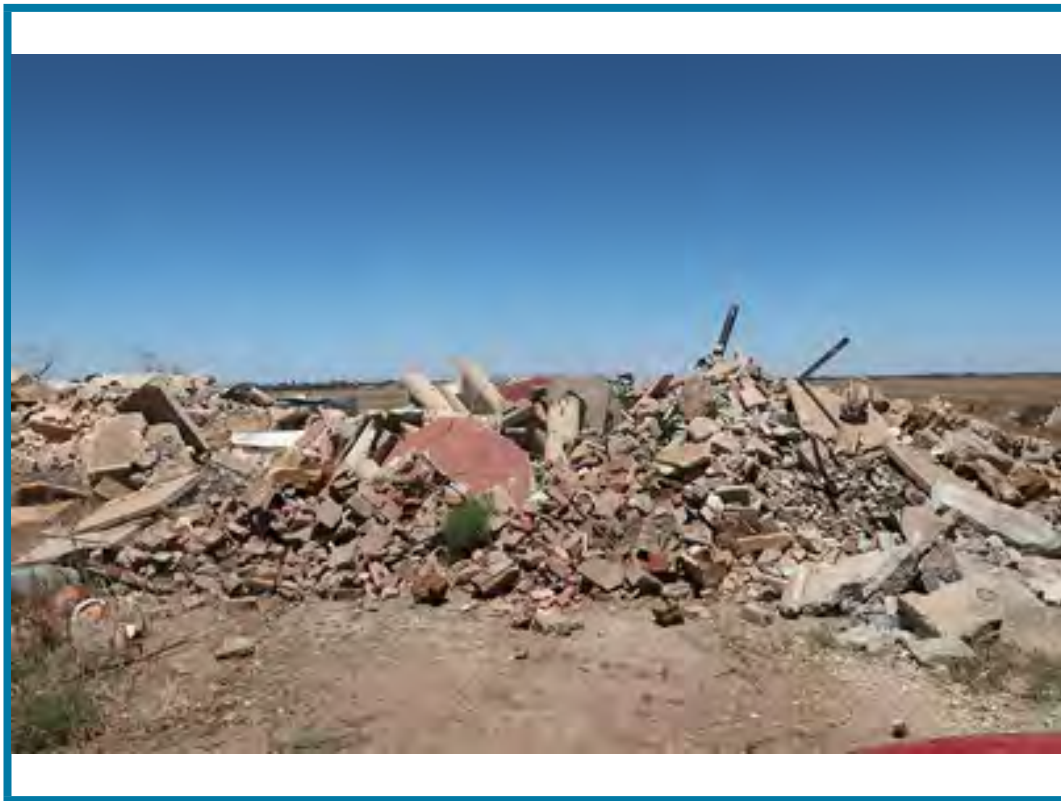
Location	Area	Component Materials	ACM Identified	Type Asbestos Assessment	ConditionPriority	Signage Required
Rubish Tip - Tip pile.	Debris - Broken	Debris	Yes	Chrysotile	Sample taken 62083-002 POOR IMMEDIATE	Yes

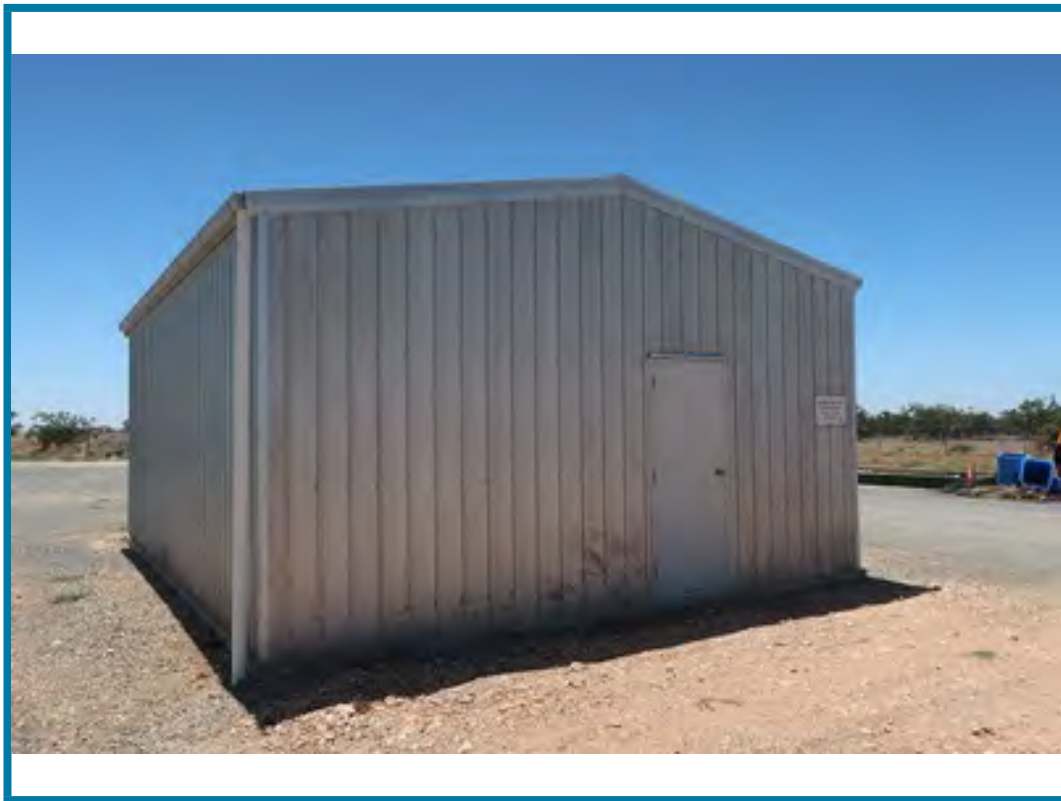
Location	Area	Component Materials	ACM Identified	Type Asbestos Assessment	Condition	Priority	Signage Required
Second chance - Shed 2 - entire perimeter of building.		No Asbestos Materials	No	No sample taken - Visual ID

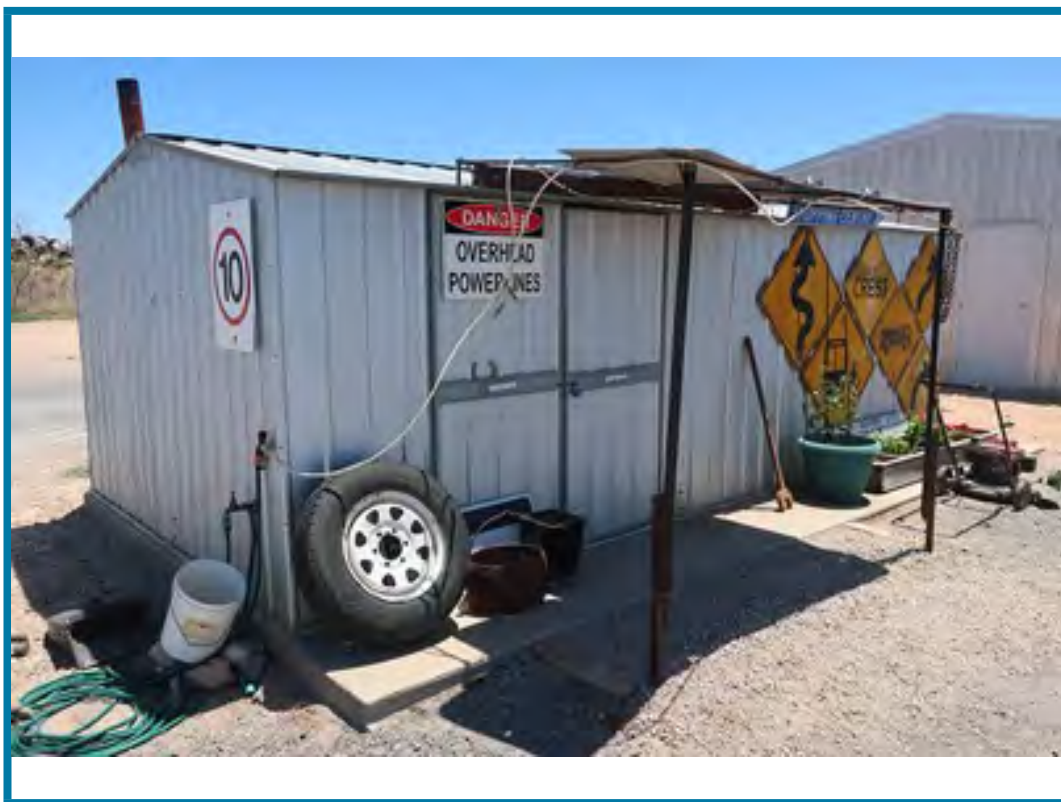
Location	Area	Component Materials	ACM Identified	Type Asbestos Assessment	Condition	Priority	Signage Required
Shed 1 LB69 Tip - entire perimeter of building.

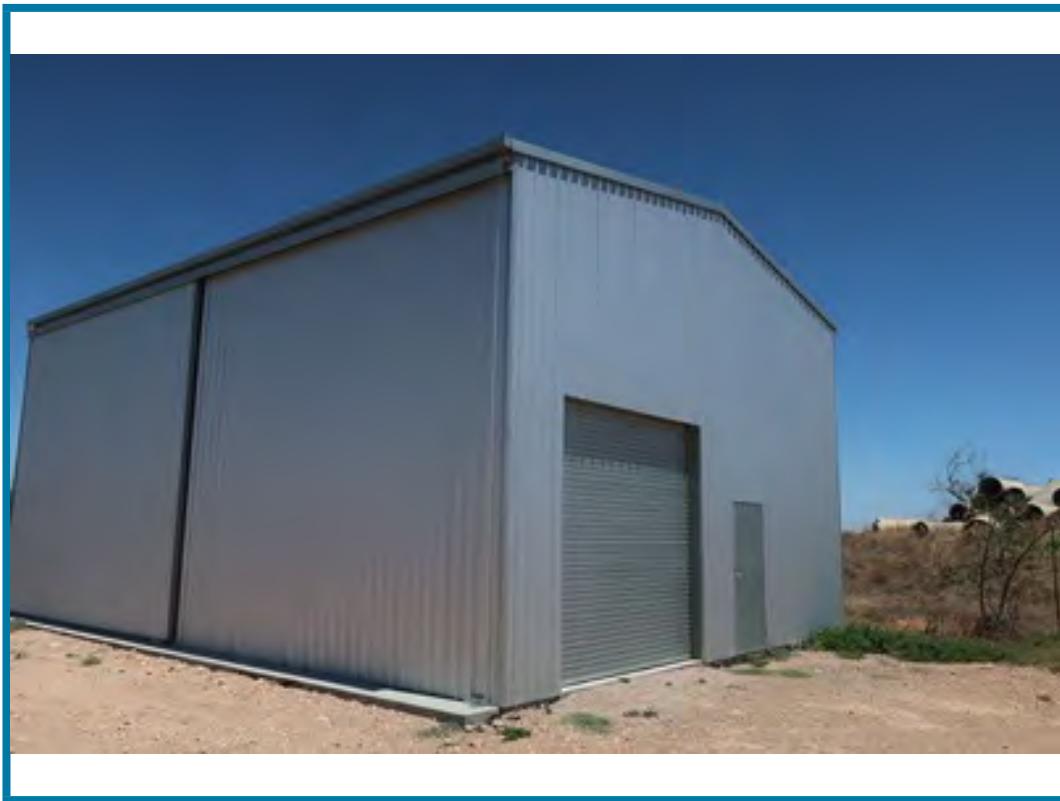
Location	Area	Component Materials	ACM Identified	Type Asbestos Assessment	ConditionPriority	Signage Required
Shed 3 - entire perimeter of building.		No Asbestos Materials	No	No sample taken - Visual ID
