Asbestos Report

YARRIAMBIACK SHIRE COUNCIL

PROPERTY ADDRESS:
LB16 PUBLIC HALL
28B SWANN STREET
BRIM VIC 3391

INSPECTION DATE: 8 FEBRUARY 2021
REFERENCE NUMBER: 62088

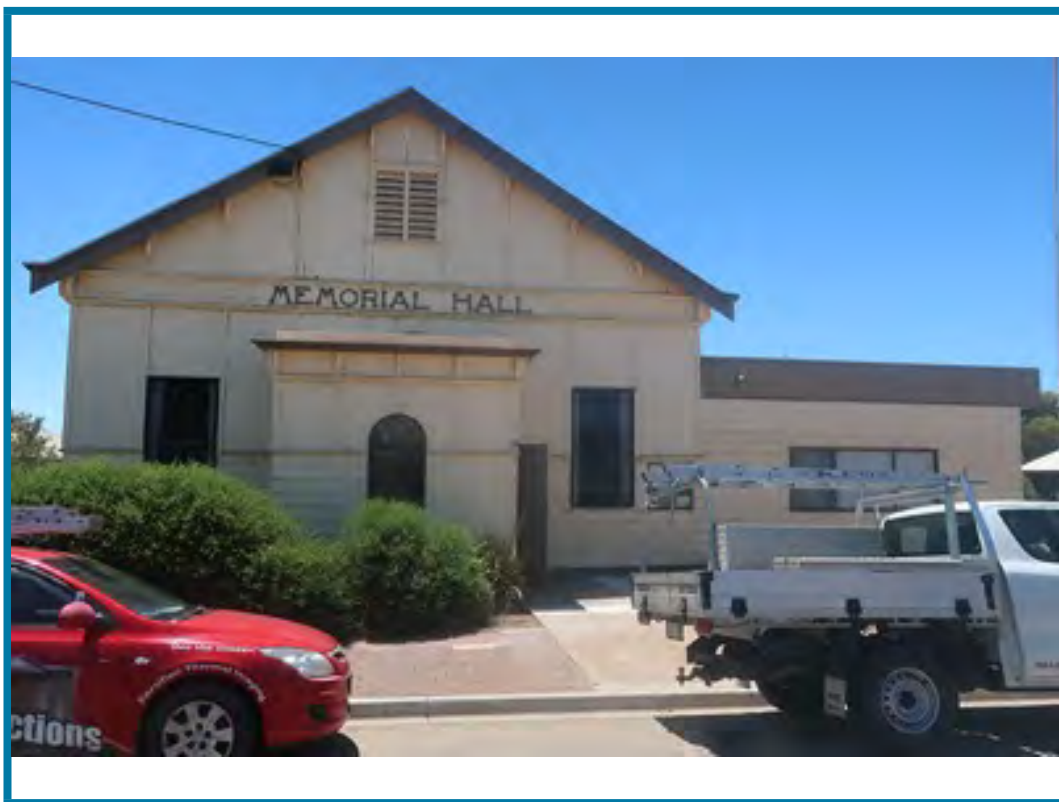
Location	Area	Component Materials	ACM Identified	Type Asbestos Assessment	Condition	Priority	Signage Required
LB16 Public Hall - entire perimeter of building.	Walls - planking	F C Sheeting	No	No Asbestos Detected			
				Sample taken 62088-001

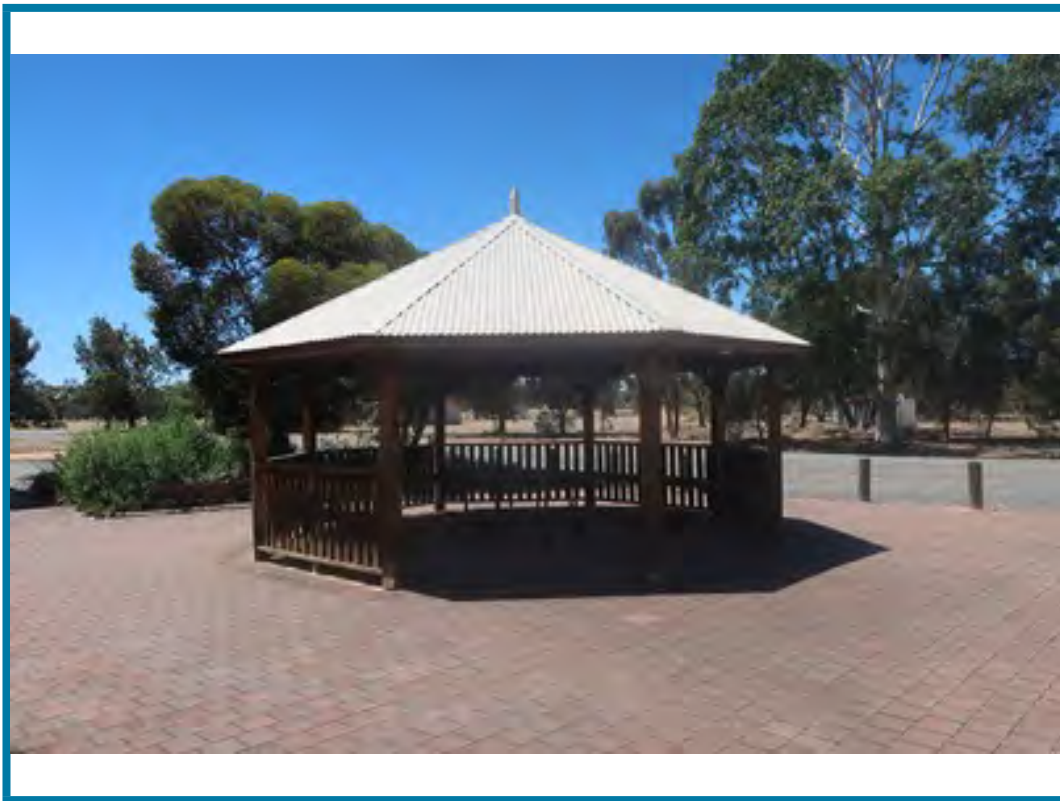
Location	Area	Component Materials	ACM Identified	Type Asbestos Assessment	ConditionPriority	Signage Required
Rotunda - Rotunda.		No Asbestos Materials	No	No sample taken - Visual ID

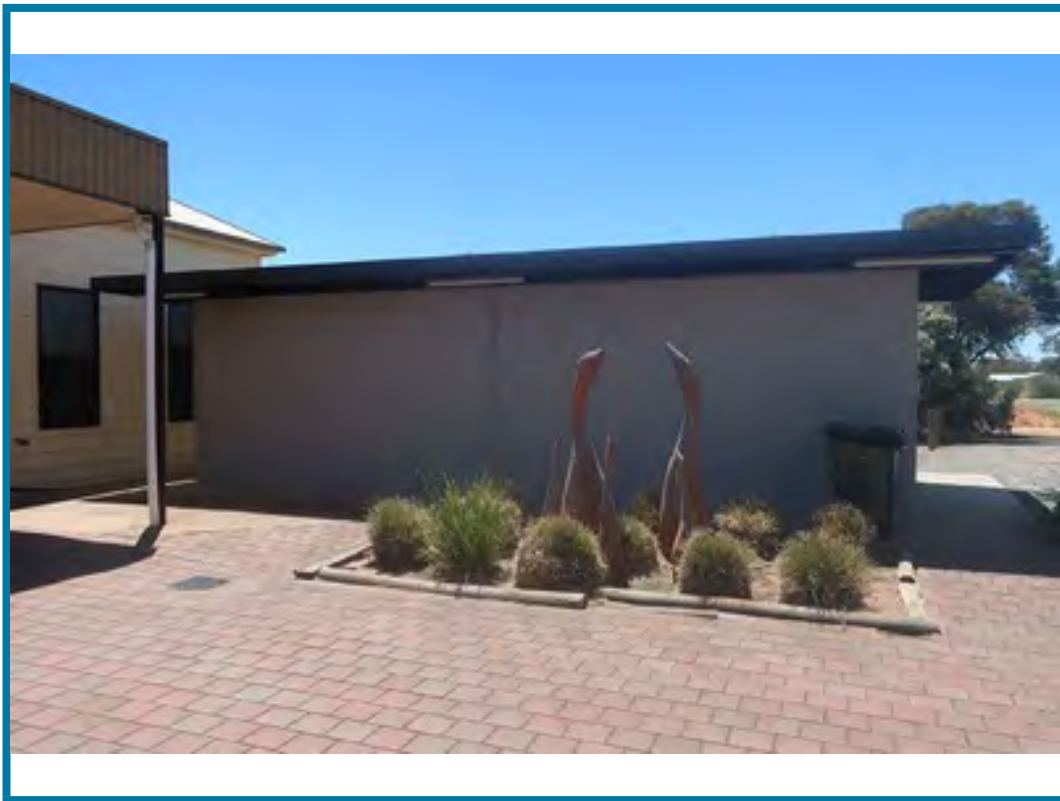
Location	Area	Component Materials	ACM Identified	Type Asbestos Assessment	ConditionPriority	Signage Required
Toilet Block - entire perimeter of building.		No Asbestos Materials	No	No sample taken - Visual ID
