# Asbestos Report

YARRIAMBIACK SHIRE COUNCIL

PROPERTY ADDRESS:  
LB76 & 81 CARAVAN PARK  
20-26 WYCHUNGA STREET  
LASCELLES VIC 3482

INSPECTION DATE: 10 FEBRUARY 2021  
REFERENCE NUMBER: 62089

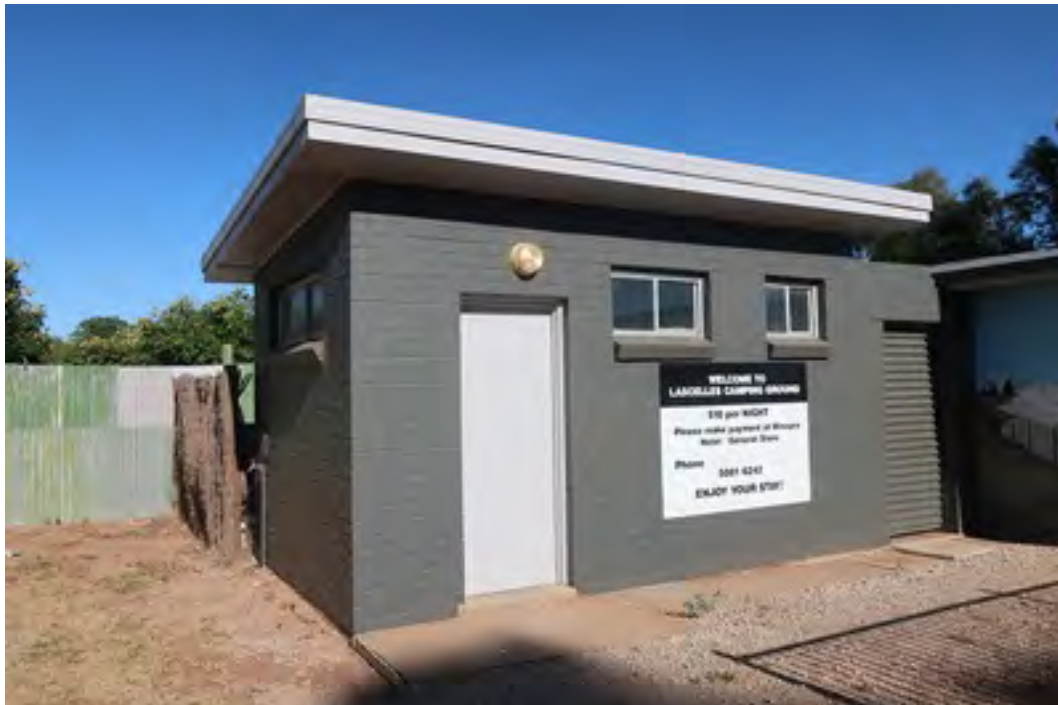
**Area 2**

RISK ASSESSMENT					
Type of Asbestos or Hazardous Material	No sample taken - Visual ID	Condition	GOOD	Likelihood of Damage	L (Low) – possible
		Activity	Moderate		
		Sealed	Yes	Friability	Bonded (non-friable)
		Labelled	Y	Exposure Risk	Low - Negligible or low risk
		Quantity

Priority	MEDIUM	Label Required	Yes	Re- Audit Date	10 Feb 2022
Action	No remedial action required, unless disturbed				
Recommendation	Maintain paint or sealant to ACM surfaces. Particular attention should be given to side edges, ensure paint/sealant covers ALL exposed ACM surfaces.				
Legislative Requirements Victorian Regulation 2007	Warning labels should be affixed. Avoid mechanical damage and abrasion. Remove if refurbishment, structural alteration or demolition is to be carried out in this area. Re-inspect every 12 months or earlier if disturbed or removed in accordance with the Victorian OH&S Regulation 2017. All remedial/removal repairs require a Clearance Inspection & Certificate to be recorded by an approved and competent assessor.

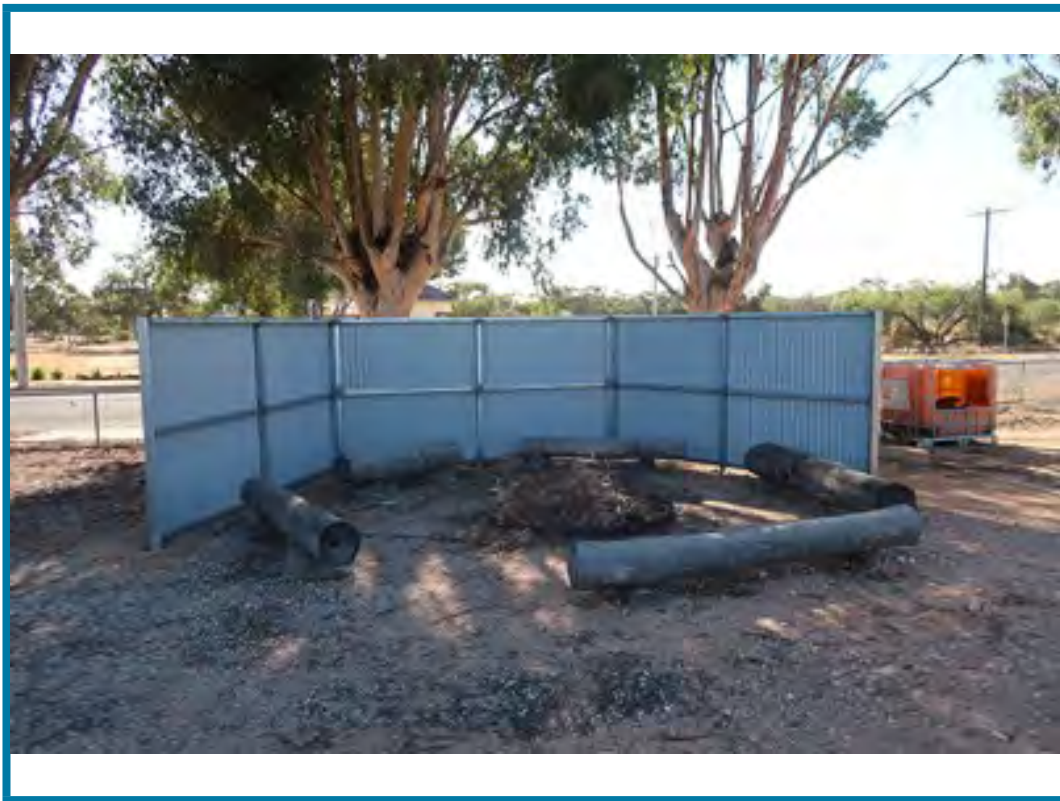
# Fire pit

<b>Location</b>	<b>Area</b>	<b>Component Materials</b>	<b>ACM Identified</b>	<b>Type Asbestos Assessment</b>	<b>Condition Priority</b>	<b>Signage Required</b>
Fire pit - Fire pit.		No Asbestos Materials	No	No sample taken - Visual ID

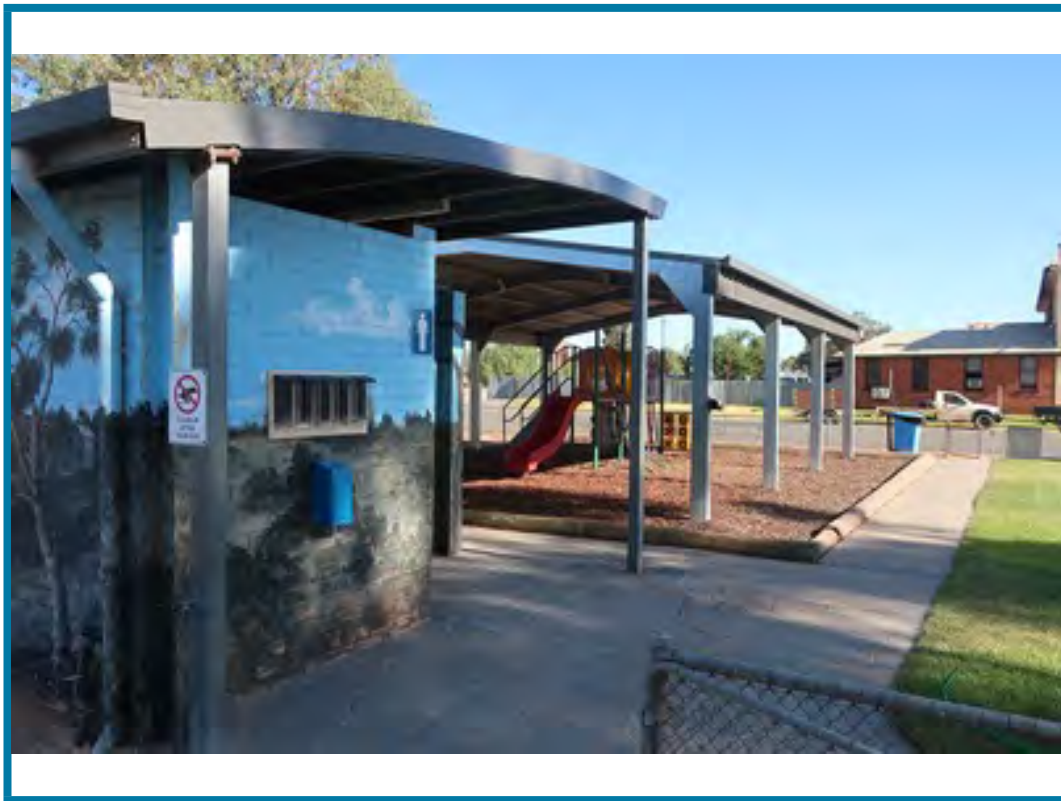
# Playground

<b>Location</b>	<b>Area</b>	<b>Component Materials</b>	<b>ACM Identified</b>	<b>Type Asbestos Assessment</b>	<b>Condition Priority</b>	<b>Signage Required</b>
Playground - Playground.		No Asbestos Materials	No	No sample taken - Visual ID

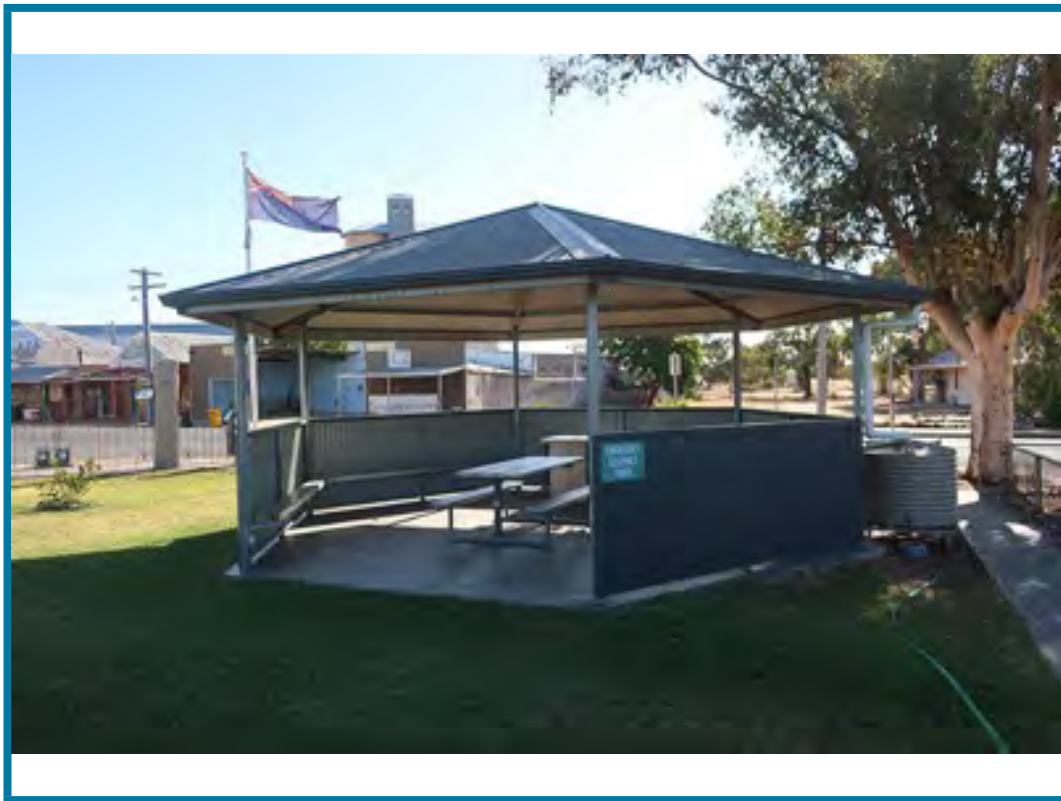
# Rotunda

Location	Area	Component Materials	ACM Identified	Type Asbestos Assessment	Condition	Priority	Signage Required
Rotunda - entire perimeter of building.		No Asbestos Materials	No	No sample taken - Visual ID

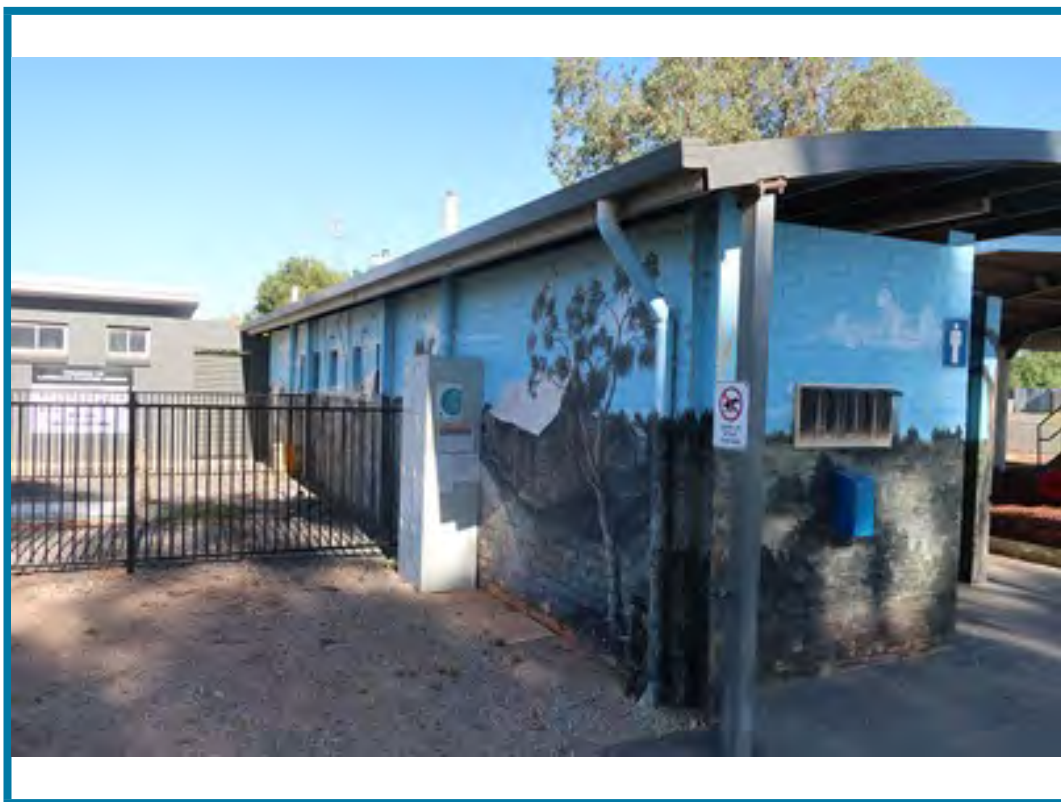
# Toilet Block

Location	Area	Component Materials	ACM Identified	Type Asbestos Assessment	Condition Priority	Signage Required
Toilet Block - entire perimeter of building.		No Asbestos Materials	No	No sample taken - Visual ID
