# Asbestos Report

YARRIAMBIACK SHIRE COUNCIL

PROPERTY ADDRESS:  
LB98 TENNIS COURTS / RECREATION  
CICELY STREET  
LASCELLES VIC 3482

INSPECTION DATE: 10 FEBRUARY 2021  
REFERENCE NUMBER: 62090

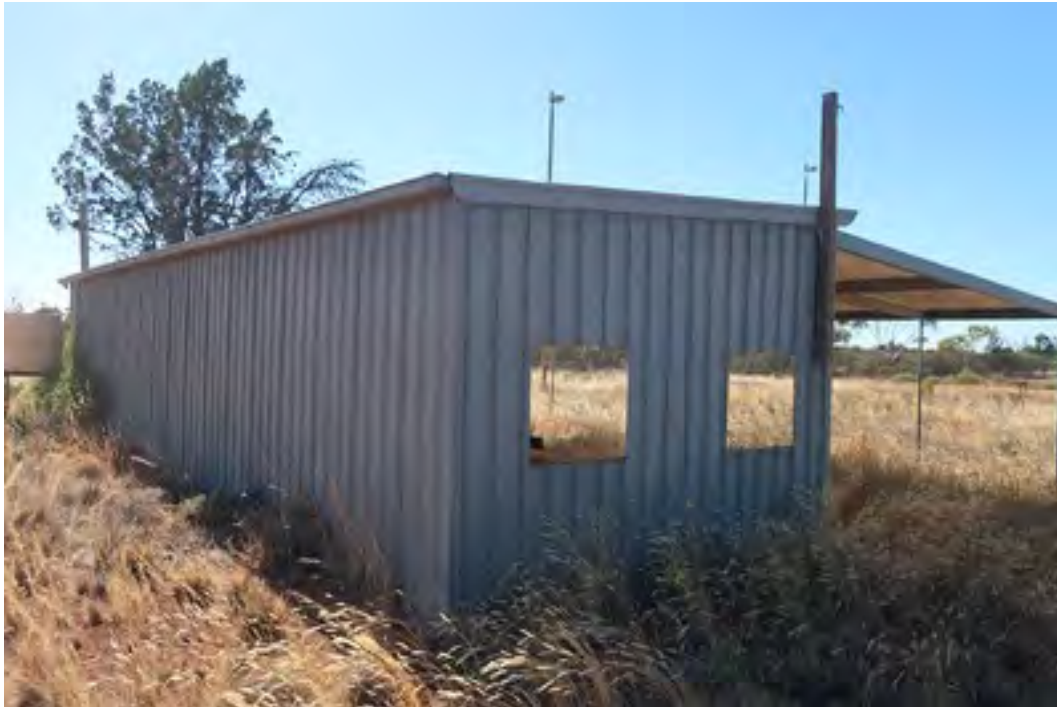
# Shed

- 1 Shed LB98 Tennis Courts / Recreation: rear of building. The Debris - Broken (Debris) has Asbestos Containing Material (ACM) present.
- 2 Shed LB98 Tennis Courts / Recreation: Storage. The Electrical board (Backing Board (Zelemite)) has Asbestos Containing Material (ACM) present.

Broken sections - The damaged area requires immediate remedial repairs. It is recommended the asbestos sheeting be replaced (preferred) or edges sealed with approved sealant and then the area be concealed by laminating (sheeting).

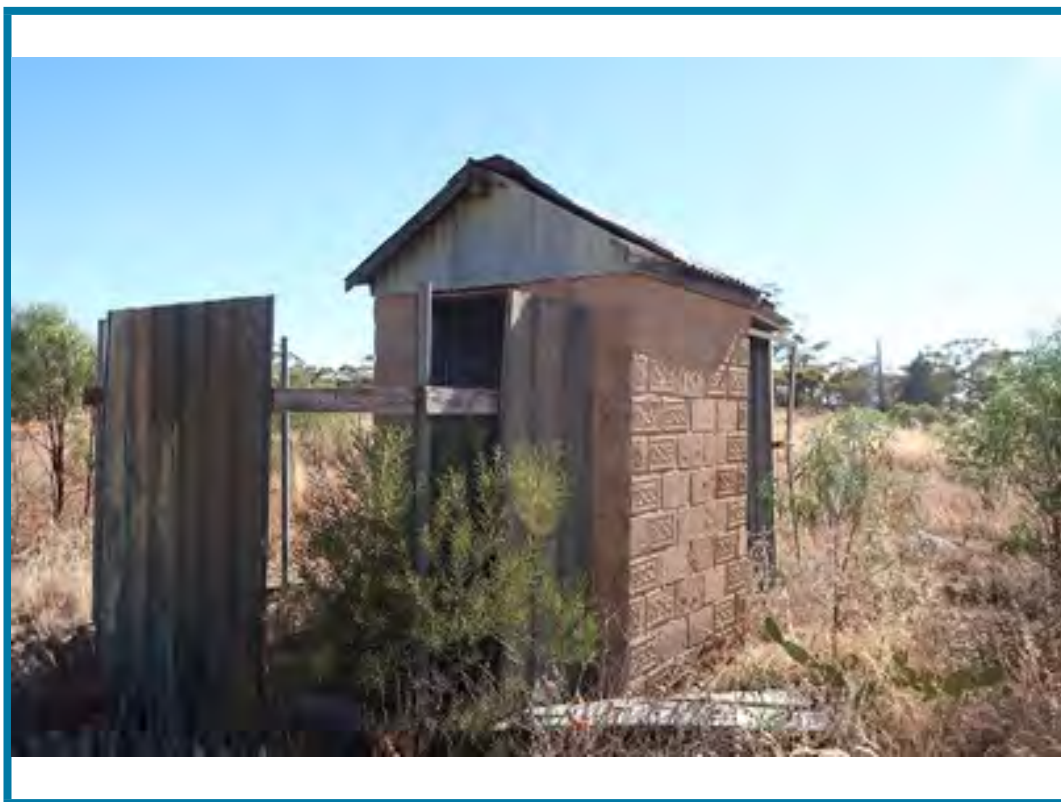
# Out house

<b>Location</b>	<b>Area</b>	<b>Component Materials</b>	<b>ACM Identified</b>	<b>Type Asbestos Assessment</b>	<b>ConditionPriority</b>	<b>Signage Required</b>
Out house - entire perimeter of building.		No Asbestos Materials	No	No sample taken - Visual ID

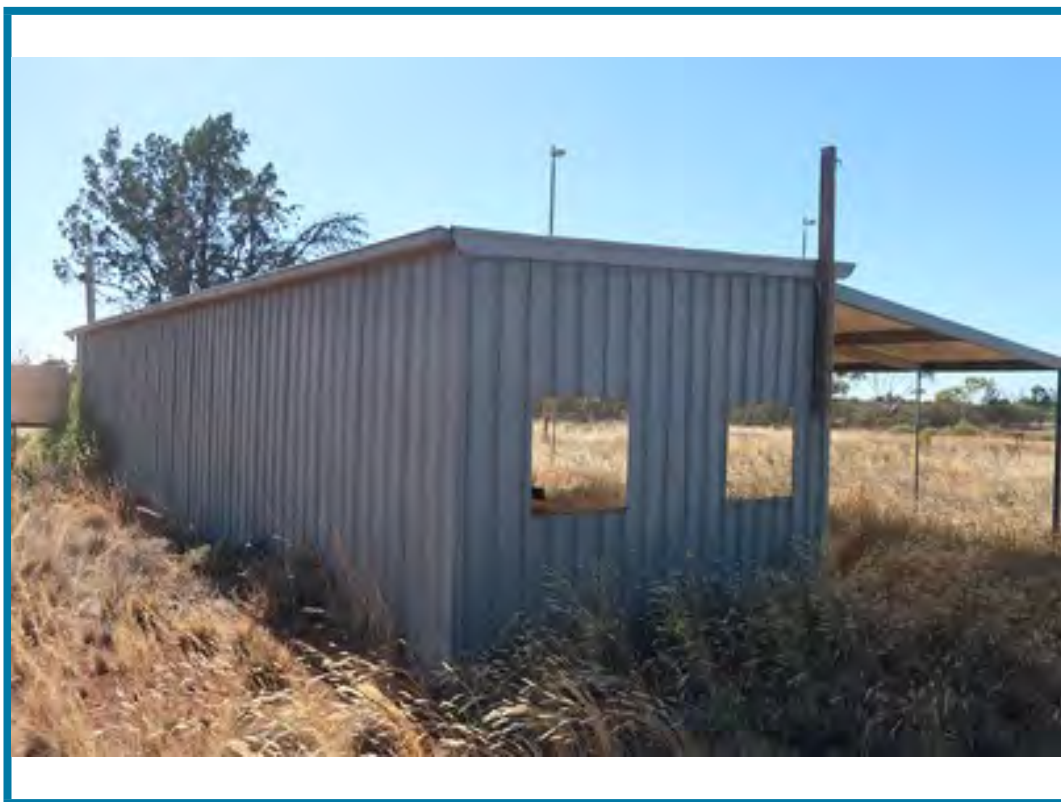
# Shed

Location	Area	Component Materials	ACM Identified	Type Asbestos Assessment	ConditionPriority	Signage Required
Shed - entire perimeter of building.		No Asbestos Materials	No	No sample taken - Visual ID

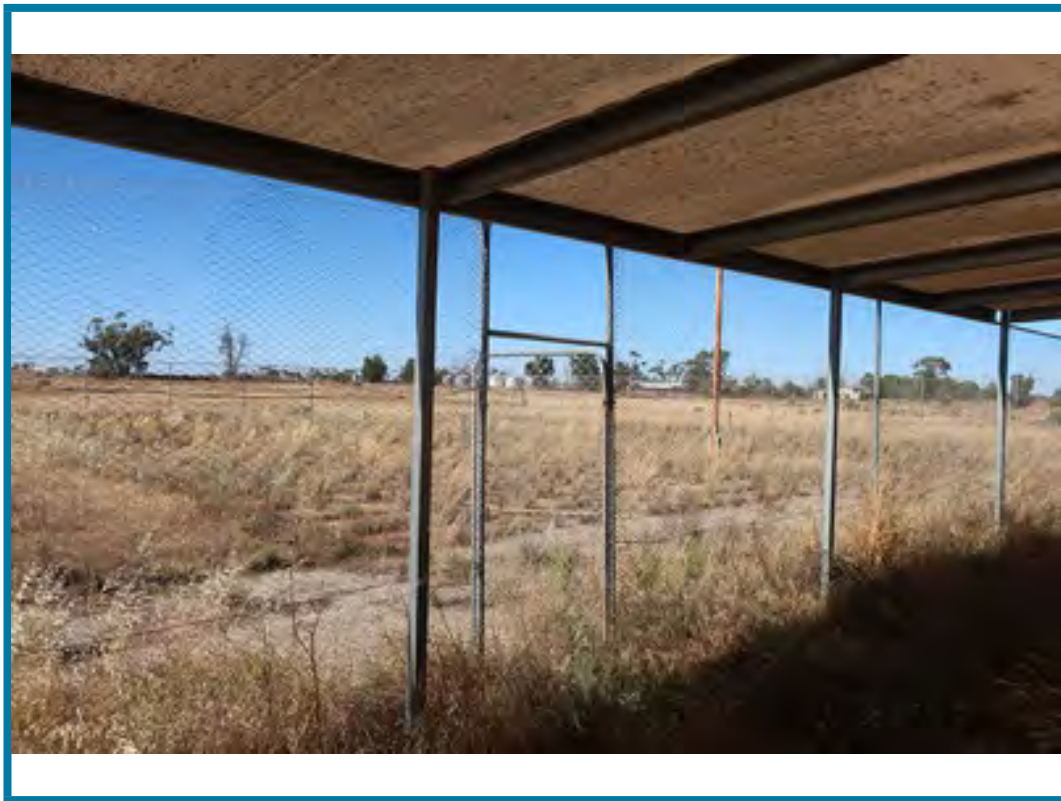
# Tennis Court

<b>Location</b>	<b>Area</b>	<b>Component Materials</b>	<b>ACM Identified</b>	<b>Type Asbestos Assessment</b>	<b>Condition Priority</b>	<b>Signage Required</b>
Tennis Court - Tennis Court.		No Asbestos Materials	No	No sample taken - Visual ID
