Asbestos Report

YARRIAMBIACK SHIRE COUNCIL

PROPERTY ADDRESS:
LB38 ELDERLY CITIZEN CLUBROOMS
MAIN STREET
MINYIP VIC 3392

INSPECTION DATE: 10 FEBRUARY 2021
REFERENCE NUMBER: 62093

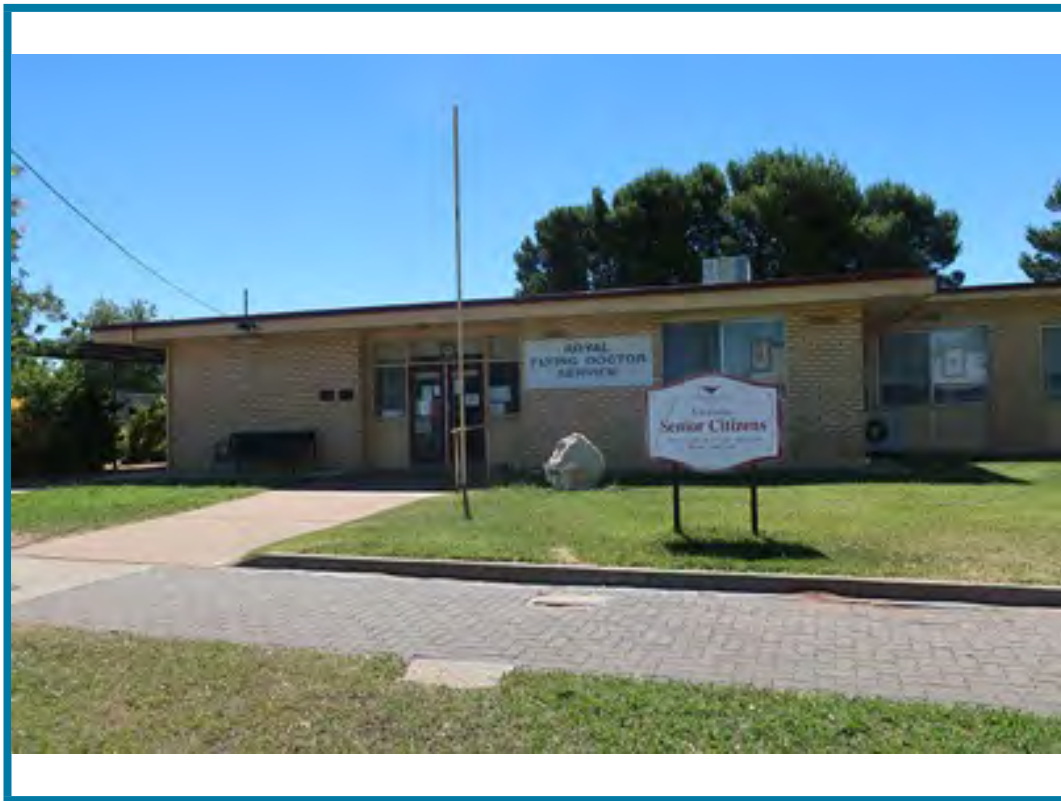
Location	Area	Component Materials	ACM Identified	Type Asbestos Assessment	Condition	Priority	Signage Required
Clubrooms - entire perimeter of building.	Soffit	F C Sheeting	Yes	No sample taken - Visual ID	GOOD	MEDIUM	Yes

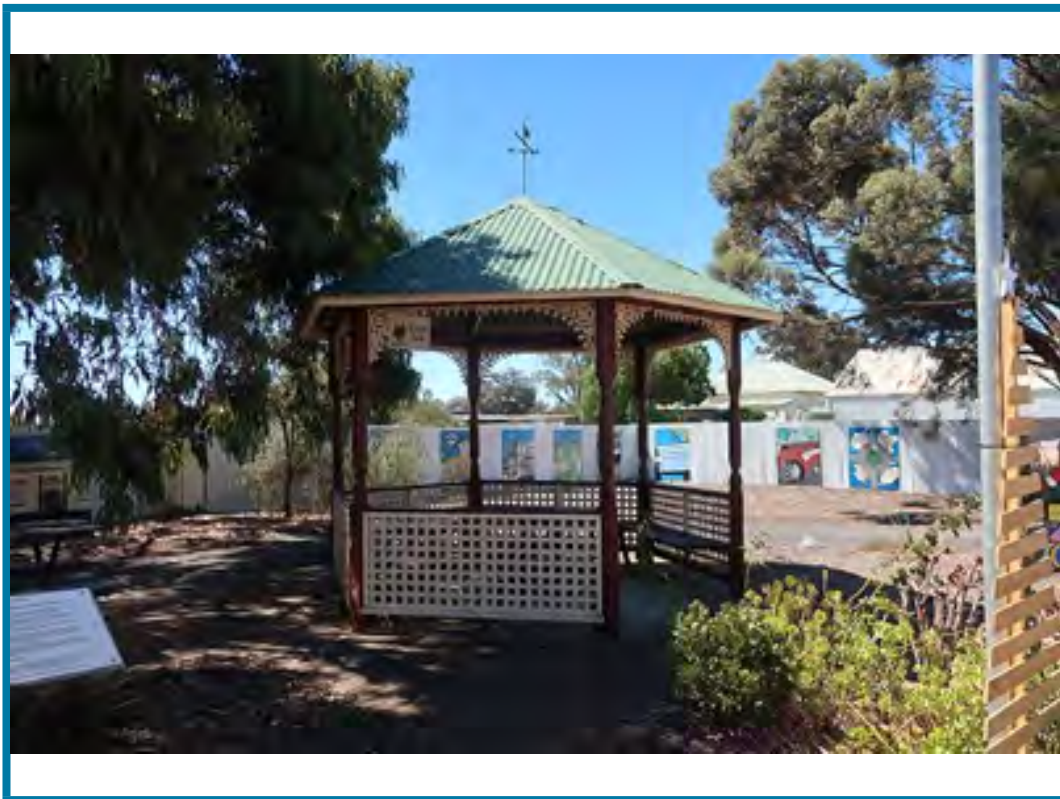
Location	Area	Component Materials	ACM Identified	Type Asbestos Assessment	Condition Priority	Signage Required
Rotunda - Rotunda.		No Asbestos Materials	No	No sample taken - Visual ID
