Asbestos Report

YARRIAMBIACK SHIRE COUNCIL

PROPERTY ADDRESS:
LB30A PRESCHOOL
29 MAIN STREET
MINYIP VIC 3392

INSPECTION DATE: 10 FEBRUARY 2021
REFERENCE NUMBER: 62094

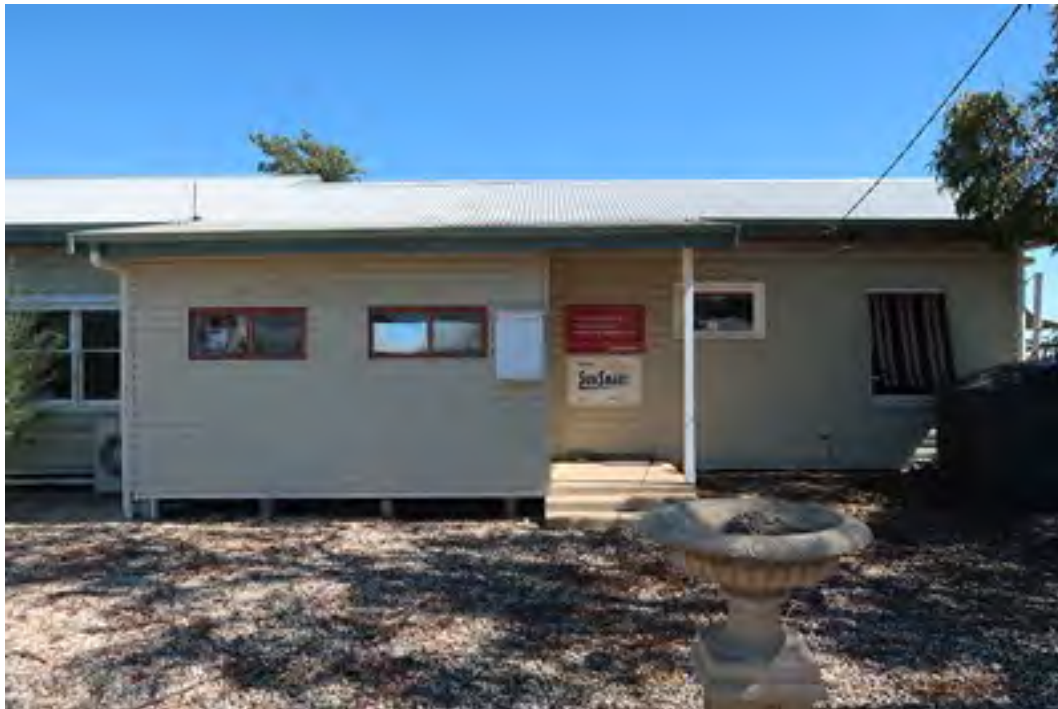
Area 1

Type of Asbestos or Hazardous Material	No sample taken - Visual ID	Condition	AVERAGE	Likelihood of Damage	L (Low) – possible
		Activity	Moderate		
		Sealed	No	Friability	Bonded (non-friable)
		Labelled	Y	Exposure Risk	Medium - Moderate risk
		Quantity

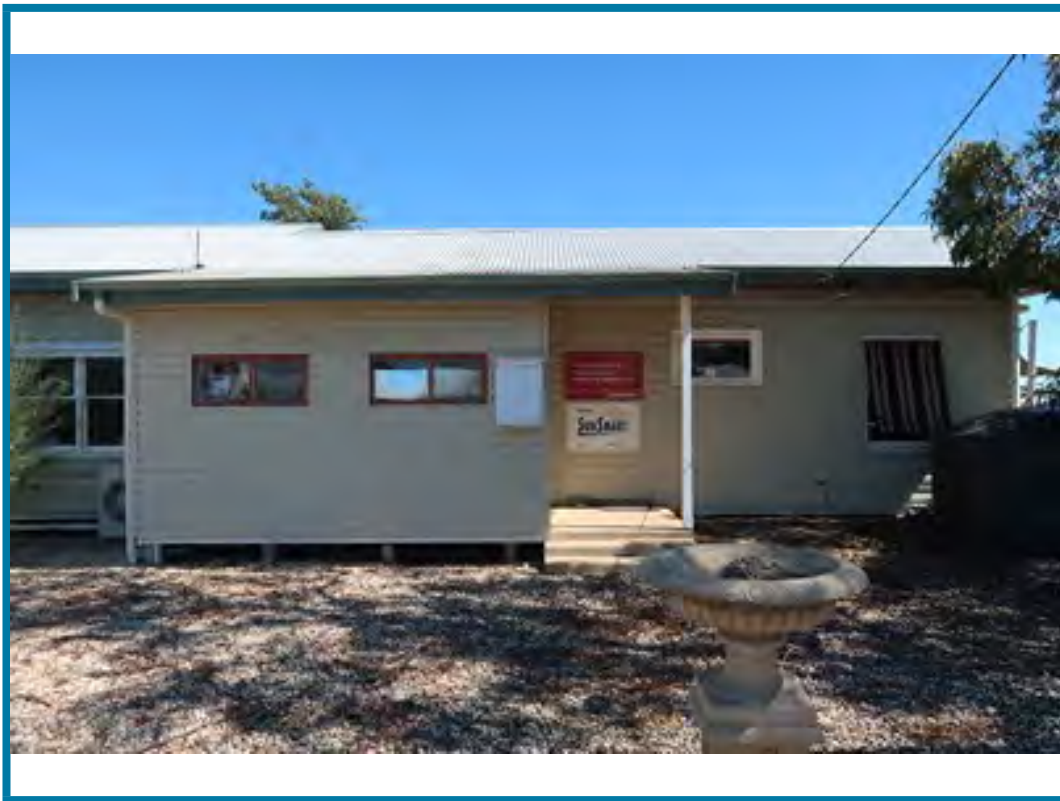
Location	Area	Component Materials	ACM Identified	Type Asbestos Assessment	ConditionPriority	Signage Required
LB30A Preschool - entire perimeter of building.	Soffit	F C Sheeting	No	No Asbestos Detected		
				Sample taken 62094-001

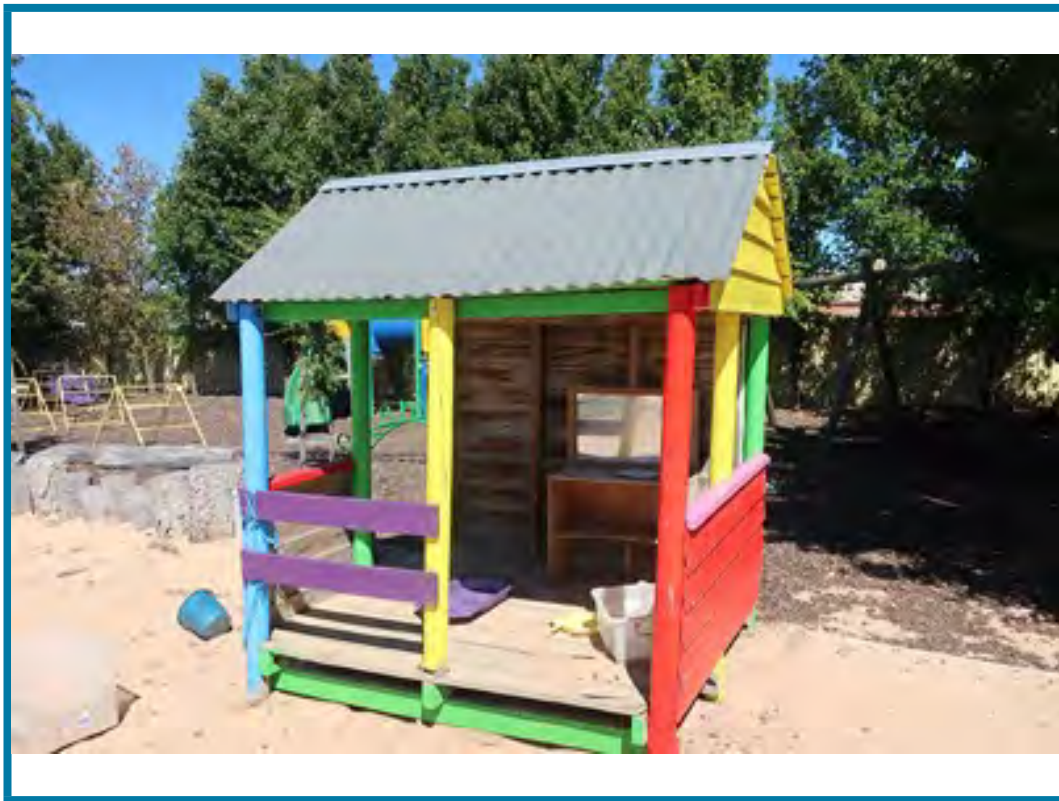
Location	Area	Component Materials	ACM Identified	Type Asbestos Assessment	Condition Priority	Signage Required
Playground - Hut.		No Asbestos Materials	No	No sample taken - Visual ID

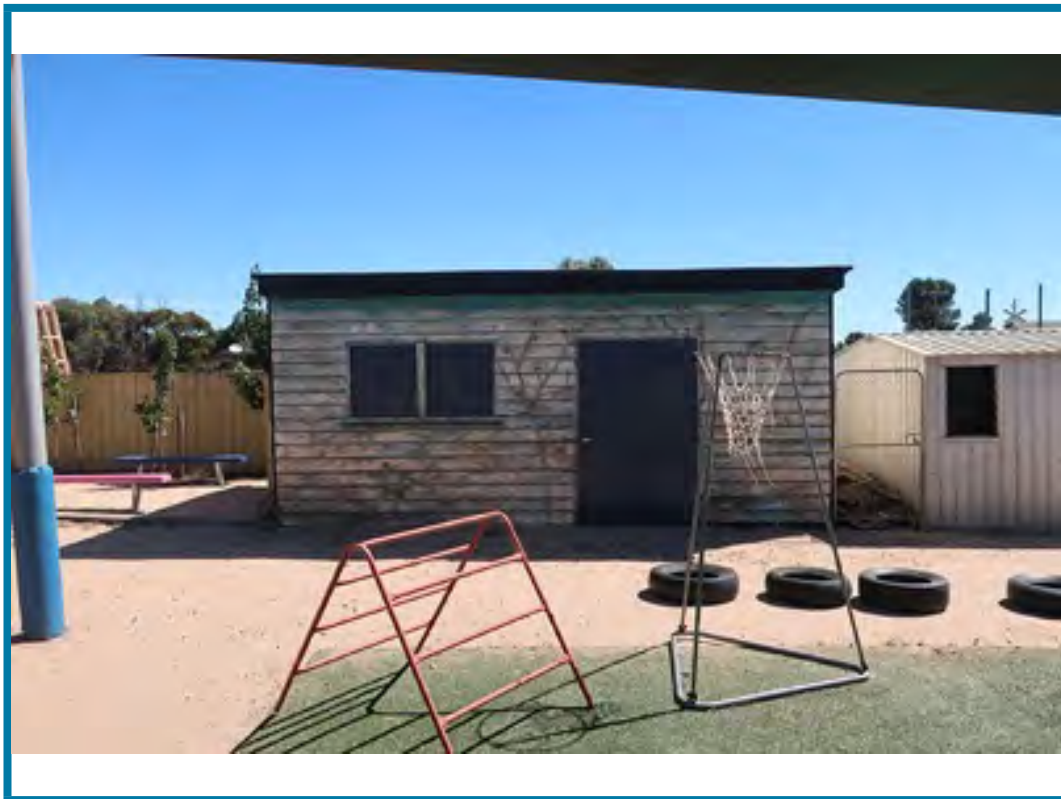
Location	Area	Component Materials	ACM Identified	Type Asbestos Assessment	ConditionPriority	Signage Required
Store Shed - entire perimeter of building.	 	No Asbestos Materials	No	No sample taken - Visual ID		
Store Shed - entire perimeter of building.	 	No Asbestos Materials	No	No sample taken - Visual ID		
Store Shed - Shed.	 	No Asbestos Materials	No	No sample taken - Visual ID		
Store Shed - Shed.	 	No Asbestos Materials	No	No sample taken - Visual ID
