Asbestos Report

YARRIAMBIACK SHIRE COUNCIL

PROPERTY ADDRESS:
LR2B CARAVAN PARK
48 LAKE STREET
MURTOA VIC 3390

INSPECTION DATE: 10 FEBRUARY 2021
REFERENCE NUMBER: 62095

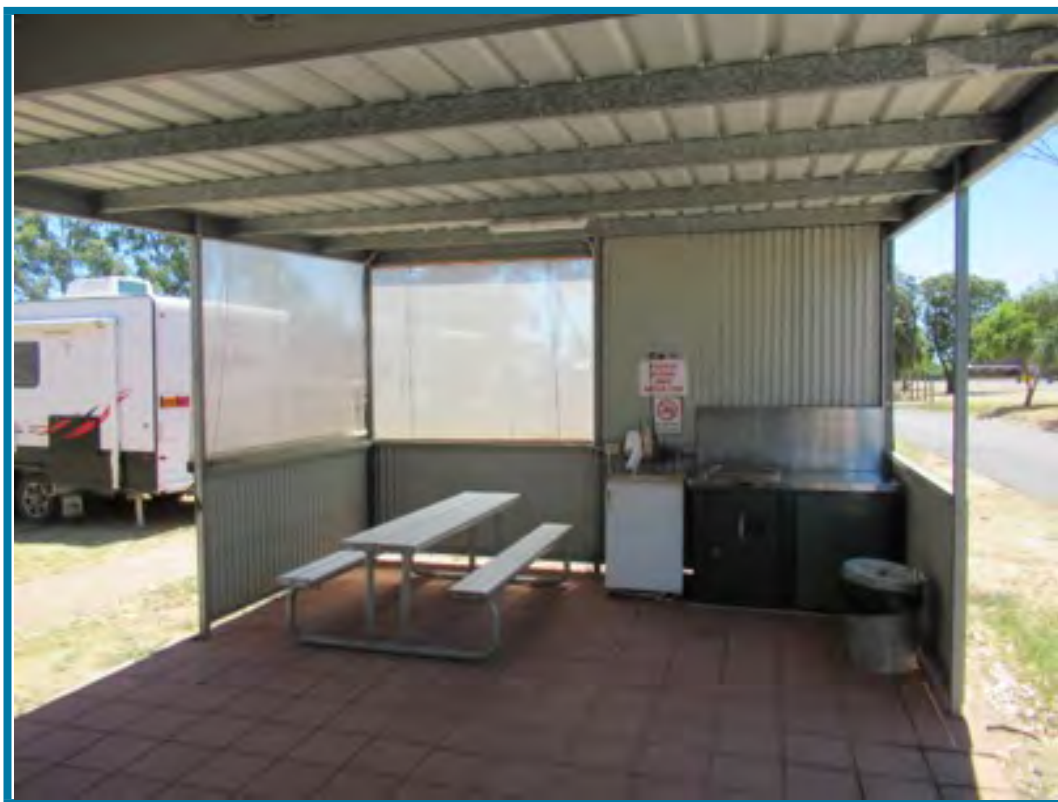
Location	Area	Component Materials	ACM Identified	Type Asbestos Assessment	ConditionPriority	Signage Required
Shelter - Shelter.		No Asbestos Materials	No	No sample taken - Visual ID

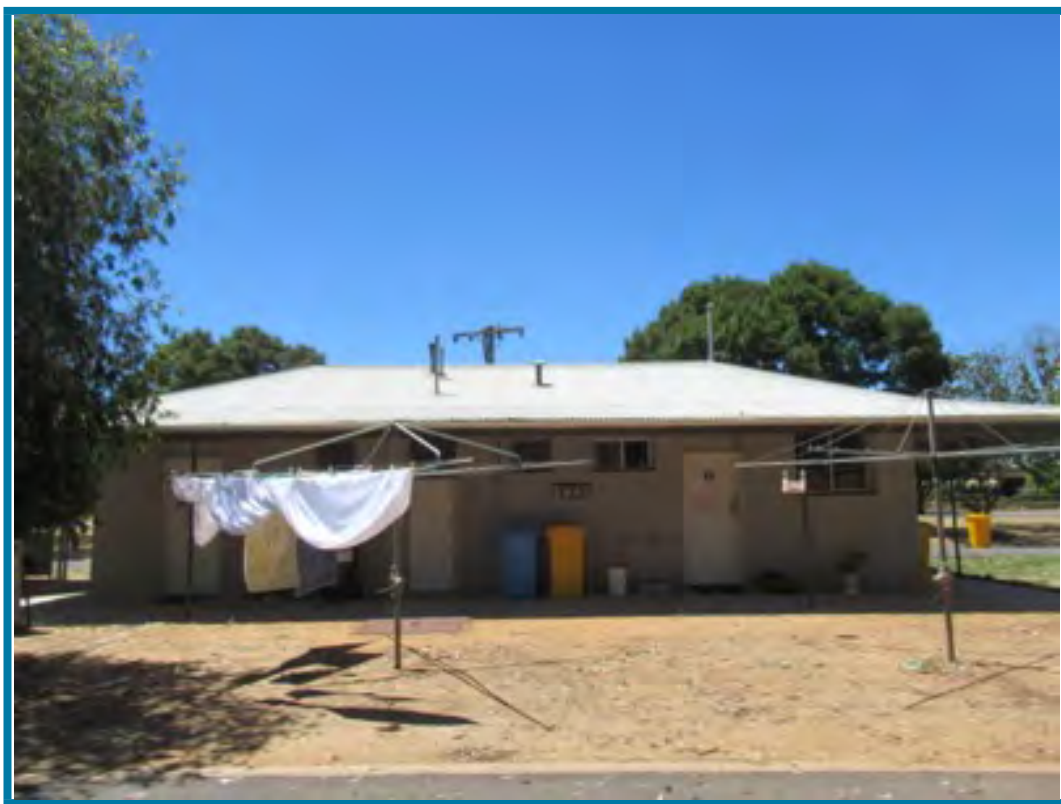
Location	Area	Component Materials	ACM Identified	Type Asbestos Assessment	Condition	Priority	Signage Required
Toilet block - External & Internal.	Infill panel/s above windows	F C Sheeting	Yes	No sample taken - Visual ID	GOOD	MEDIUM	Yes
