# Asbestos Report

YARRIAMBIACK SHIRE COUNCIL

PROPERTY ADDRESS:  
LR4B IWC. / PRESCHOOL  
38-40 MARMA STREET  
MURTOA VIC 3390

INSPECTION DATE: 10 FEBRUARY 2021  
REFERENCE NUMBER: 62096

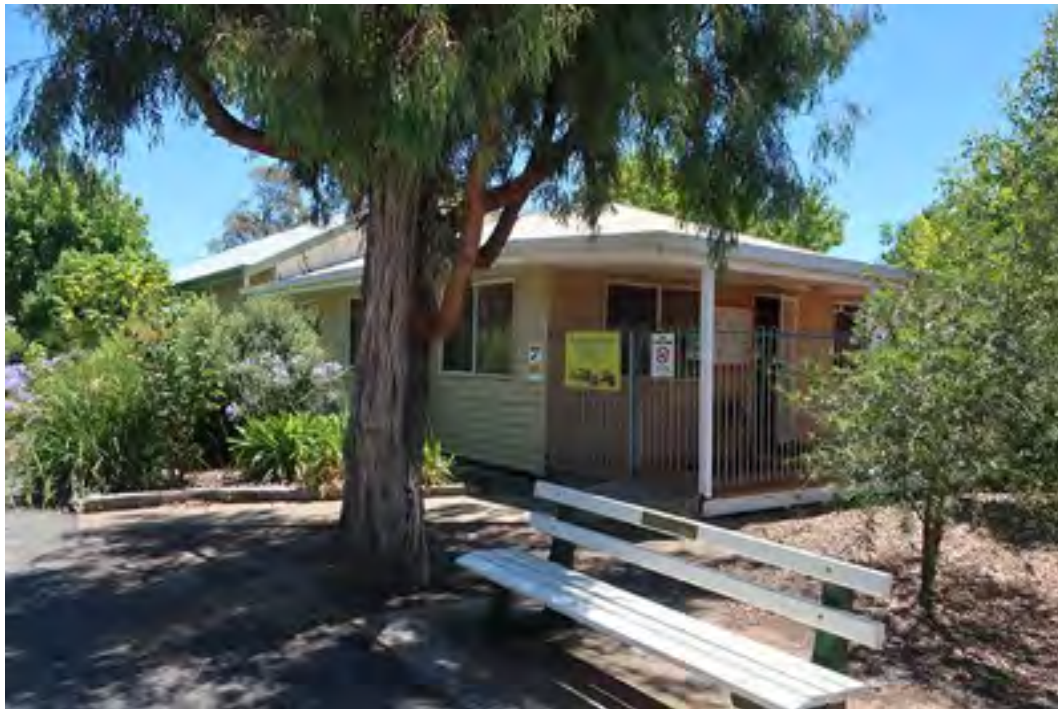
**Area 2**

2	LR4B IWC. / Preschool: Rear Entry. The Walls and Ceiling (F C Sheeting) has Asbestos Containing Material (ACM) present.
1	LR4B IWC. / Preschool: Play Room. The Airconditioner - Heater Element board (Backing board) has Asbestos Containing Material (ACM) present.

RISK ASSESSMENT					
Type of Asbestos or Hazardous Material	Chrysotile	Condition	GOOD	Likelihood of Damage	L (Low) – possible
	Sample taken 62096-002	Activity	Moderate		
		Sealed	Yes	Friability	Bonded (non-friable)
		Labelled	Y	Exposure Risk	Low - Negligible or low risk
		Quantity

Priority	MEDIUM	Label Required	Yes	Re- Audit Date	10 Feb 2022
Action	No remedial action required, unless disturbed				
Recommendation	Maintain paint or sealant to ACM surfaces. Particular attention should be given to side edges, ensure paint/sealant covers ALL exposed ACM surfaces.				
Legislative Requirements Victorian Regulation 2007	Warning labels should be affixed. Avoid mechanical damage and abrasion. Remove if refurbishment, structural alteration or demolition is to be carried out in this area. Re-inspect every 12 months or earlier if disturbed or removed in accordance with the Victorian OH&S Regulation 2017. All remedial/removal repairs require a Clearance Inspection & Certificate to be recorded by an approved and competent assessor.

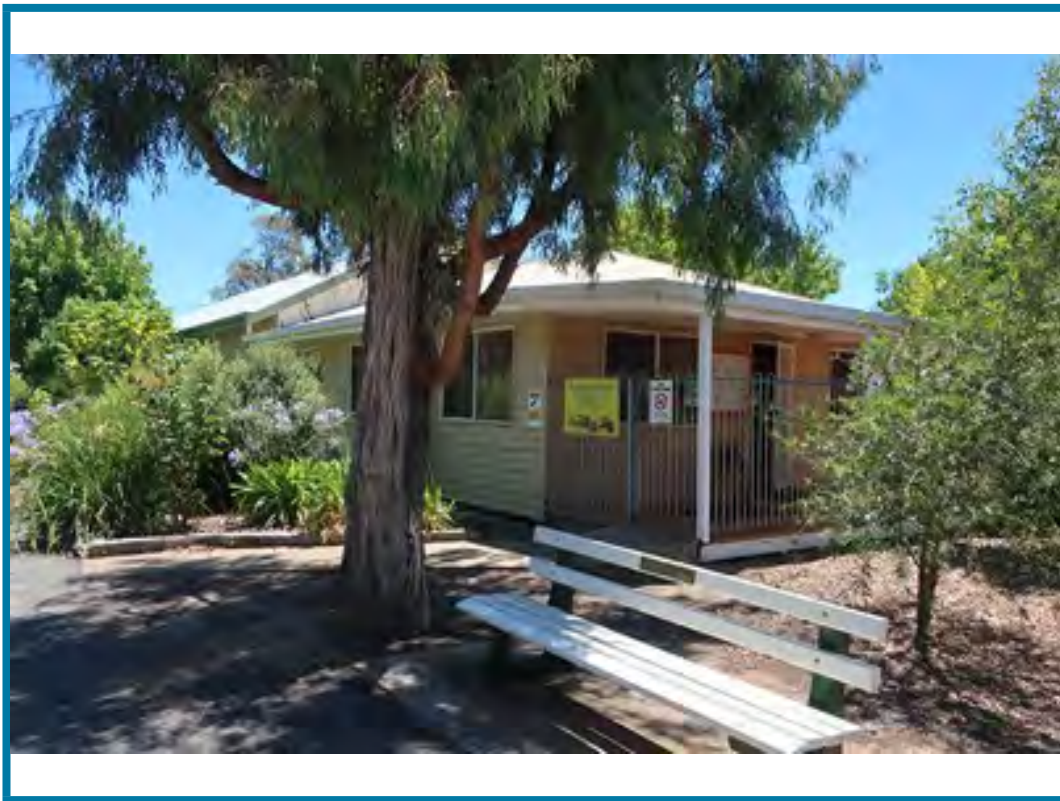
Location	Area	Component Materials	ACM Identified	Type Asbestos Assessment	Condition	Priority	Signage Required
LR4B IWC. / Preschool - entire perimeter of building.	Soffit	F C Sheeting	No	No Asbestos Detected			
				Sample taken	62096-001

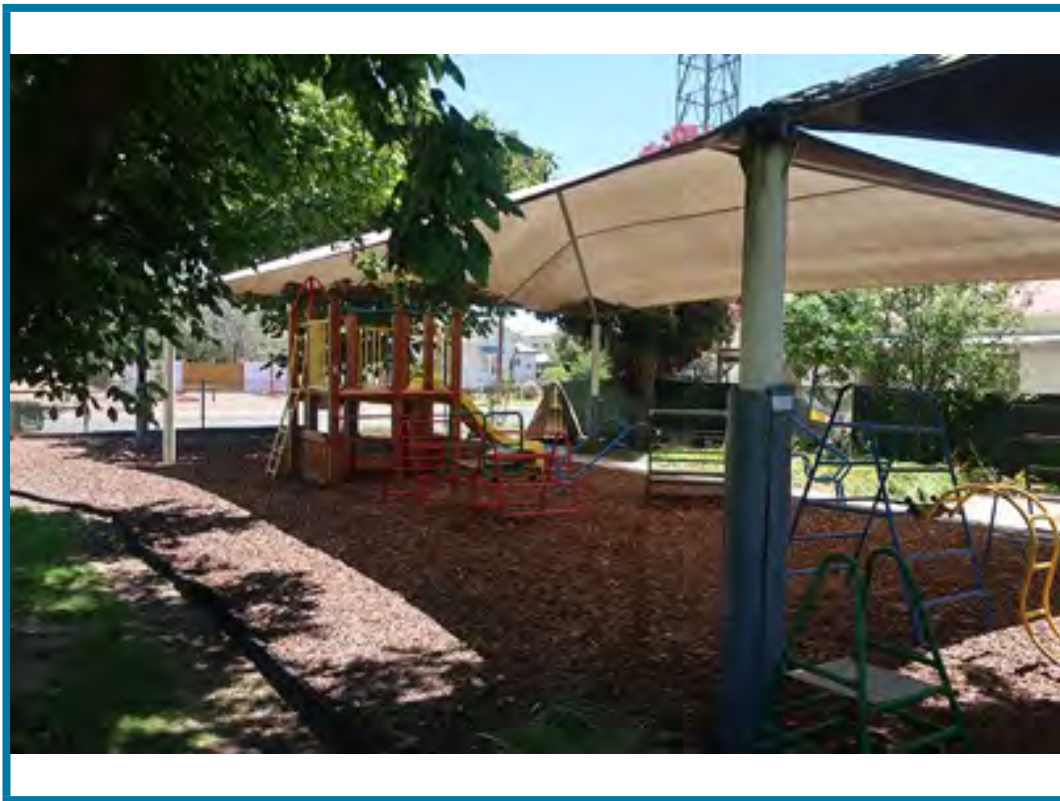
Location	Area	Component Materials	ACM Identified	Type Asbestos Assessment	Condition	Priority	Signage Required
Playground - Playground.		No Asbestos Materials	No	No sample taken - Visual ID

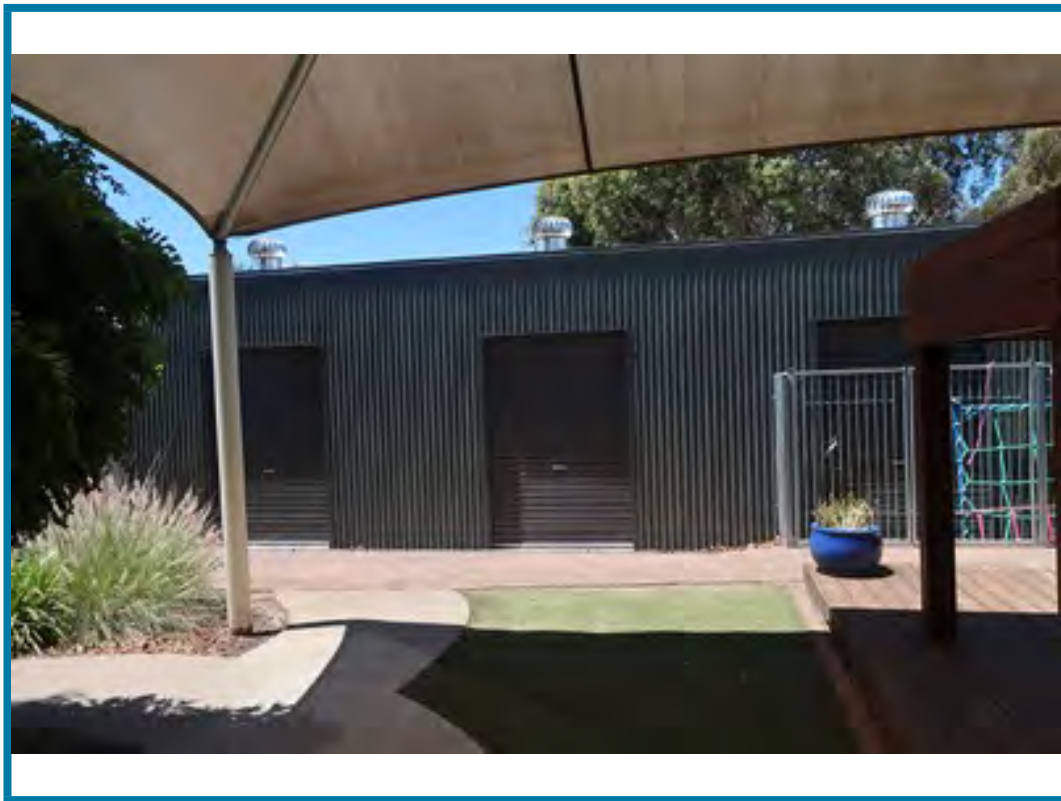
Location	Area	Component Materials	ACM Identified	Type Asbestos Assessment	Condition	Priority	Signage Required
Shed - entire perimeter of building.		No Asbestos Materials	No	No sample taken - Visual ID
