# Asbestos Report

YARRIAMBIACK SHIRE COUNCIL

PROPERTY ADDRESS:  
LB36 SHIRE DEPOT / WORKSHOP  
1469 WIMMERA HIGHWAY  
MURTOA VIC 3390

INSPECTION DATE: 10 FEBRUARY 2021  
REFERENCE NUMBER: 62098

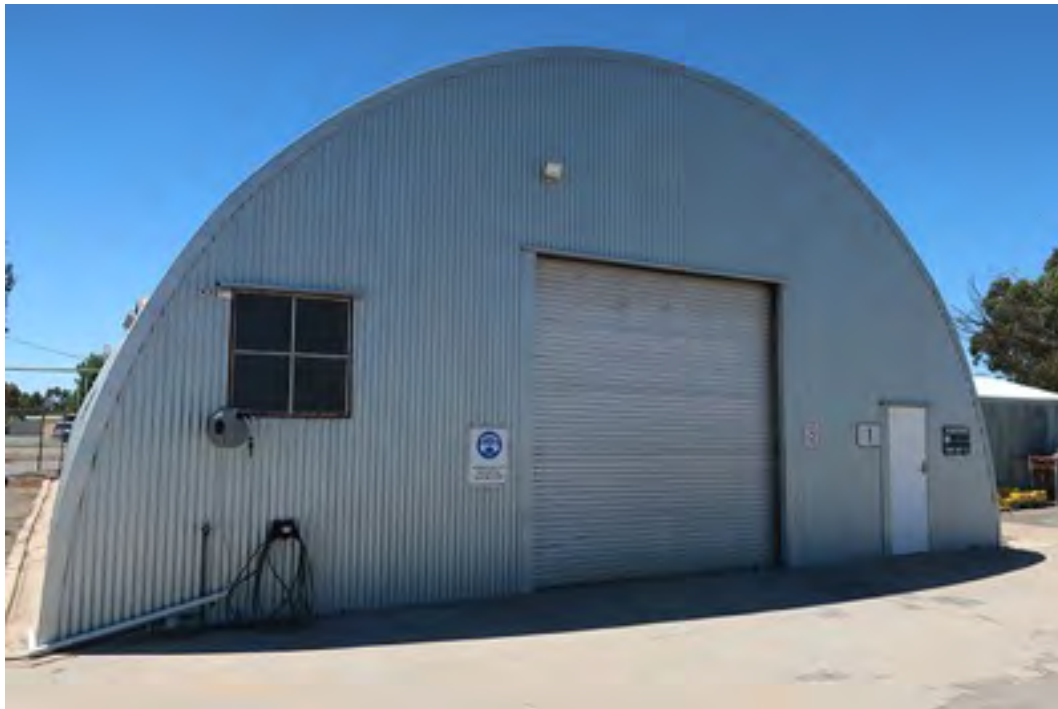
**Area 3**

RISK ASSESSMENT					
Type of Asbestos or Hazardous Material	Chrysotile	Condition	AVERAGE	Likelihood of Damage	L (Low) – possible
	Sample taken 62098-002	Activity	Moderate	Friability	Exposed Fibres
		Sealed	Yes	Exposure Risk	Medium - Moderate risk
		Labelled	Y		
		Quantity

Priority	HIGH	Label Required	Yes	Re- Audit Date	10 Feb 2022
Action	Remedial repairs required - seal raw material / edges				
Recommendation	Penetration Holes - The exposed edges require approved sealant. It is further recommended the gaps be filled with sealant.				
Legislative Requirements Victorian Regulation 2007	Damaged ACM visible in area. Requires IMMEDIATE ATTENTION. WARNING labels should be affixed. Avoid mechanical damage and abrasion. Remove if refurbishment, structural alteration or demolition is to be carried out in this area. Re-inspect every 12 months or earlier if disturbed or removed in accordance with the Victorian OH&S Regulation 2017. All remedial/removal repairs require a Clearance Inspection & Certificate to be recorded by an approved and competent assessor.

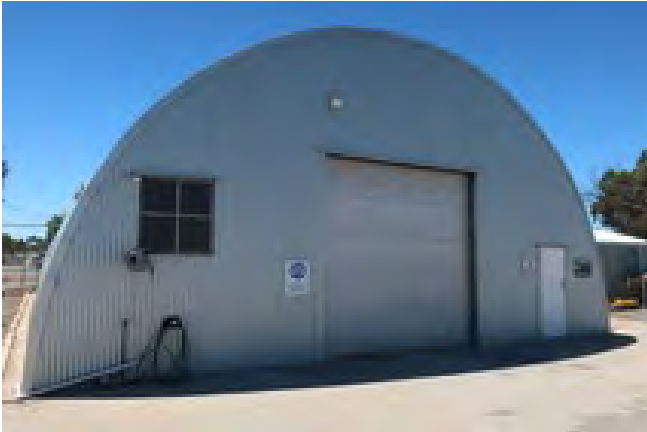
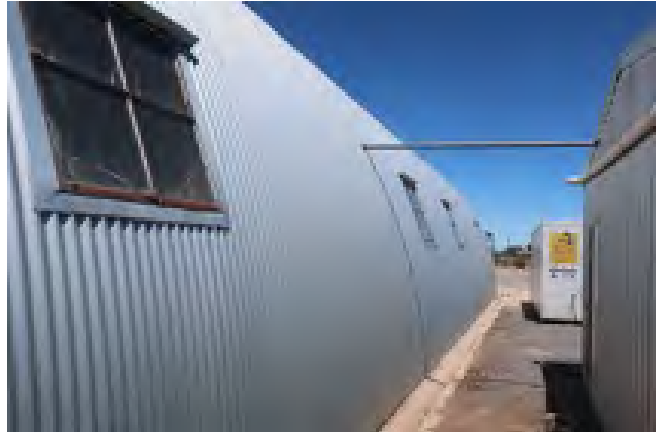
<b>Type of Asbestos or Hazardous Material</b>	No sample taken - Visual ID	<b>Condition</b>	GOOD	<b>Likelihood of Damage</b>	L (Low) – possible
		<b>Activity</b>	Moderate		
		<b>Sealed</b>	Yes	<b>Friability</b>	Bonded (non-friable)
		<b>Labelled</b>	Y	<b>Exposure Risk</b>	Low - Negligible or low risk
		<b>Quantity</b>

<b>Priority</b>	MEDIUM	<b>Label Required</b>	Yes	<b>Re- Audit Date</b>	10 Feb 2022
<b>Action</b>	No remedial action required, unless disturbed				
<b>Recommendation</b>	Maintain paint or sealant to ACM surfaces. Particular attention should be given to side edges, ensure paint/sealant covers ALL exposed ACM surfaces.				
<b>Legislative Requirements Victorian Regulation 2007</b>	Warning labels should be affixed. Avoid mechanical damage and abrasion. Remove if refurbishment, structural alteration or demolition is to be carried out in this area. Re-inspect every 12 months or earlier if disturbed or removed in accordance with the Victorian OH&S Regulation 2017. All remedial/removal repairs require a Clearance Inspection & Certificate to be recorded by an approved and competent assessor.

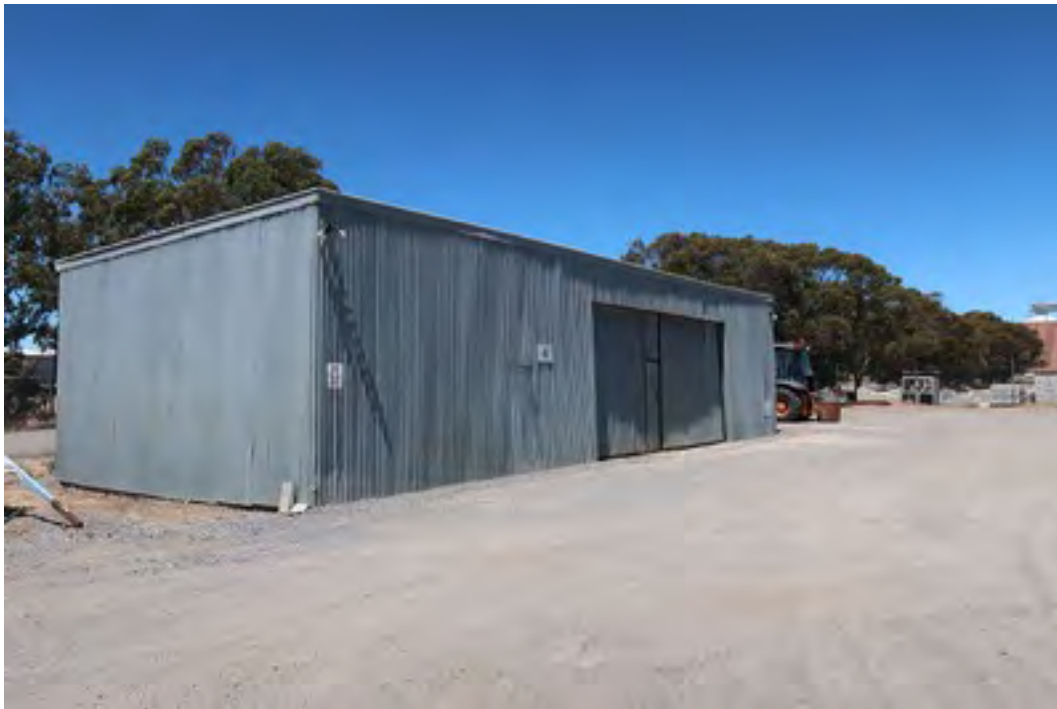
**Area 1**

1 4 - Shed: left side of building. The Debris - Broken (Debris) has Asbestos Containing Material (ACM) present.

**4 - Shed: left side of builing. The Debris - Broken (Debris) has Asbestos Containing Material (ACM) present.**

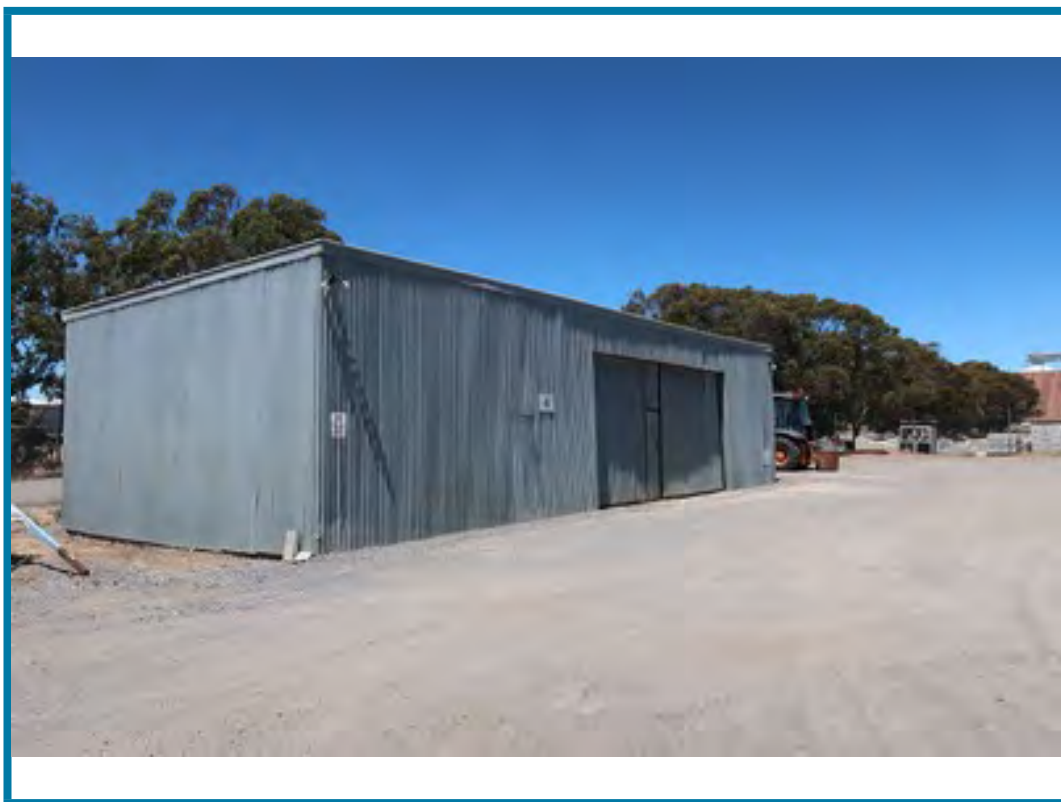
## 4 - Shed

Location	Area	Component Materials	ACM Identified	Type Asbestos Assessment	Condition	Priority	Signage Required
4 - Shed - entire perimeter of building.		No Asbestos Materials	No	No sample taken - Visual ID

4 - Shed - left side of builing.	Debris - Broken	Debris	Yes	Chrysotile

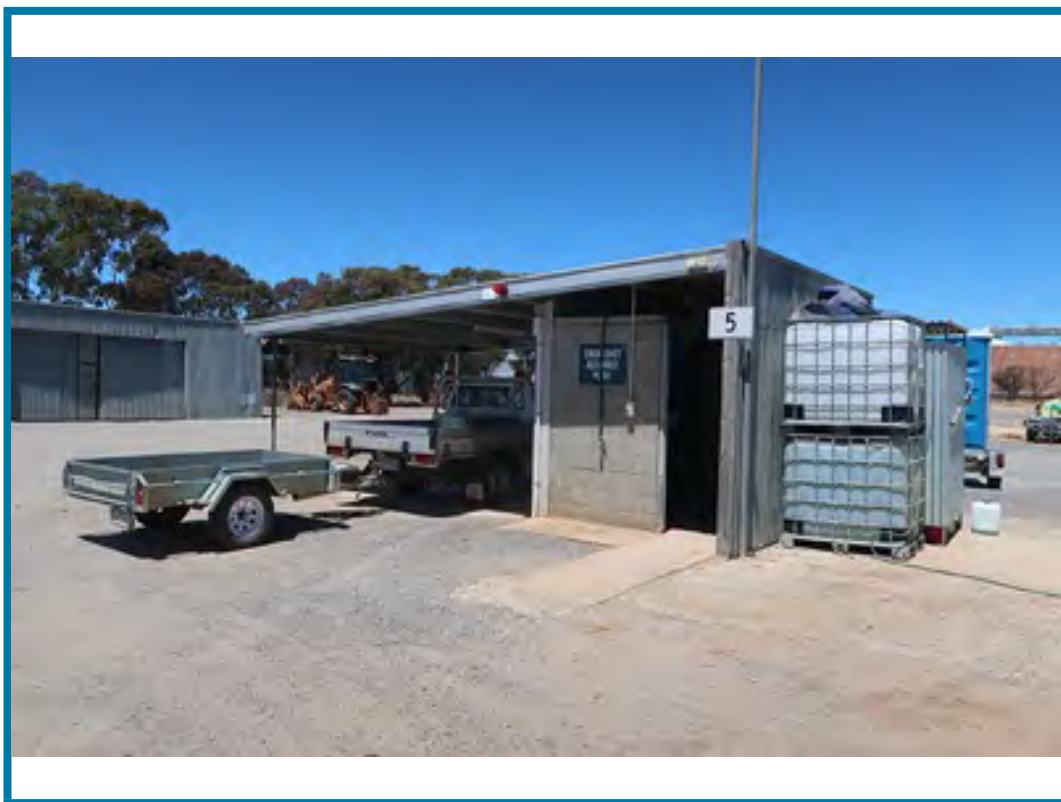
## 5 - Toilet block

Location	Area	Component Materials	ACM Identified	Type Asbestos Assessment	Condition	Priority	Signage Required
5 - Toilet block - front & rear of building.	Wall - cover panel	F C Sheeting	No	No Asbestos Detected			
				Sample taken 62098-010

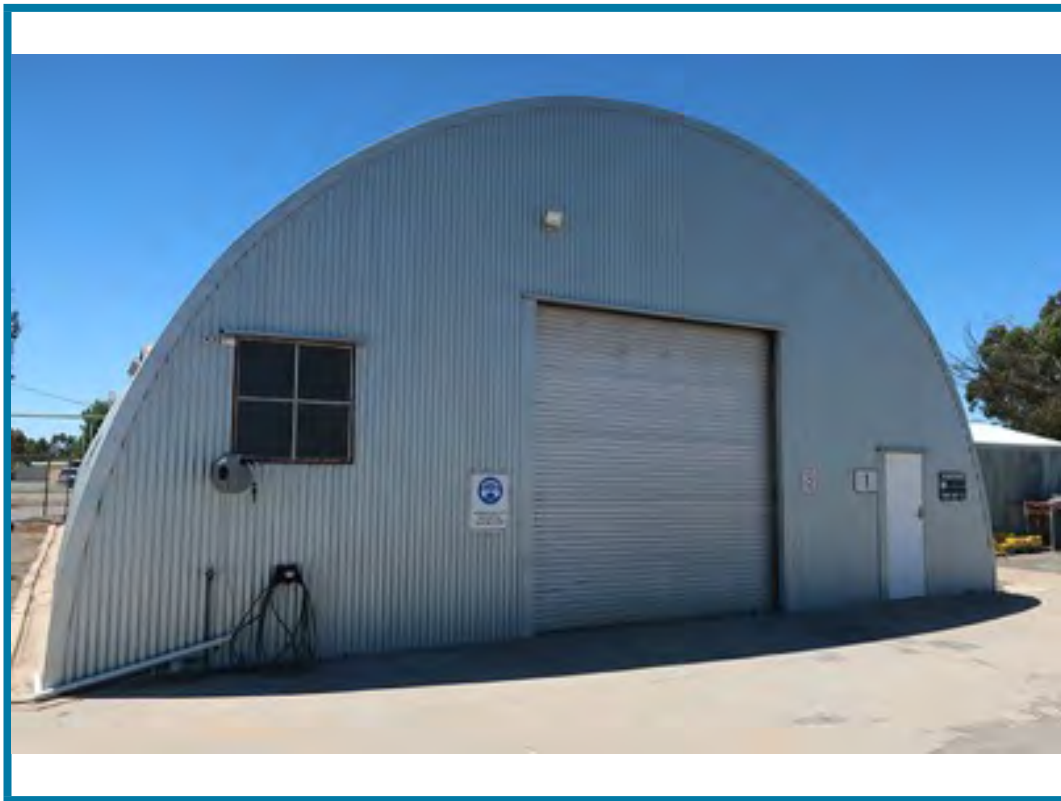
# Main building LB36 Shire Depot / Workshop

Location	Area	Component Materials	ACM Identified	Type Asbestos Assessment	Condition	Priority	Signage Required
Main building LB36 Shire Depot / Workshop - entire perimeter of building.		No Asbestos Materials	No	No sample taken - Visual ID

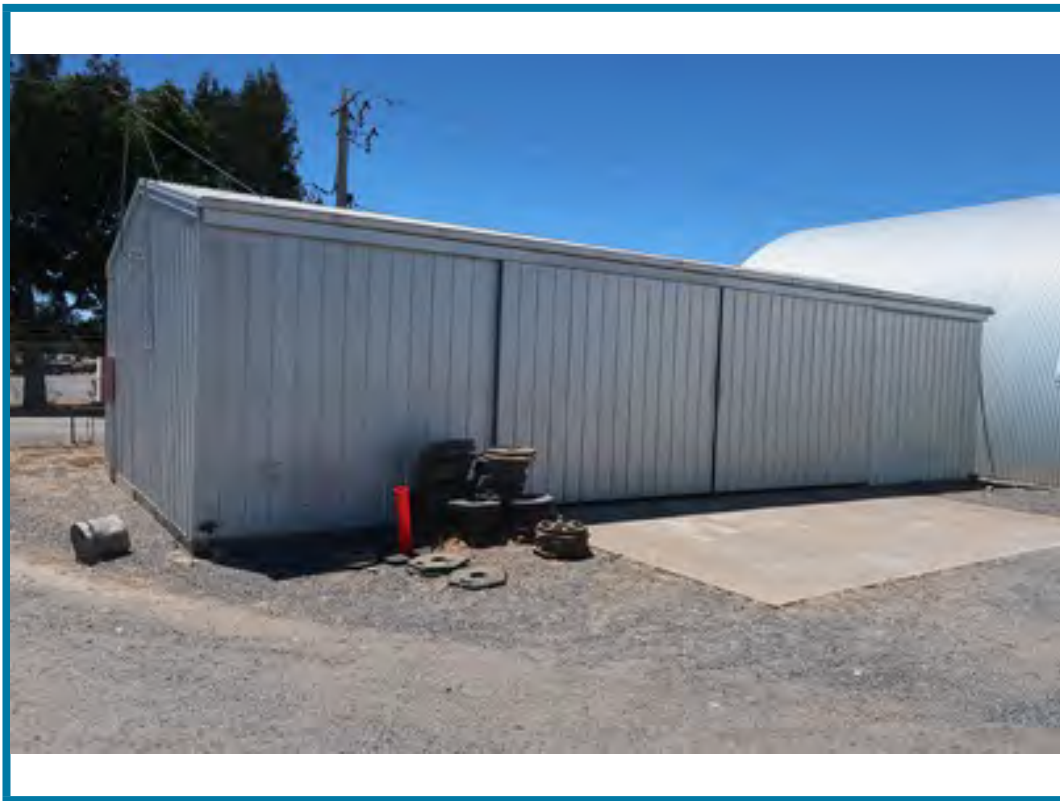
# Shed

Location	Area	Component Materials	ACM Identified	Type Asbestos Assessment	Condition Priority	Signage Required
Shed - entire perimeter of building.		No Asbestos Materials	No	No sample taken - Visual ID
