Asbestos Report

YARRIAMBIACK SHIRE COUNCIL

PROPERTY ADDRESS:
LR23 TIP LICENCE
1281 WIMMERA HIGHWAY
MURTOA VIC 3390

INSPECTION DATE: 10 FEBRUARY 2021
REFERENCE NUMBER: 62100

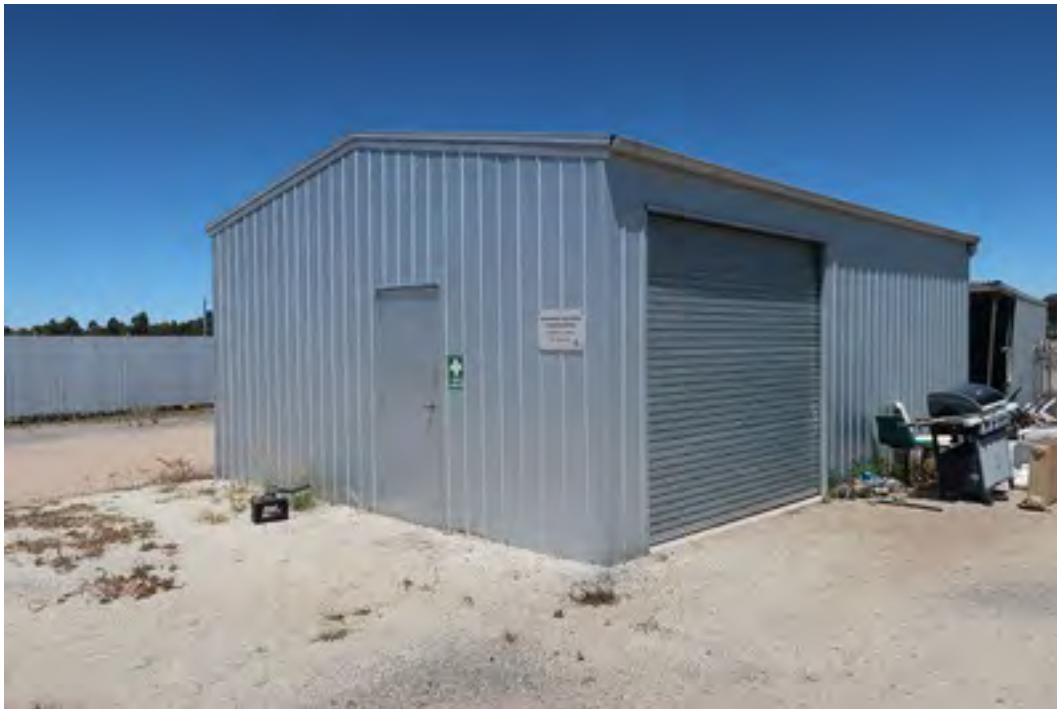
Shed 1

Area 4

RISK ASSESSMENT					
Type of Asbestos or Hazardous Material	No sample taken - No Access	Condition		Likelihood of Damage	
		Activity			
		Sealed		Friability	
		Labelled	No	Exposure Risk	
		Quantity

RISK CONTROL					
Priority	HIGH	Label Required	Yes	Re- Audit Date	10 Feb 2022
Action					
Recommendation					
Legislative Requirements Victorian Regulation 2007	Unable to Gain Access. Assume asbestos in area and provide monitoring if work undertaken in these areas. If access is made available, contact Global Asbestos Audits for re-inspection

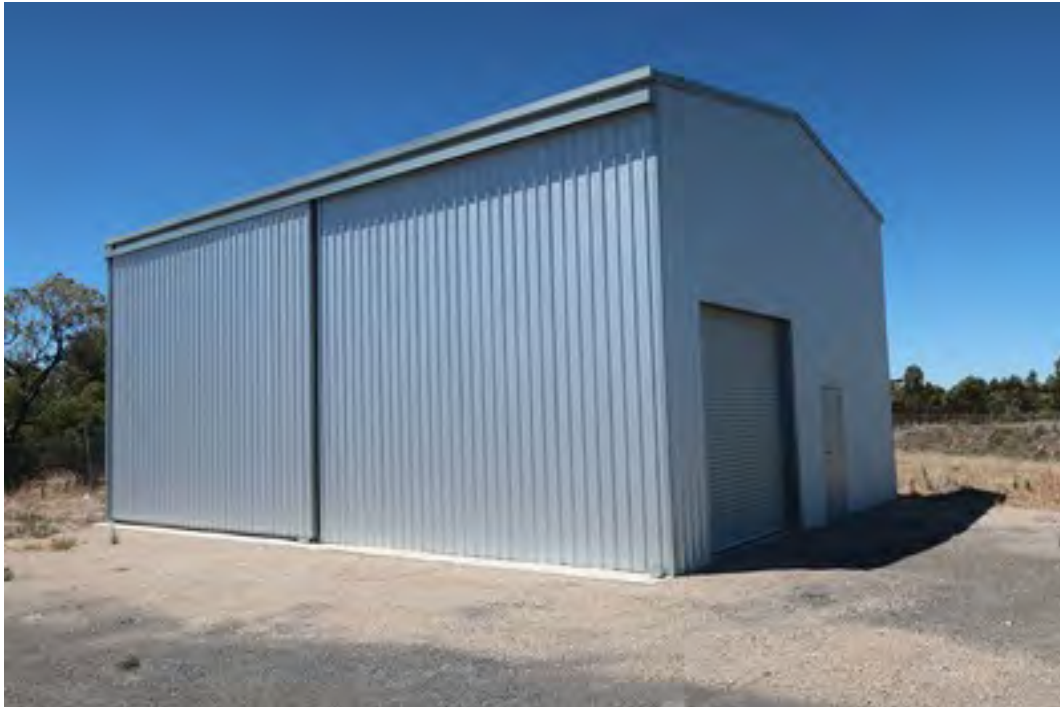
Shed 3

Area 5

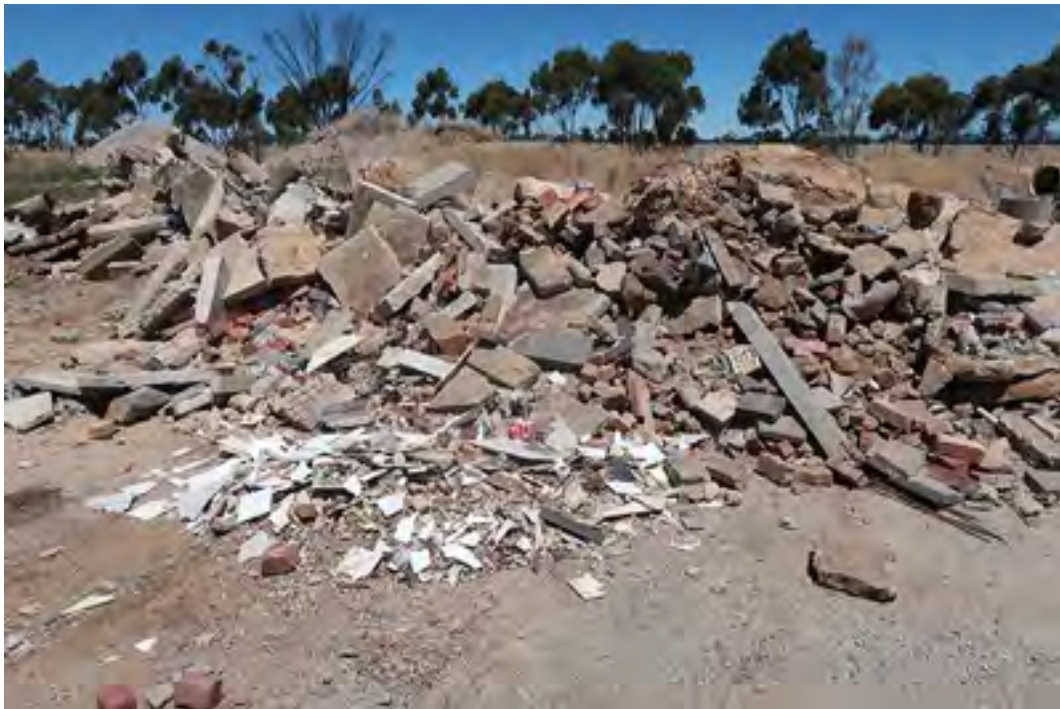
Tip pile

Area 2

Tip pile: The Debris - Broken (Debris) has Asbestos Containing Material (ACM) present.

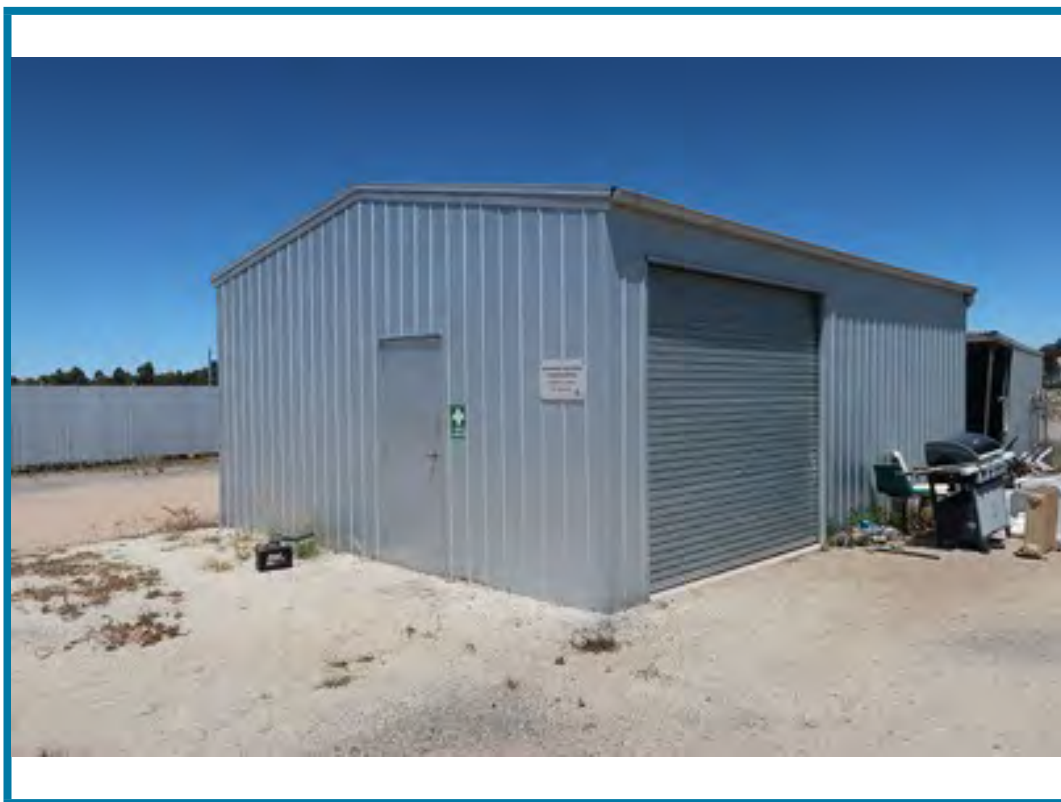
Location	Area	Component Materials	ACM Identified	Type Asbestos Assessment	Condition	Priority	Signage Required
Shed 1 - entire perimeter of building.		No Asbestos Materials	No	No sample taken - Visual ID

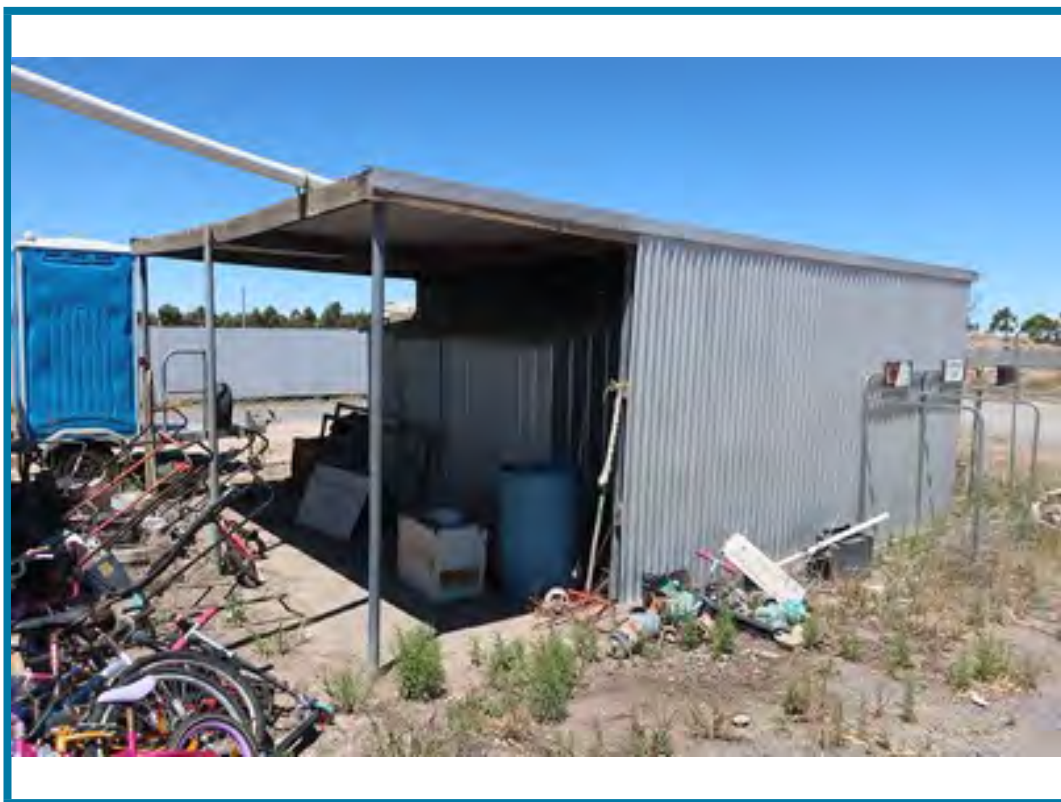
Location	Area	Component Materials	ACM Identified	Type Asbestos Assessment	Condition Priority	Signage Required
Shed 2 - entire perimeter of building.		No Asbestos Materials	No	No sample taken - Visual ID

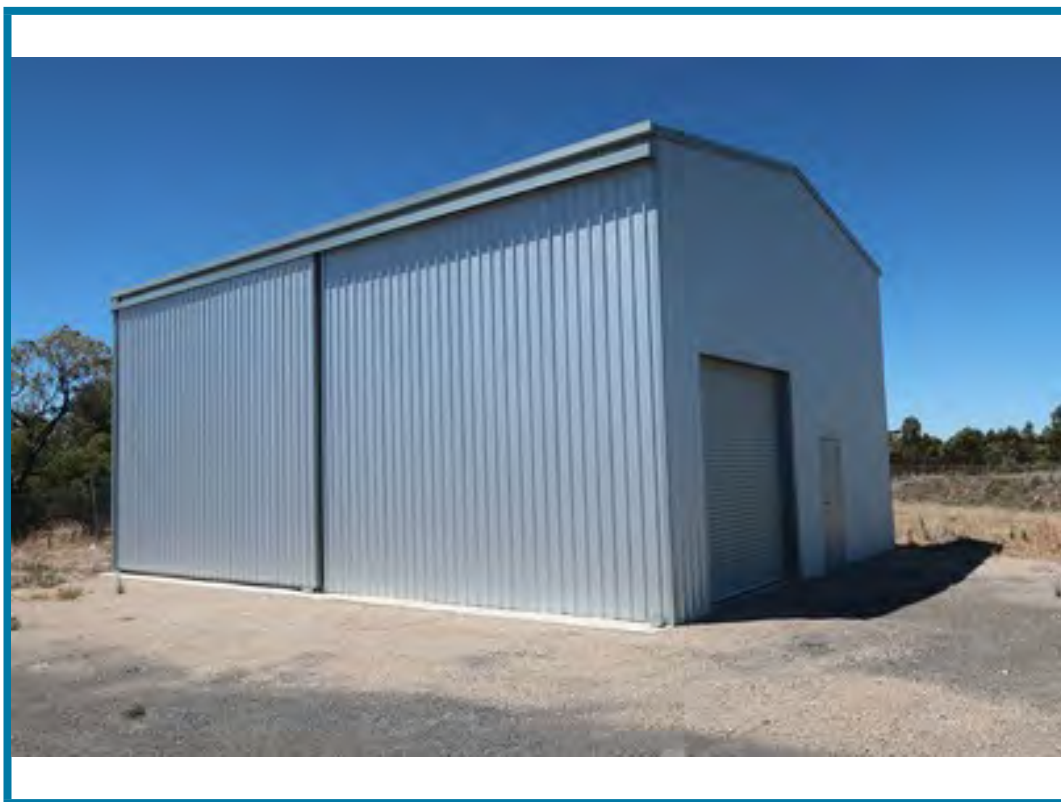
Location	Area	Component Materials	ACM Identified	Type Asbestos Assessment	Condition	Priority	Signage Required
Shed 3 - entire perimeter of building.		No Asbestos Materials	No	No sample taken - Visual ID

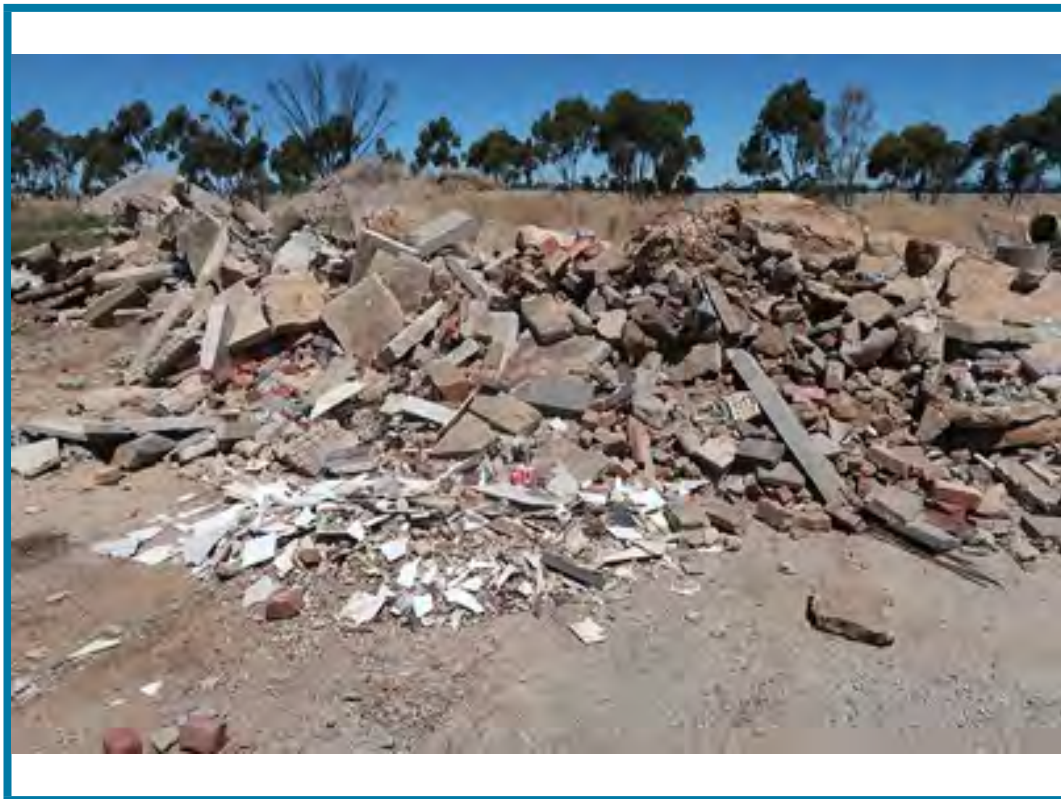
Location	Area	Component Materials	ACM Identified	Type Asbestos Assessment	Condition	Priority	Signage Required
Tip pile - Tip pile.	Debris - Broken	Debris	Yes	Chrysotile			
				Sample taken 62100-001			
					POOR	IMMEDIATE	Yes
				Refer to the Abestos Register for more information.			
Tip pile - Tip pile.	Pipe(s)	Debris/waste	Yes	Chrysotile Amosite Crocidolite			
					POOR	IMMEDIATE	Yes
				Refer to the Abestos Register for more information.			
Tip pile - Tip pile; surrounding areas.	Debris - Broken	Debris	Yes	Chrysotile			
				Same as Sample - 62100-001			
					POOR	IMMEDIATE	Yes
				Refer to the Abestos Register for more information.
