Asbestos Report

YARRIAMBIACK SHIRE COUNCIL

PROPERTY ADDRESS:
LB82 TOILET BLOCK
34-36 MARMA STREET
MURTOA VIC 3390

INSPECTION DATE: 10 FEBRUARY 2021
REFERENCE NUMBER: 62101

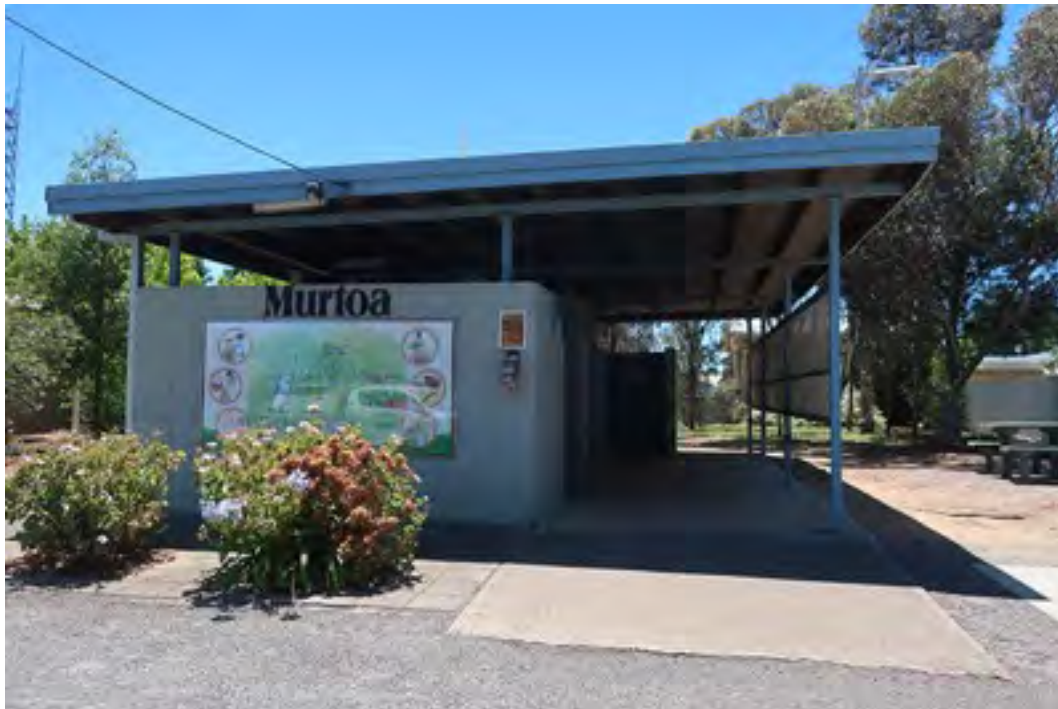
ASBESTOS REGISTER: LB82 Toilet Block, 34-36 Marma Street, Murtoa VIC 3390

Area 1**Toilet block LB82 Toilet Block: front of building. The Service pit (Fibrous Cement Product) has Asbestos Containing Material (ACM) present.****RISK ASSESSMENT**

Type of Asbestos or Hazardous Material	Chrysotile	Condition	AVERAGE	Likelihood of Damage	M (Medium) - likely
	Amosite	Activity	Moderate		
	Sample taken 62101-001	Sealed	No	Friability	Bonded (non-friable)
		Labelled	Y	Exposure Risk	Medium - Moderate risk
		Quantity
