Asbestos Report

YARRIAMBIACK SHIRE COUNCIL

PROPERTY ADDRESS:
LR29 RUBBISH TIP
38 PATCHEWOLLOCK TIP ROAD
PATCHEWOLLOCK VIC 3491

INSPECTION DATE: 10 FEBRUARY 2021
REFERENCE NUMBER: 62105

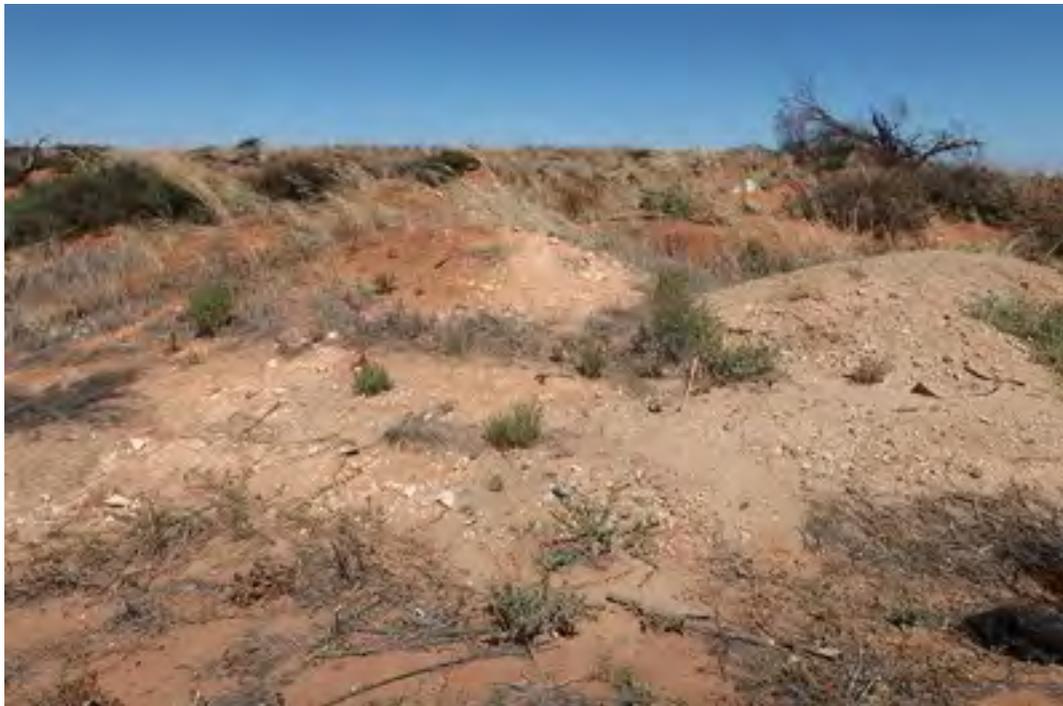
ASBESTOS REGISTER: LR29 Rubbish Tip, 38 Patchewollock Tip Road, Patchewollock VIC 3491

Area 1**Grounds: The Debris - Broken (Debris) has Asbestos Containing Material (ACM) present.****RISK ASSESSMENT**

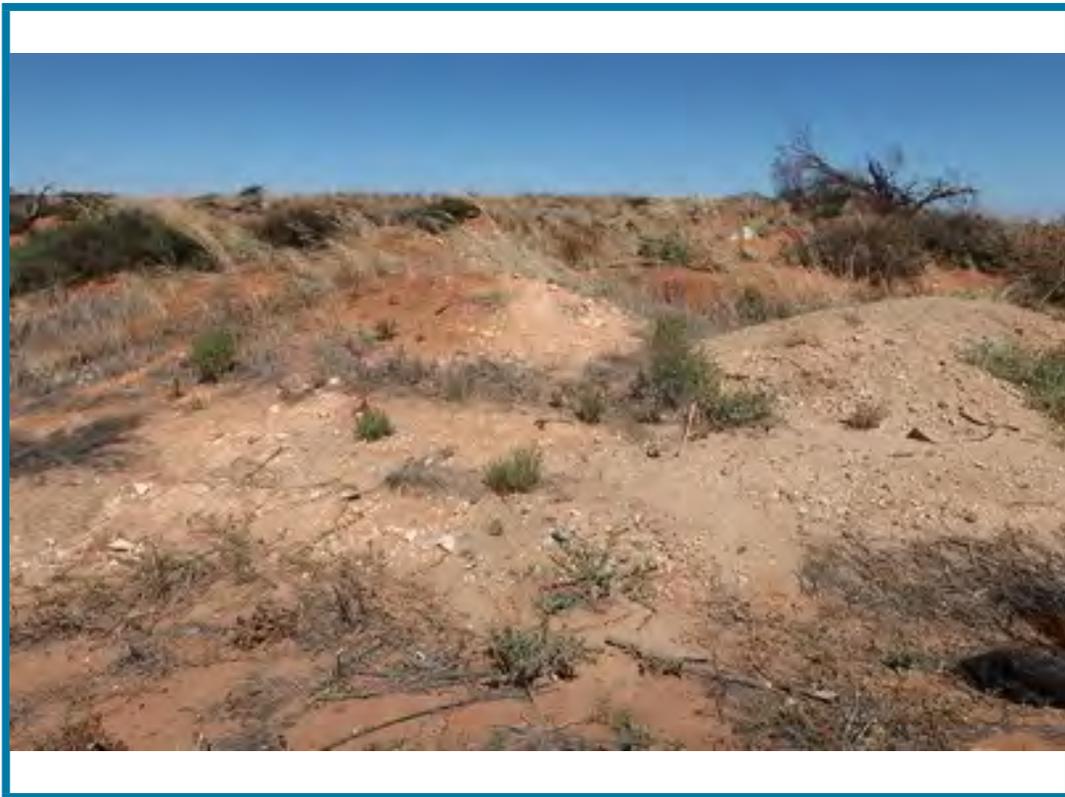
Location	Area	Component Materials	ACM Identified	Type Asbestos Assessment	Condition	Priority	Signage Required
Grounds - Grounds.	Debris - Broken	Debris	Yes	Chrysotile	Sample taken 62105-001	POOR IMMEDIATE	Yes
