# Asbestos Report

YARRIAMBIACK SHIRE COUNCIL

PROPERTY ADDRESS:  
LB115 IWC / PRESCHOOL  
55 CROMIE STREET  
RUPANYUP VIC 3388

INSPECTION DATE: 10 FEBRUARY 2021  
REFERENCE NUMBER: 62110

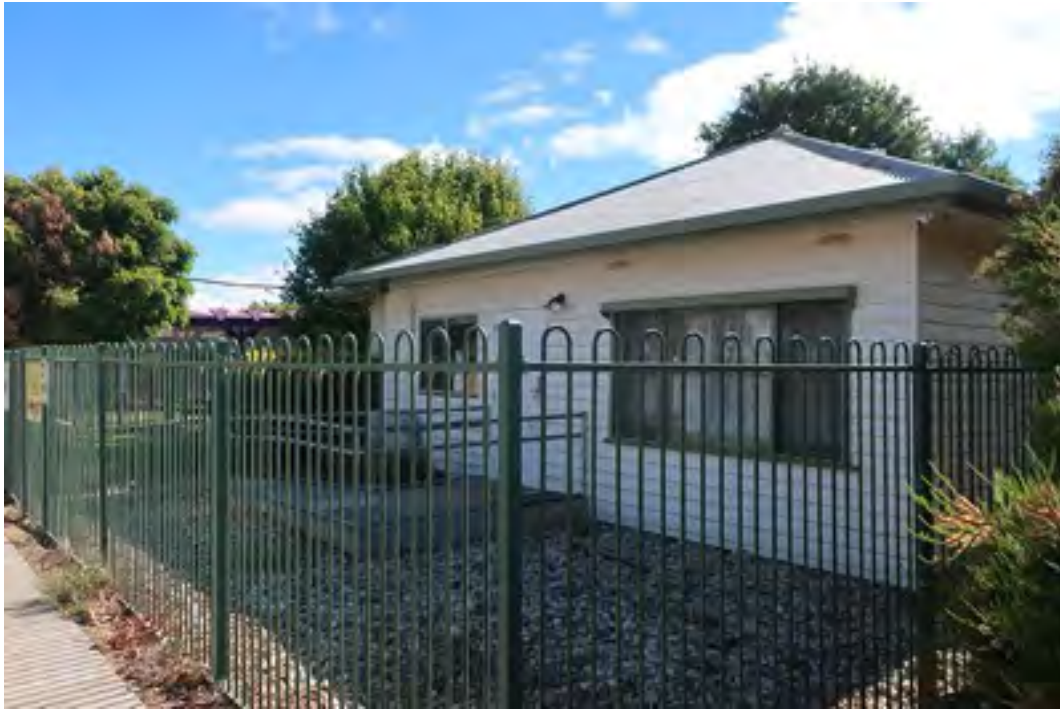
**Area 1**

<b>Type of Asbestos or Hazardous Material</b>	No sample taken - Visual ID	<b>Condition</b>	AVERAGE	<b>Likelihood of Damage</b>	L (Low) – possible
		<b>Activity</b>	Moderate		
		<b>Sealed</b>	No	<b>Friability</b>	Bonded (non-friable)
		<b>Labelled</b>	Y	<b>Exposure Risk</b>	Medium - Moderate risk
		<b>Quantity</b>

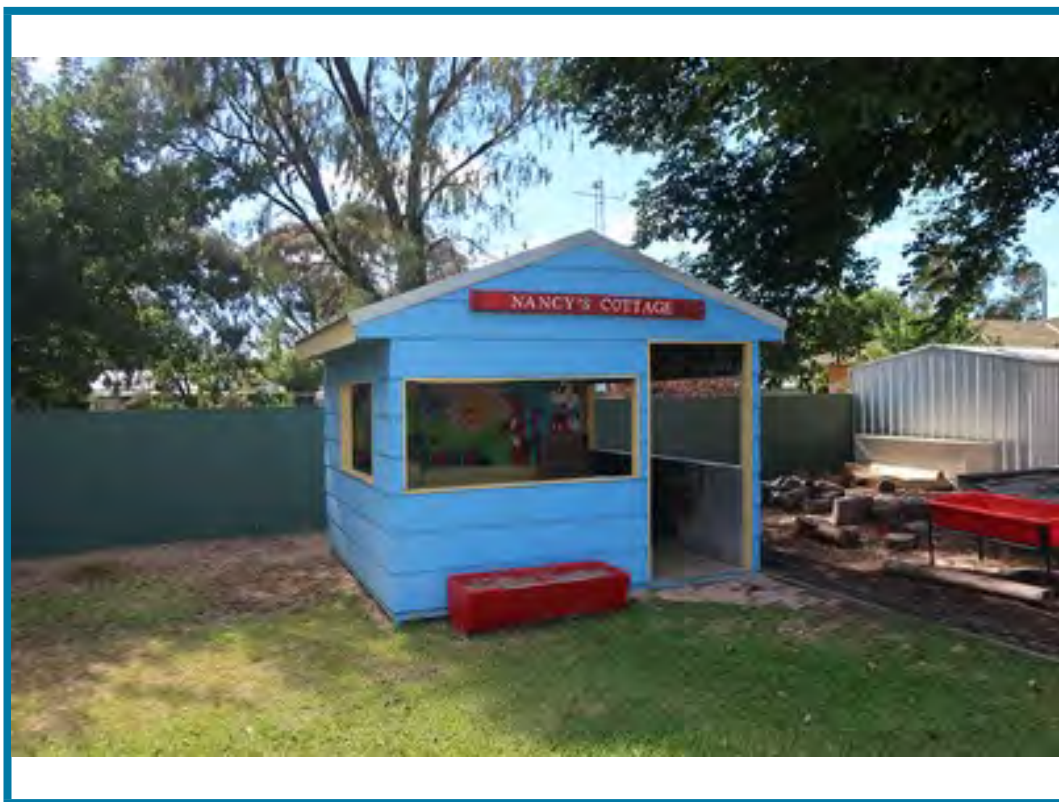
# Cubby

Location	Area	Component Materials	ACM Identified	Type Asbestos Assessment	Condition Priority	Signage Required
Cubby - entire perimeter of building.	Walls	F C Sheeting	No	No Asbestos Detected		
					Sample taken 62110-006

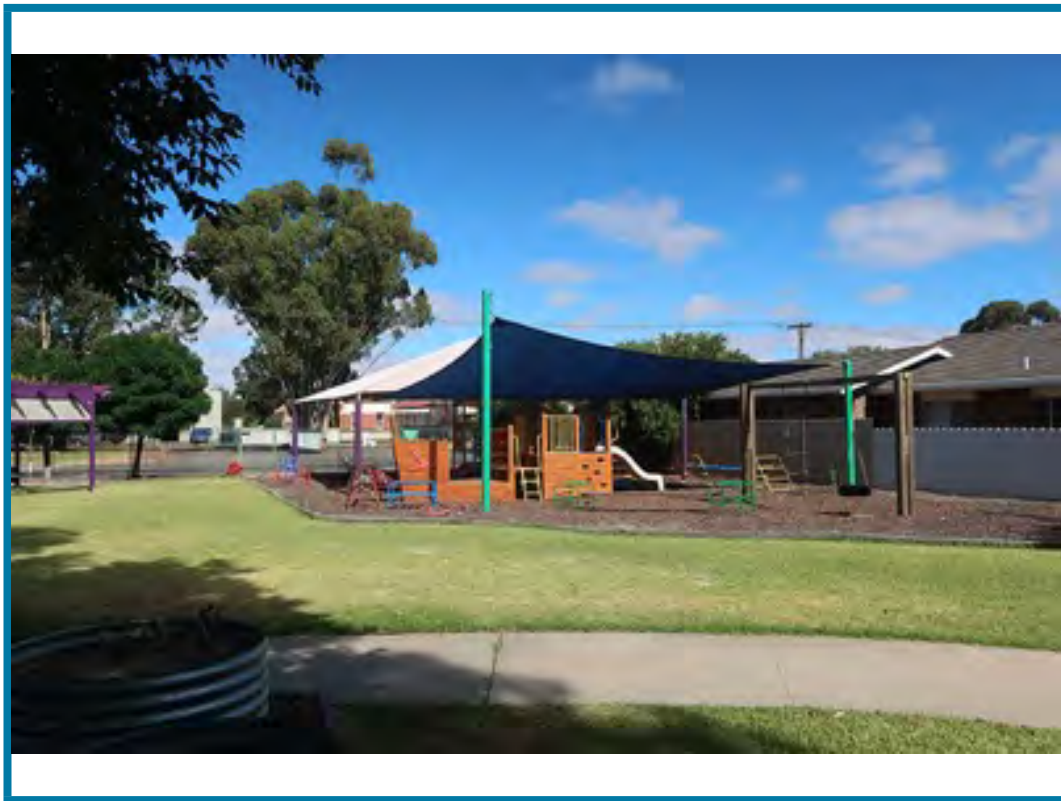
# Grounds

Location	Area	Component Materials	ACM Identified	Type Asbestos Assessment	ConditionPriority	Signage Required
Grounds - Playground.		No Asbestos Materials	No	No sample taken - Visual ID

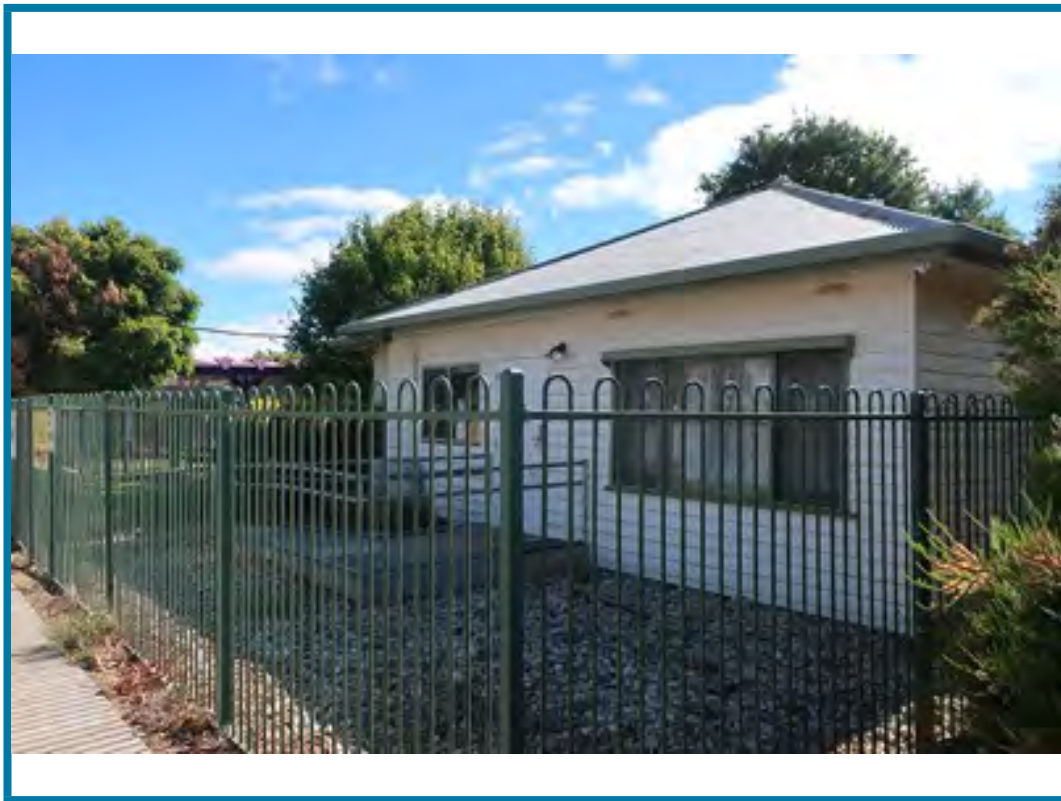
# LB115 IWC / Preschool

Location	Area	Component Materials	ACM Identified	Type Asbestos Assessment	ConditionPriority	Signage Required
LB115 IWC / Preschool - front of building.		No Asbestos Materials	No	No sample taken - Visual ID
