# Asbestos Report

YARRIAMBIACK SHIRE COUNCIL

PROPERTY ADDRESS:  
LR25 RUBBISH TIP  
141 BOYDS ROAD  
RUPANYUP VIC 3388

INSPECTION DATE: 10 FEBRUARY 2021  
REFERENCE NUMBER: 62113

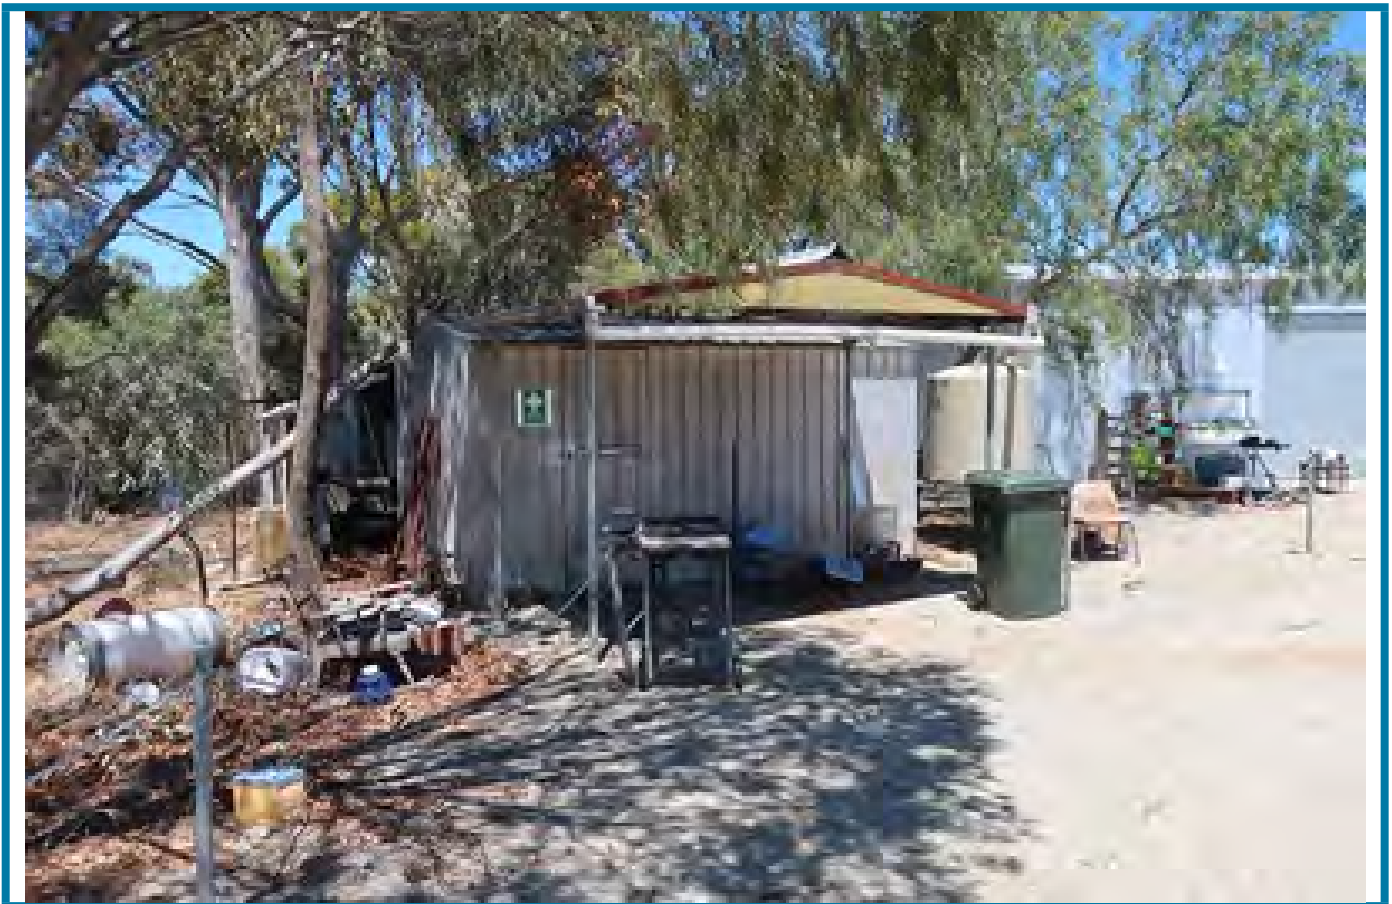
Location	Area	Component Materials	ACM Identified	Type Asbestos Assessment	Condition Priority	Signage Required
Second chance shed - entire perimeter of building.		No Asbestos Materials	No	No sample taken - Visual ID
