Asbestos Report

YARRIAMBIACK SHIRE COUNCIL

PROPERTY ADDRESS:
RUBBISH TIP
3270 SUNRAYSIA HIGHWAY
SPEED VIC 3489

INSPECTION DATE: 11 FEBRUARY 2021
REFERENCE NUMBER: 62118

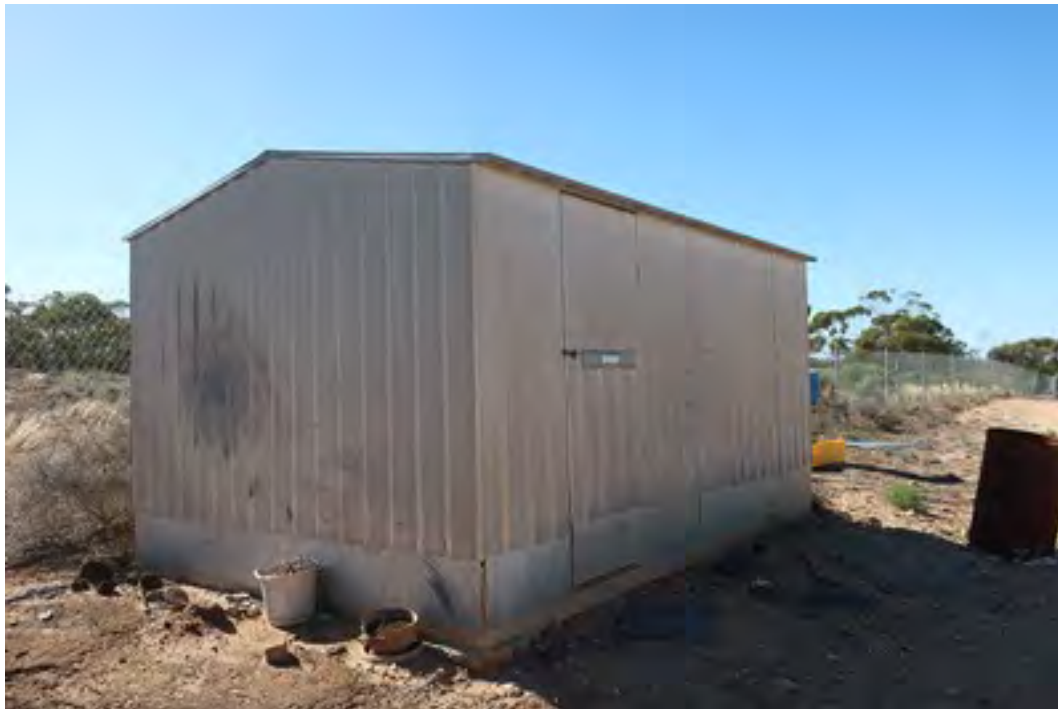
Area 2

2 Shed Rubbish Tip: left side of building. The Debris - Broken (Debris) has Asbestos Containing Material (ACM) present.

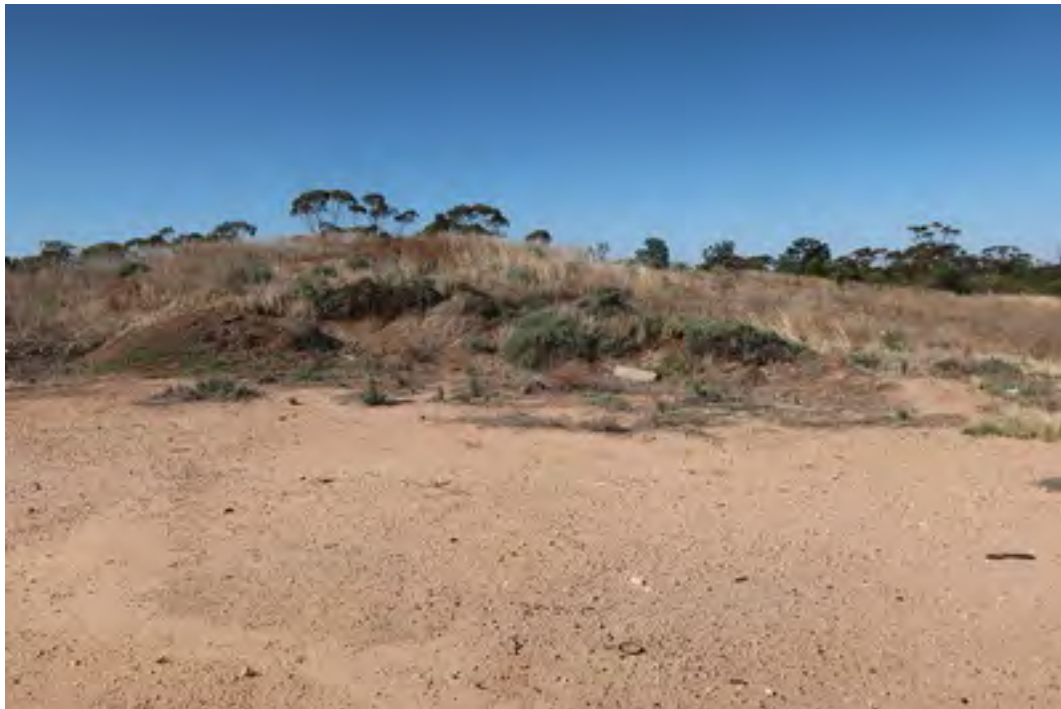
Area 1

1 Grounds: The Debris - Broken (Debris) has Asbestos Containing Material (ACM) present.

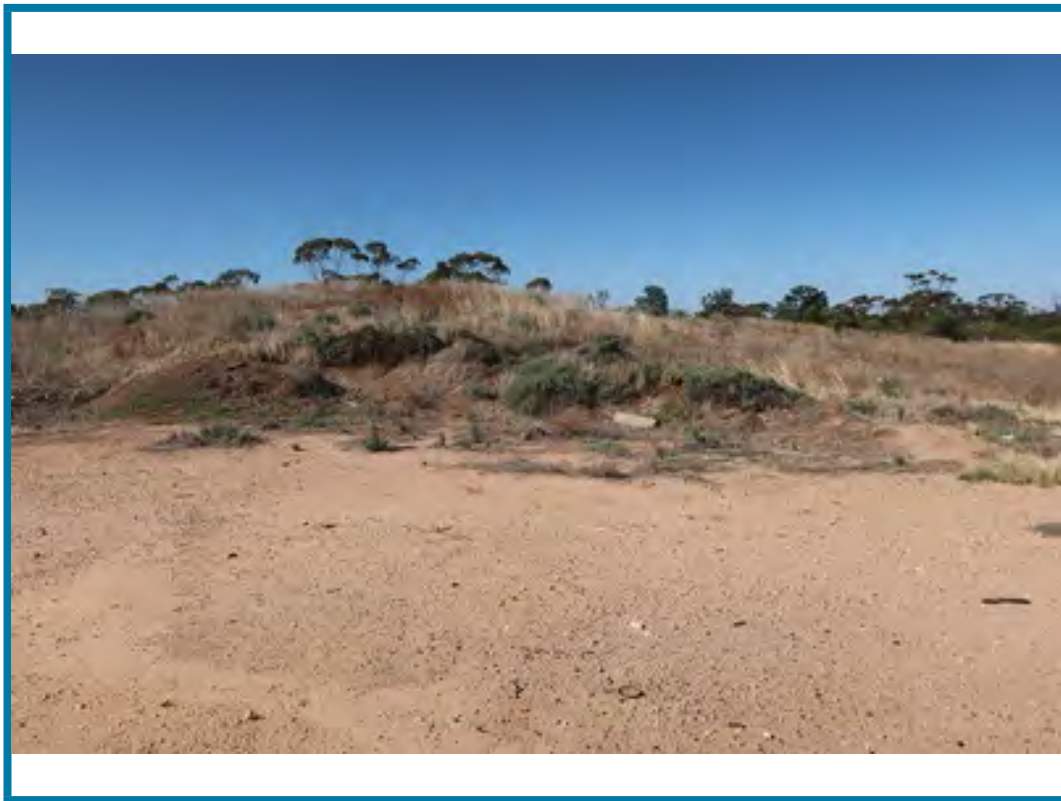
Location	Area	Component Materials	ACM Identified	Type Asbestos Assessment	ConditionPriority	Signage Required
Grounds - Grounds.	Debris - Broken	Debris	Yes	No sample taken - Visual ID	POOR IMMEDIATE	Yes
				Refer to the Abestos Register for more information.		
Grounds - Grounds.	Debris - Broken	Debris	No	No Asbestos Detected		
				Sample taken 62118-001

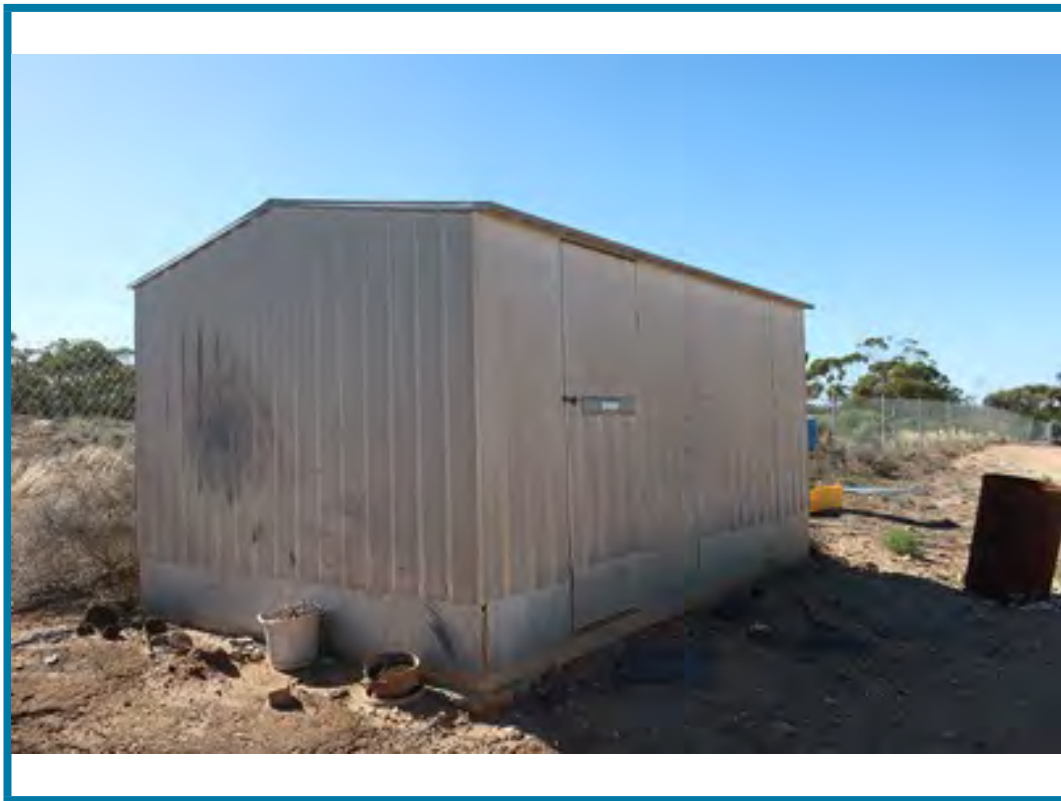
Location	Area	Component Materials	ACM Identified	Type Asbestos Assessment	Condition	Priority	Signage Required
Shed Rubbish Tip - entire perimeter of building.		No Asbestos Materials	No	No sample taken - Visual ID
