Asbestos Report

YARRIAMBIACK SHIRE COUNCIL

PROPERTY ADDRESS:
LB91 INFANT WELFARE CENTRE
8 BOSCHERT STREET
TEMPY VIC 3489

INSPECTION DATE: 11 FEBRUARY 2021
REFERENCE NUMBER: 62119

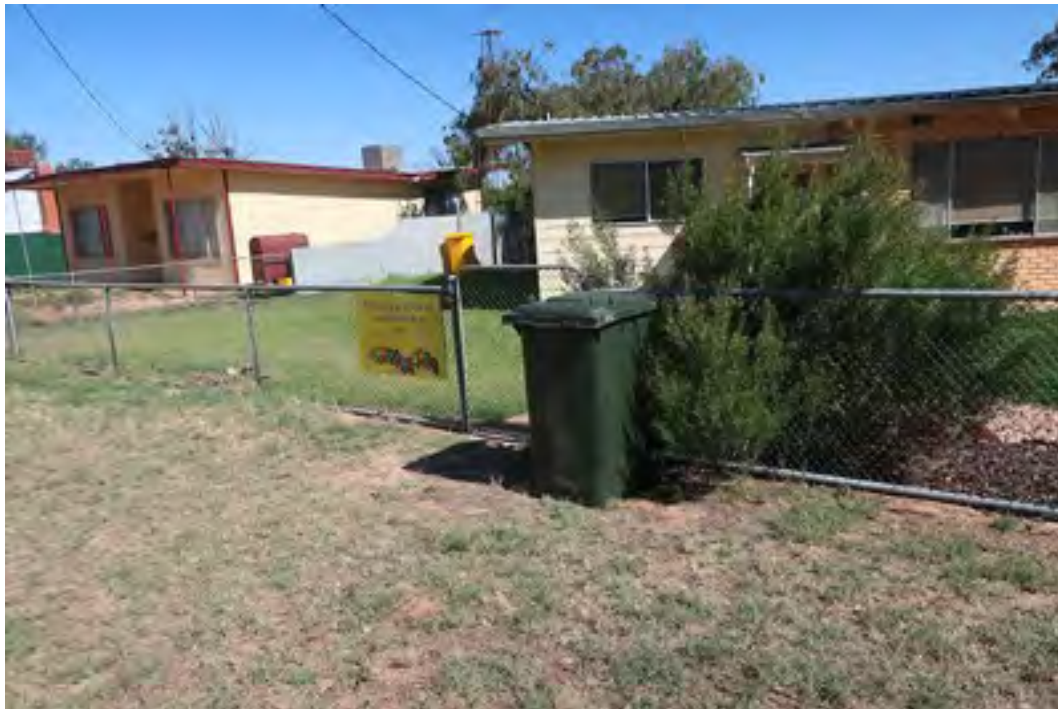
Area 2**Main building: entire perimeter of building. The Soffit (F C Sheeting) has Asbestos Containing Material (ACM) present.****RISK ASSESSMENT**

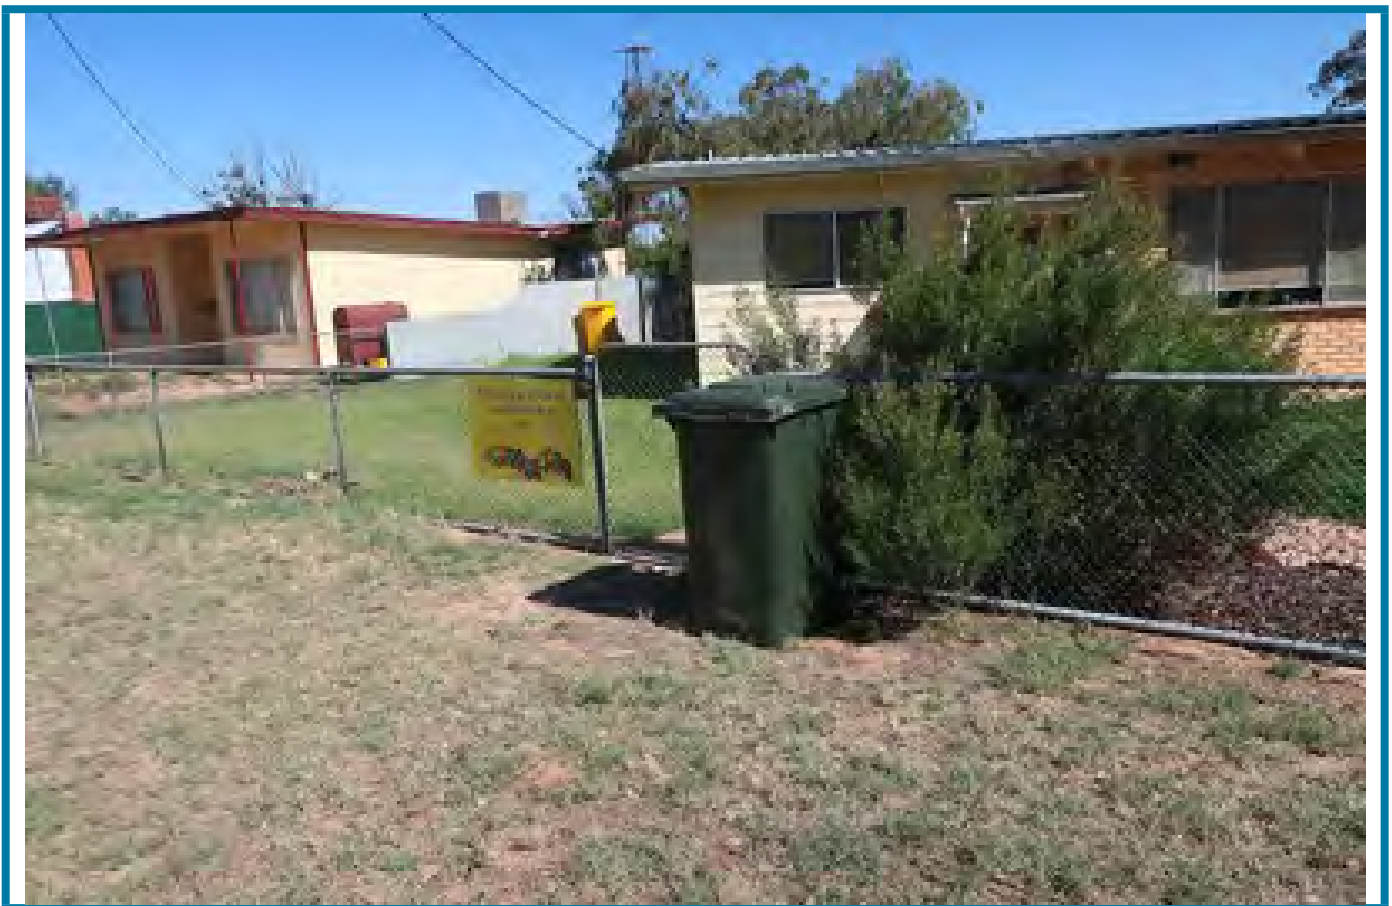
Location	Area	Component Materials	ACM Identified	Type Asbestos Assessment	Condition	Priority	Signage Required
Main building - Entry 1.	Gable Ends	Masonite	No	No sample taken - Visual ID
