Asbestos Report

YARRIAMBIACK SHIRE COUNCIL

PROPERTY ADDRESS:
LB25 MEMORIAL PARK PAVILLION
2 STATION STREET
TEMPY VIC 3489

INSPECTION DATE: 11 FEBRUARY 2021
REFERENCE NUMBER: 62120

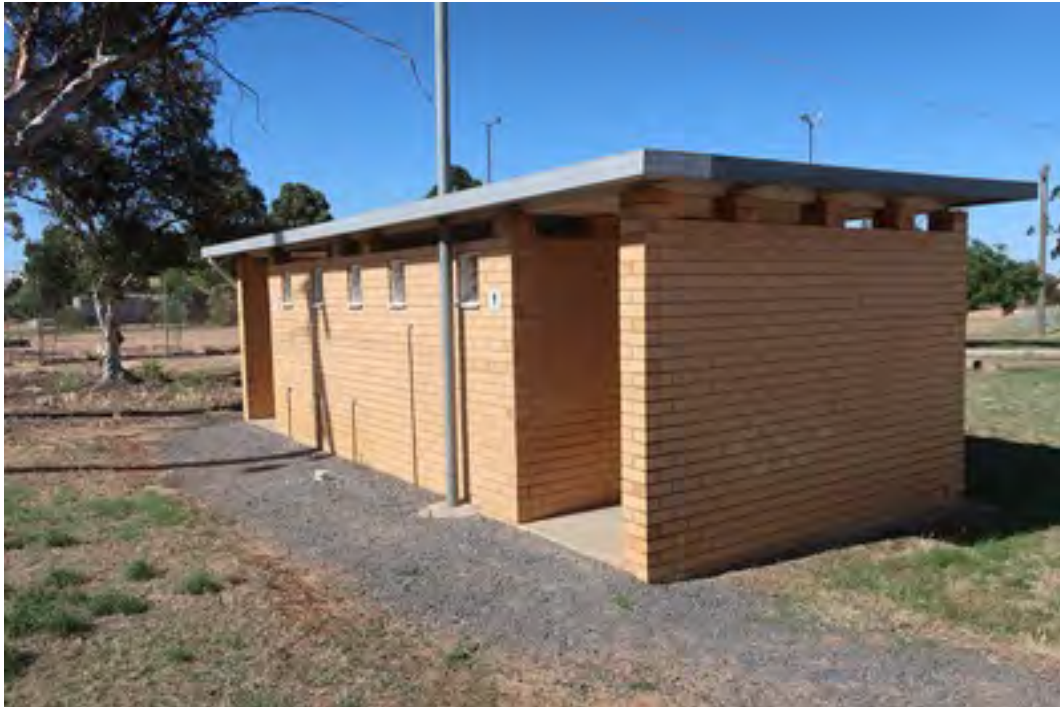
Toilets

Area 8

| RISK ASSESSMENT | | | | | |
|--|---|---|---|---|---|
| Type of Asbestos or Hazardous Material | Chrysotile | Condition | GOOD | Likelihood of Damage | L (Low) – possible |

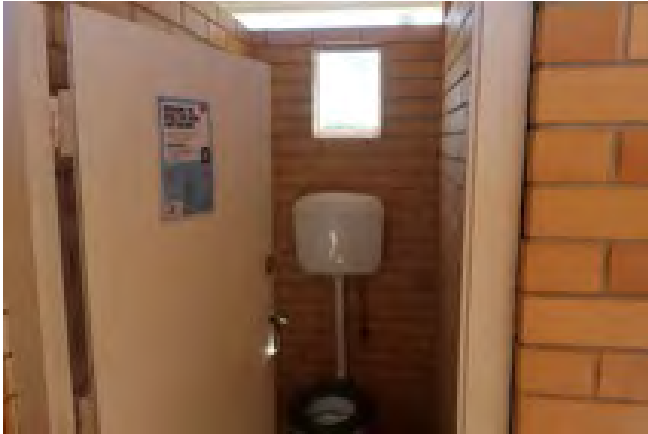
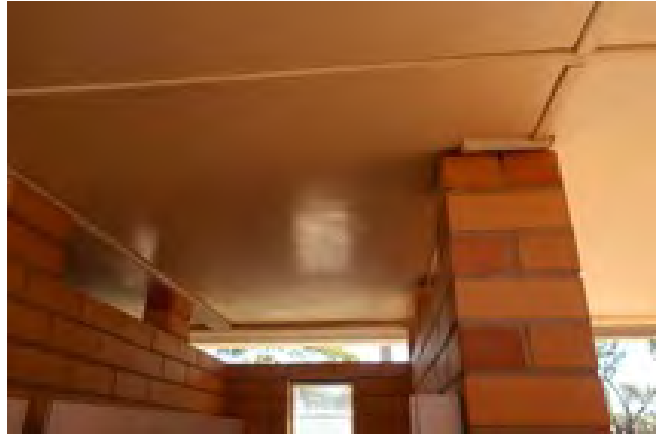
Room

| RISK ASSESSMENT | | | | | |
|--|---|---|---|---|---|
| | | Labelled | Y | Exposure Risk | Low - Negligible or low risk |

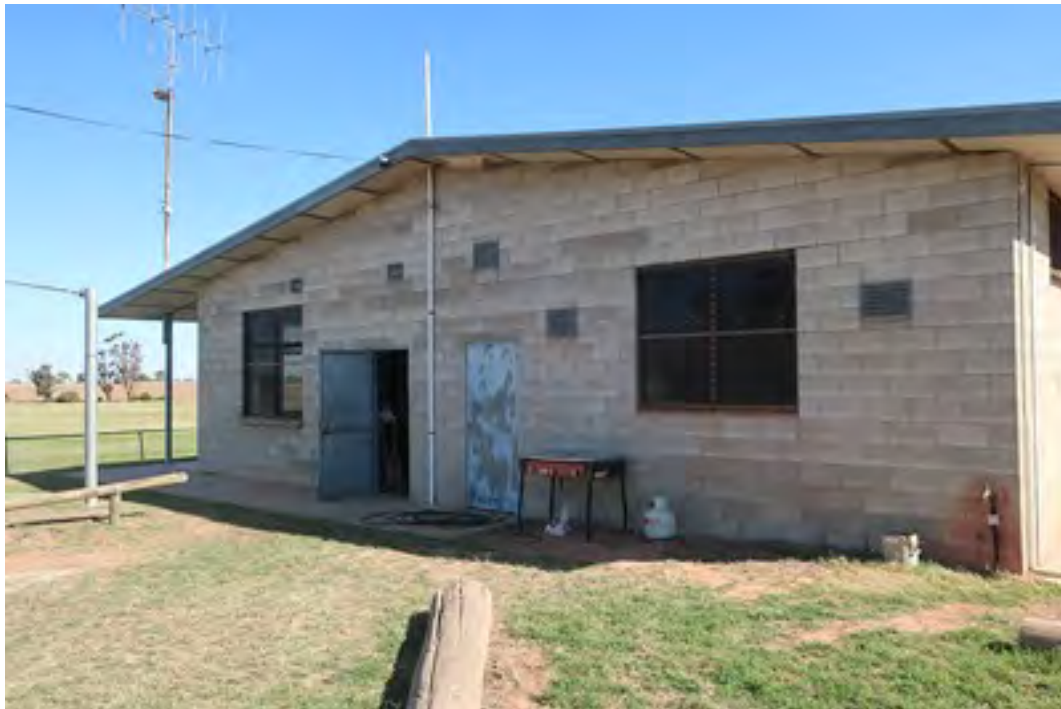
Clubrooms

Area 5

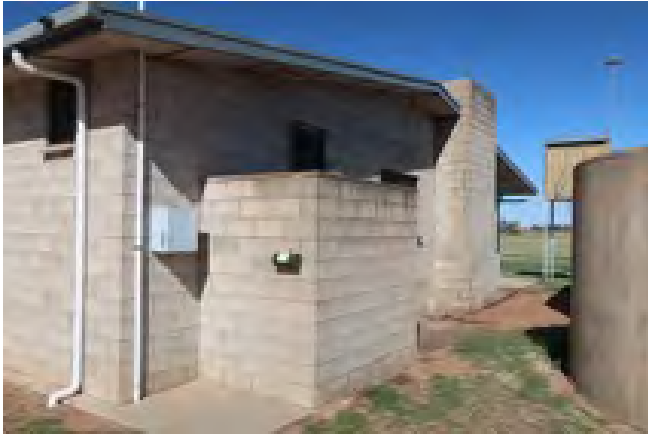
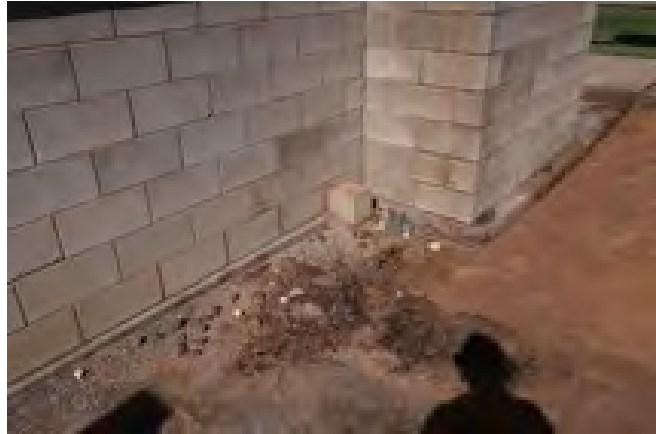
External

- 1 **Clubrooms: right side of building. The Debris - Broken (Debris) has Asbestos Containing Material (ACM) present.**

| | | Labelled | No | Exposure Risk | High - Short term exposure risk |

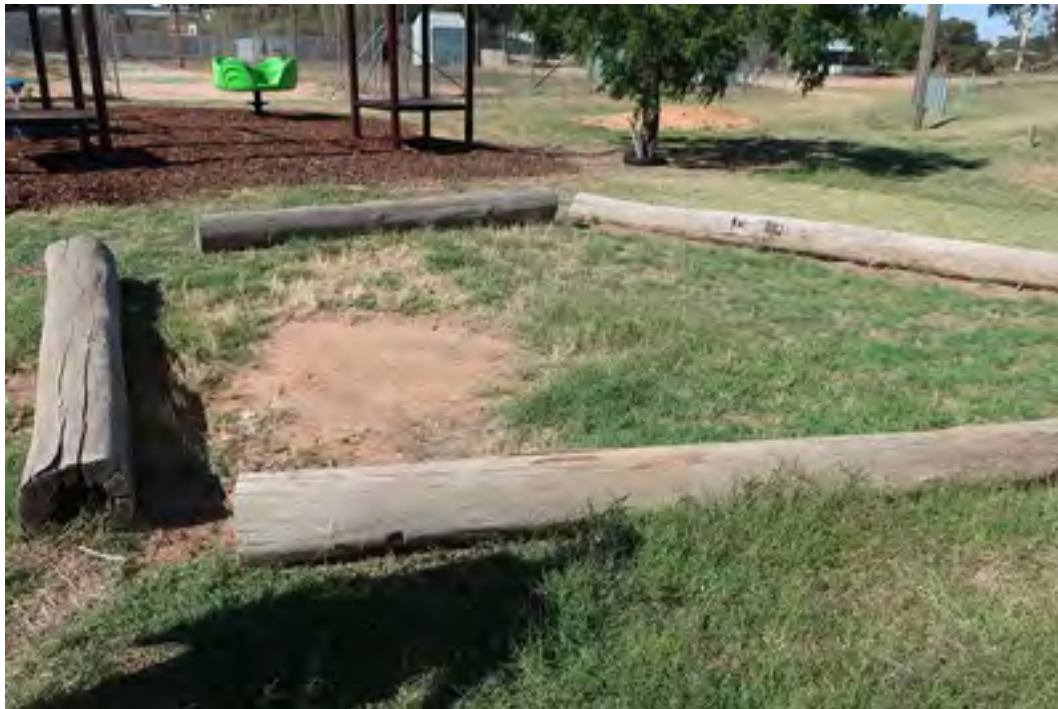
Grounds

Area 2

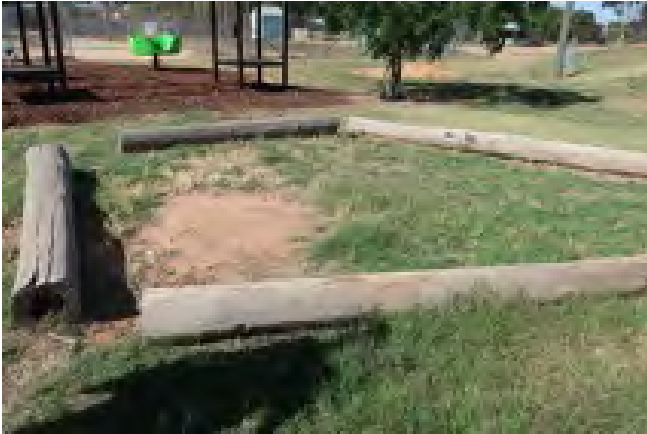
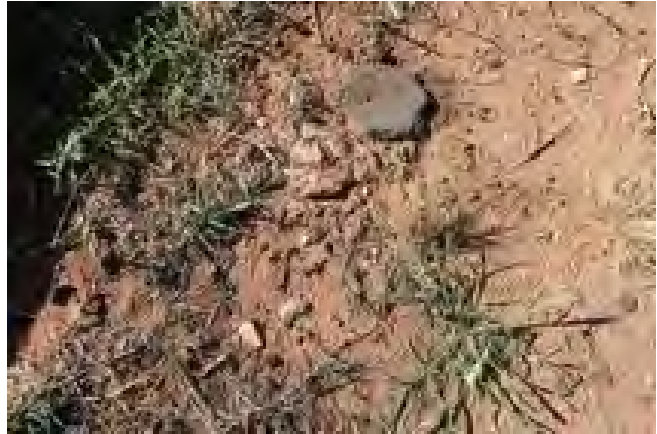
External

- 2 **Grounds: Seating area. The Debris - Broken (Debris) has Asbestos Containing Material (ACM) present.**

- 2 Grounds: Seating area. The Debris - Broken (Debris) has Asbestos Containing Material (ACM) present.

| RISK ASSESSMENT | | | | | |
|--|---|---|---|---|---|
| | | Labelled | No | Exposure Risk | High - Short term exposure risk |

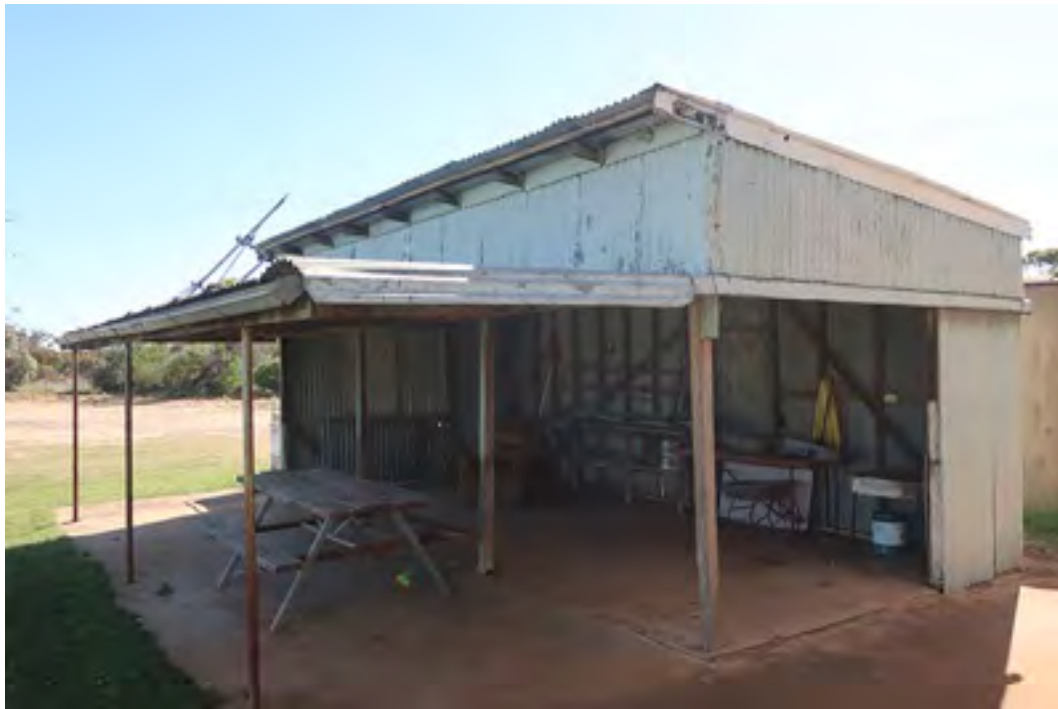
Shed

Area 3

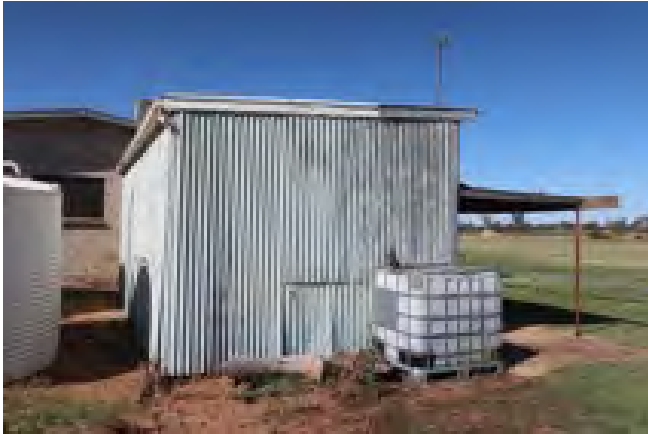
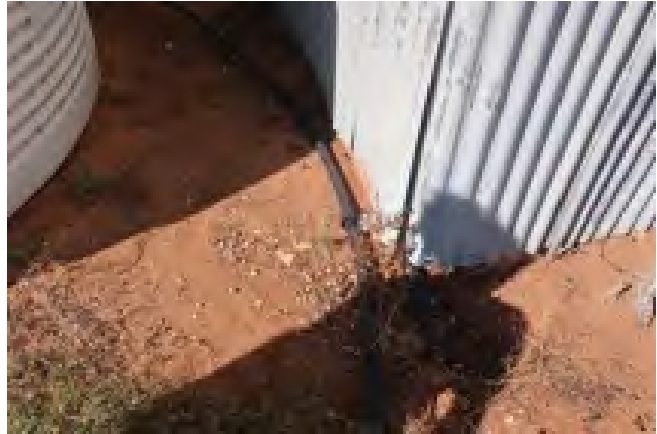
External

3 Shed: left side of building. The Debris - Broken (Debris) has Asbestos Containing Material (ACM) present.

| RISK ASSESSMENT | | | | | |
|--|---|---|---|---|---|
| | | Labelled | No | Exposure Risk | High - Short term exposure risk |
